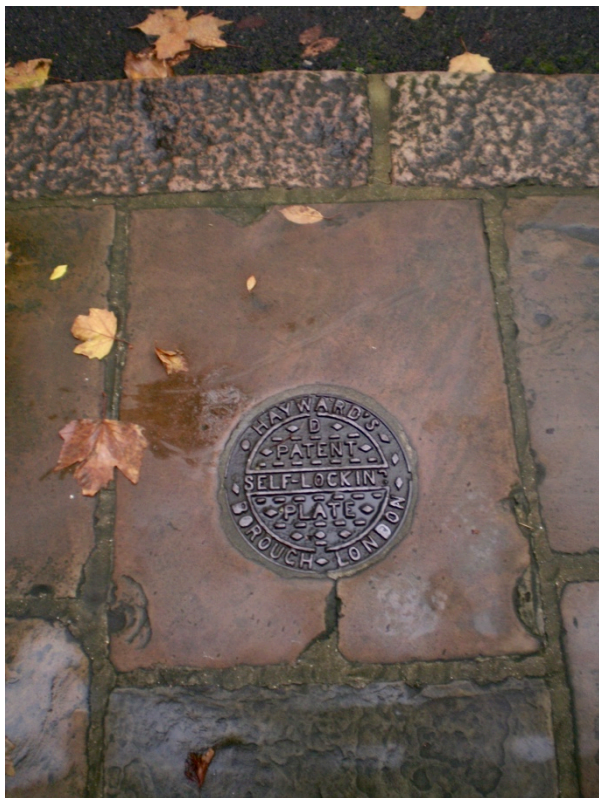
Example of cast iron coalhole plate, later replacement - Medium Significance.

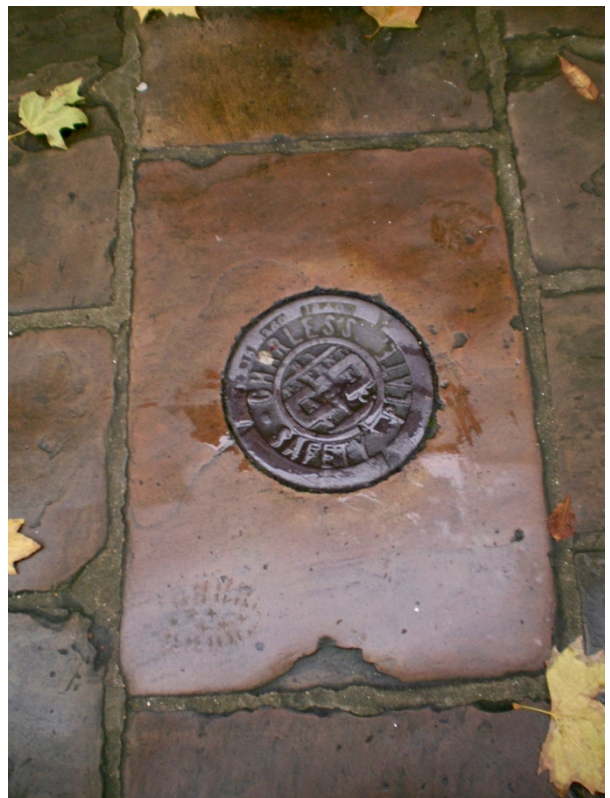
Example of cast iron coalhole plate, probably original - Medium - Significance.

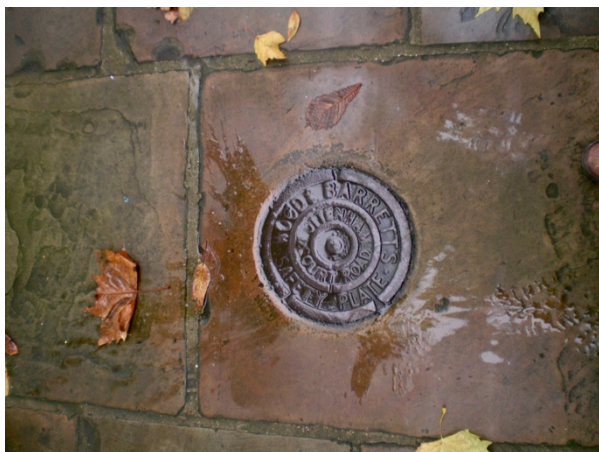
Example of cast iron coalhole plate, probably original - Medium Significance.

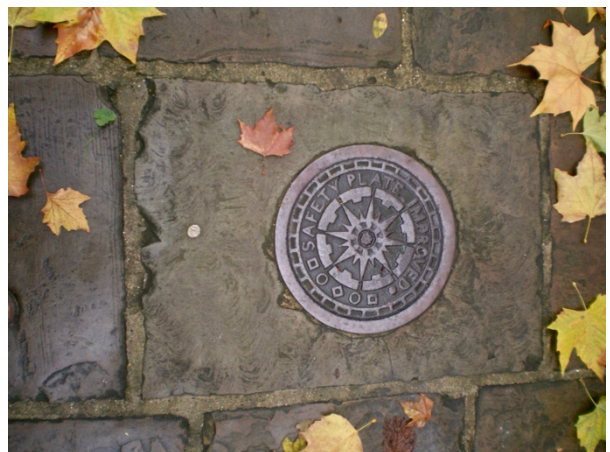
Example of cast iron coalhole plate, later replacement - Medium Significance.

York Stone Paving and Granite Kerbs - Medium Significance. Note: wide cemented joints indicate that paving has been relaid in modern times.

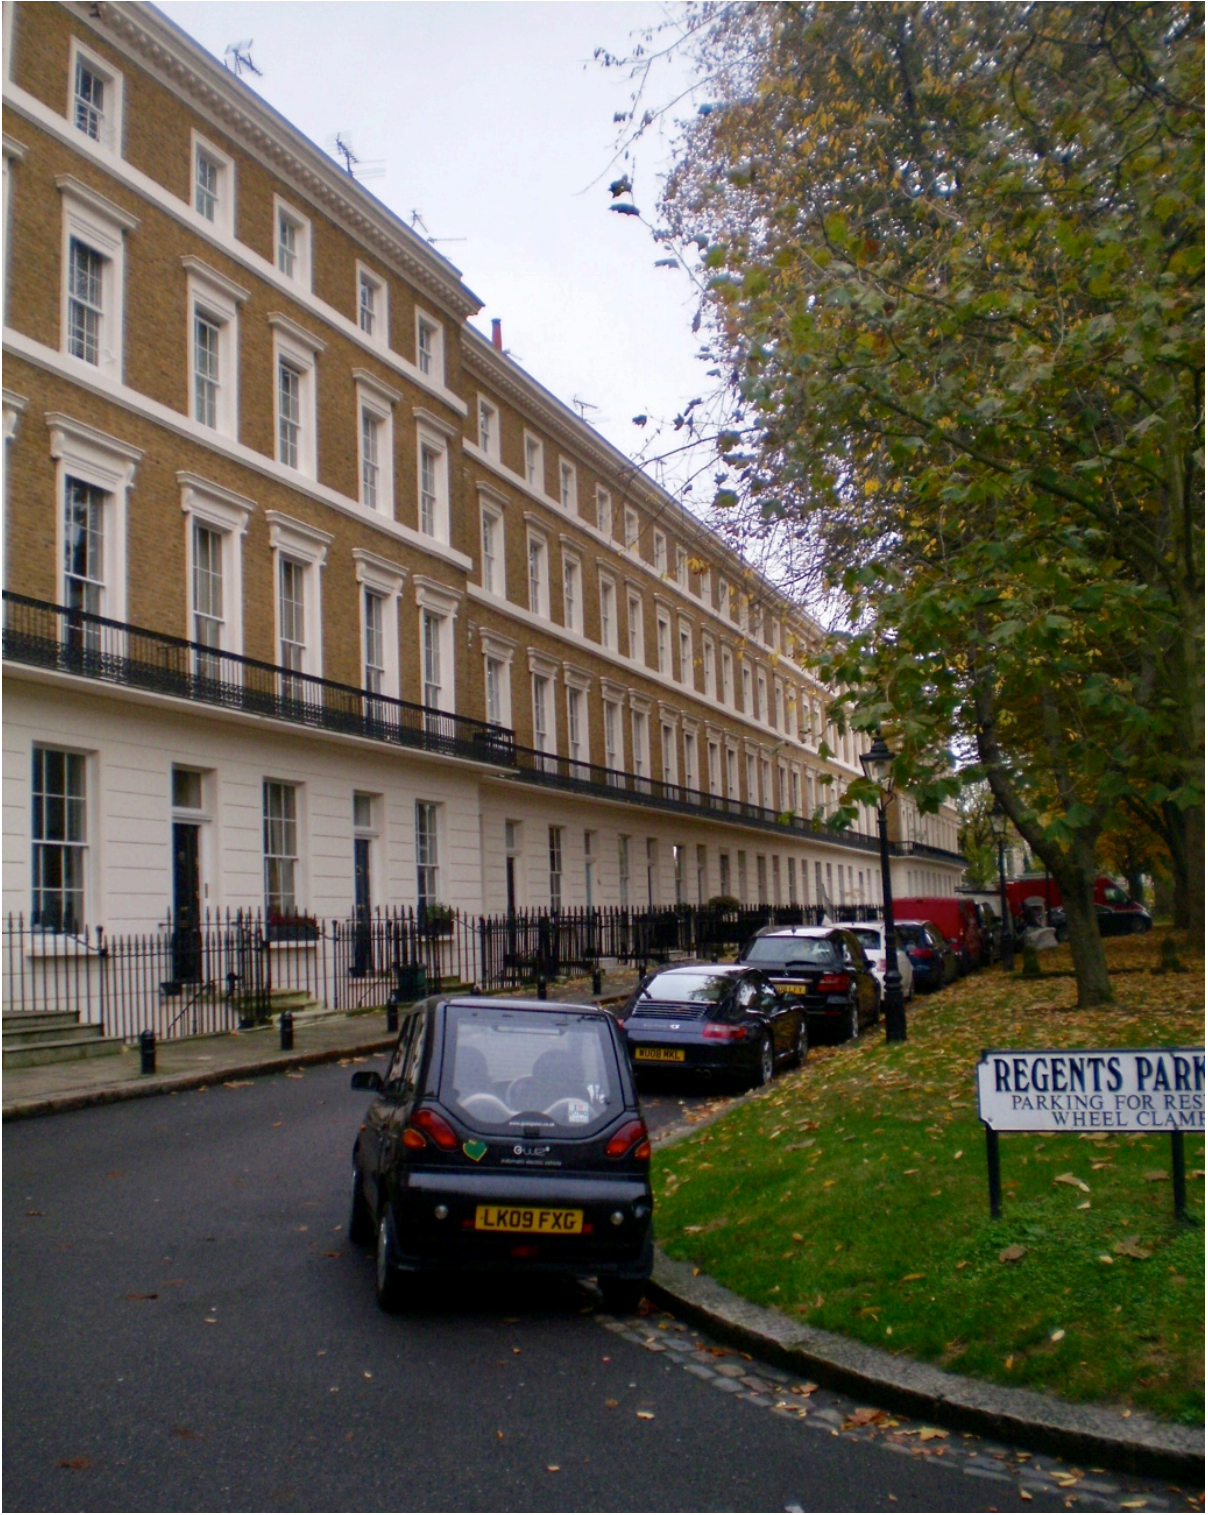
Regent's Park Terrace front elevation viewed from the north, overall - High Significance.

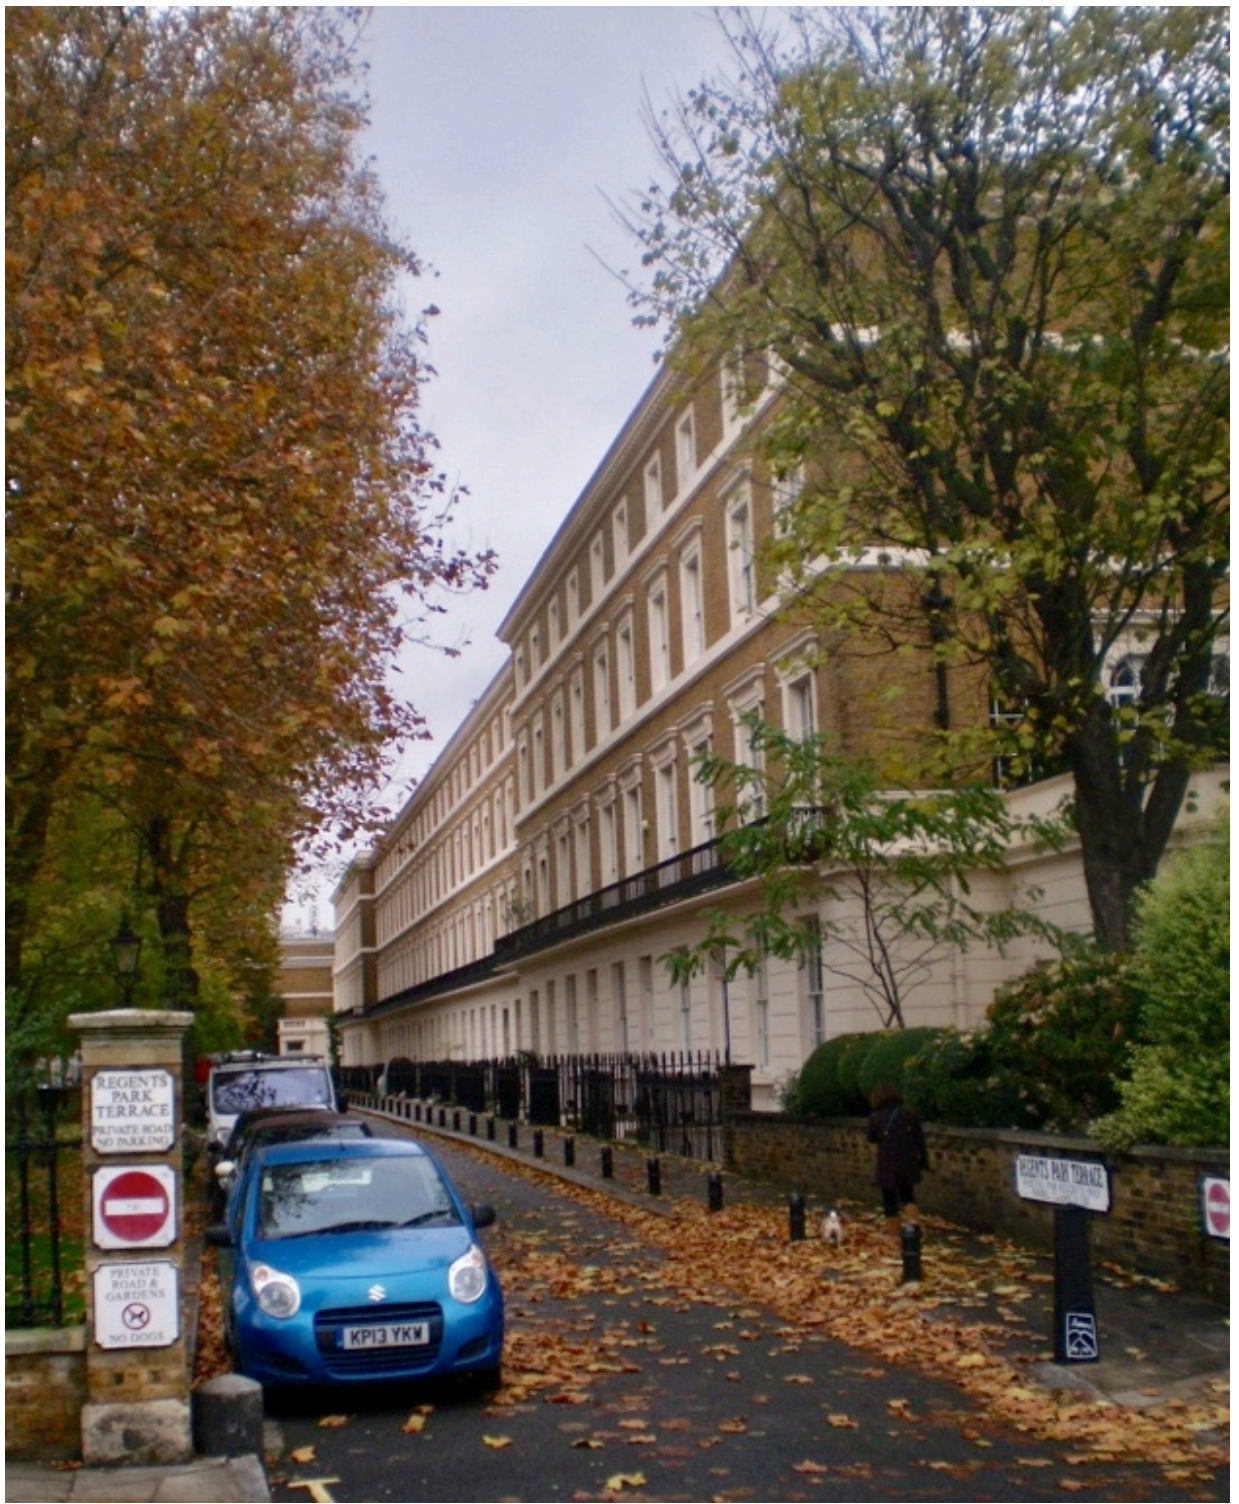
Regent's Park Terrace view from the south, overall - High Significance.

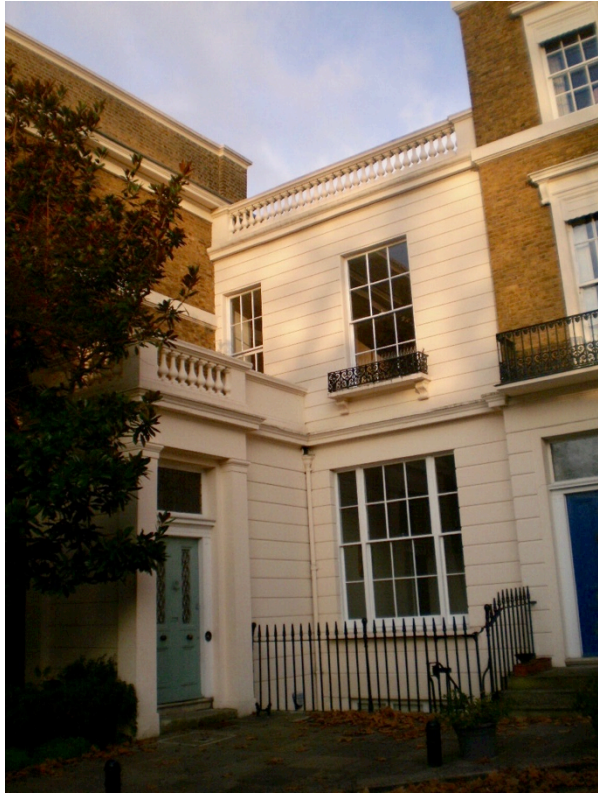
No. 22 Regent's Park Terrace, probably a later infill - High Significance.

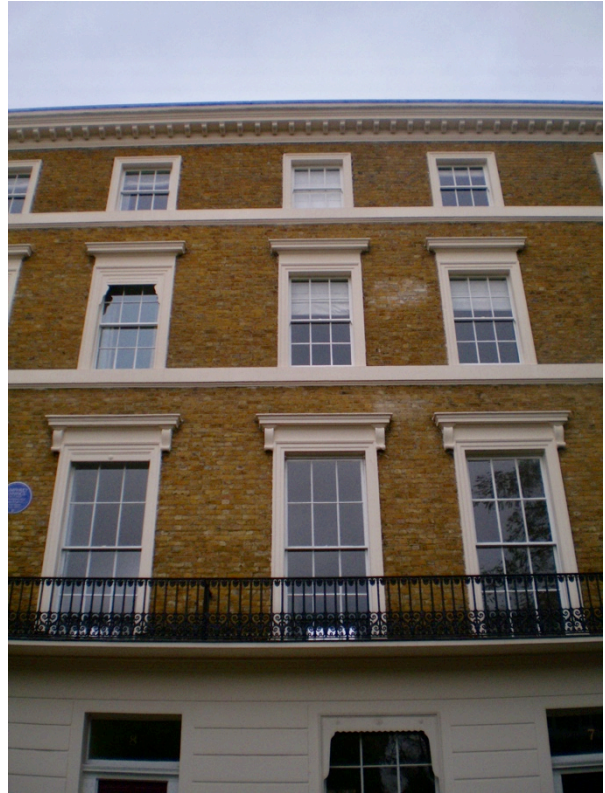
First floor stone balcony with cast iron railings. Windows with stucco architraves and corniced heads to first and second floors, Sliding sash windows. High Significance.

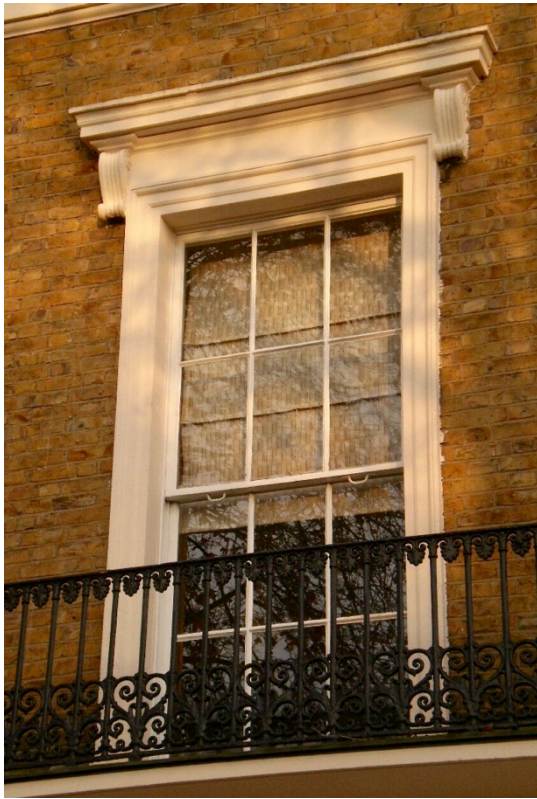
Detail of First Floor Window with bracketed cornice - High Significance

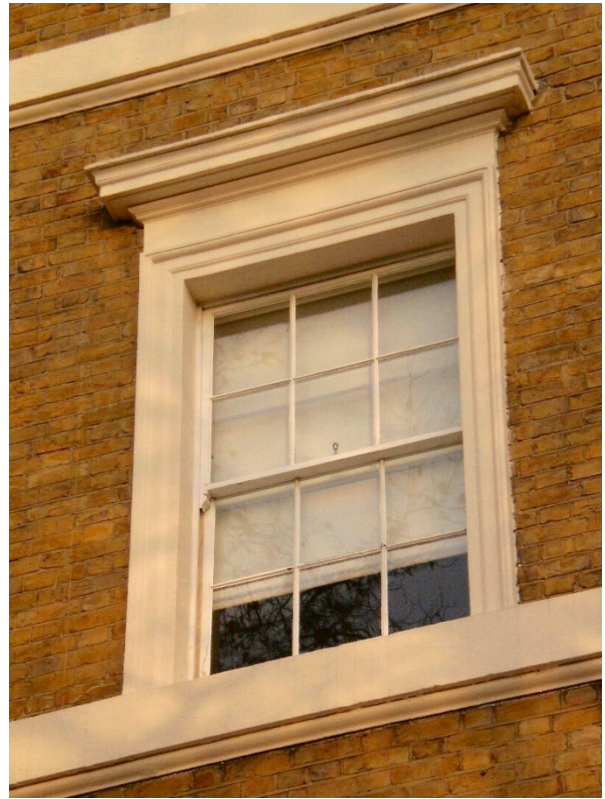
Detail of Second Floor Window with cornice - High Significance.

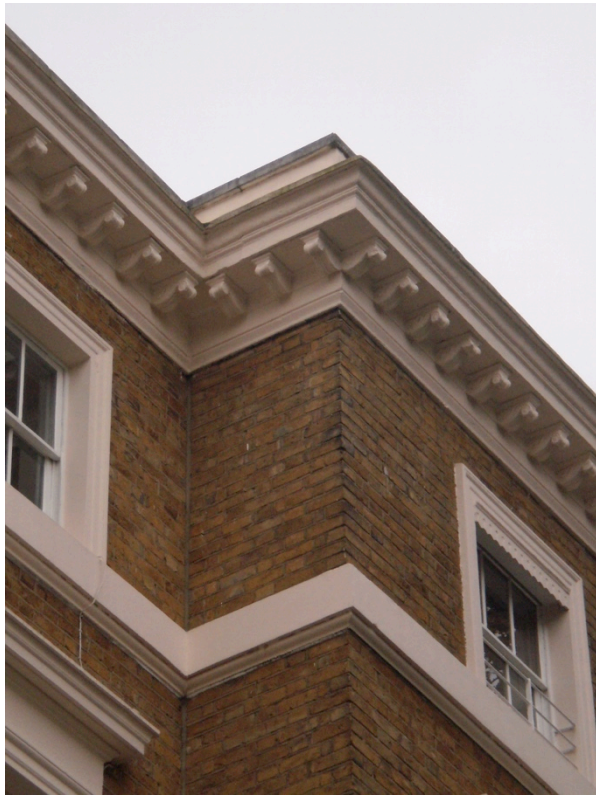
Parapet cornice with modillions, plain storey band below third floor windows. High Significance.

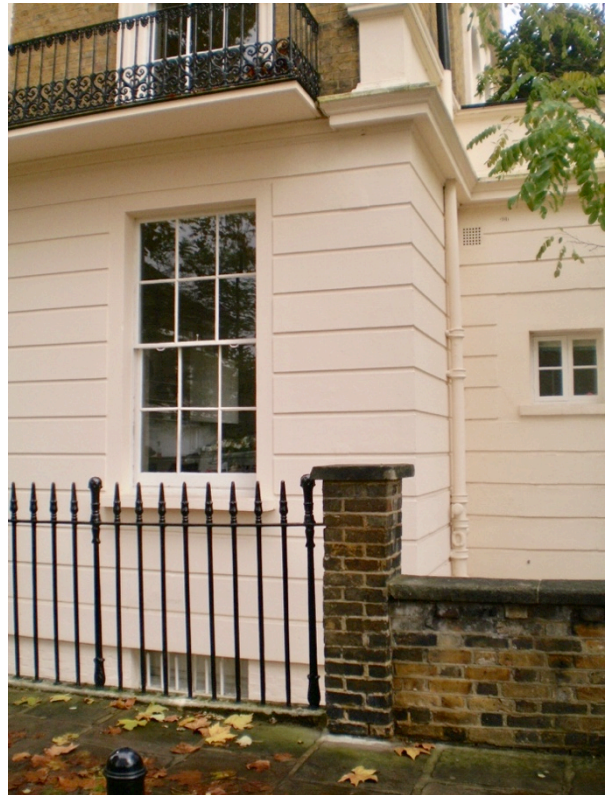
South end of terrace. Basement and ground floors stuccoed with incised horizontal rustication bandings. High Significance.

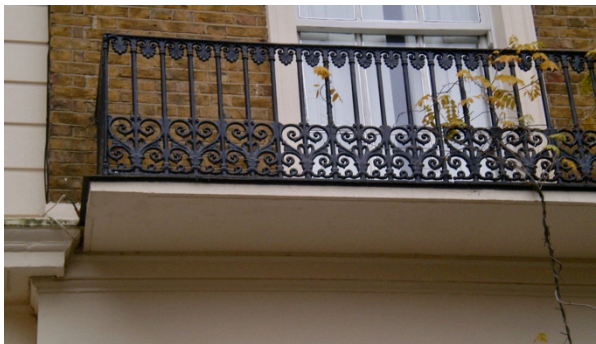
Detail of balcony and cast iron railings - High Significance.

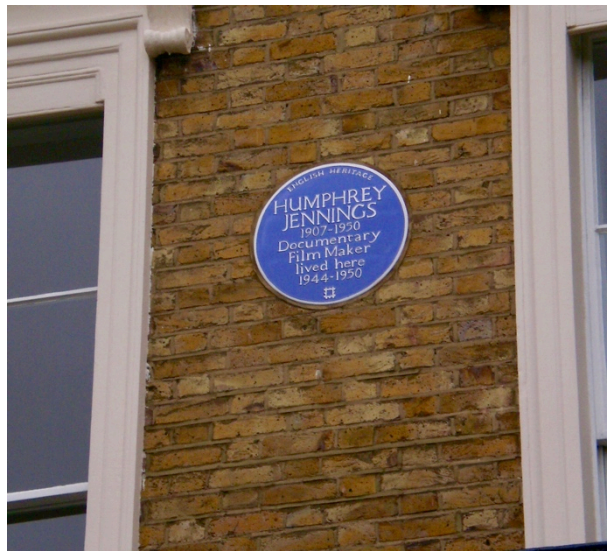
No. 8 Blue Plaque - social and cultural aspect of occupation by Humphrey Jennings - Medium Significance.

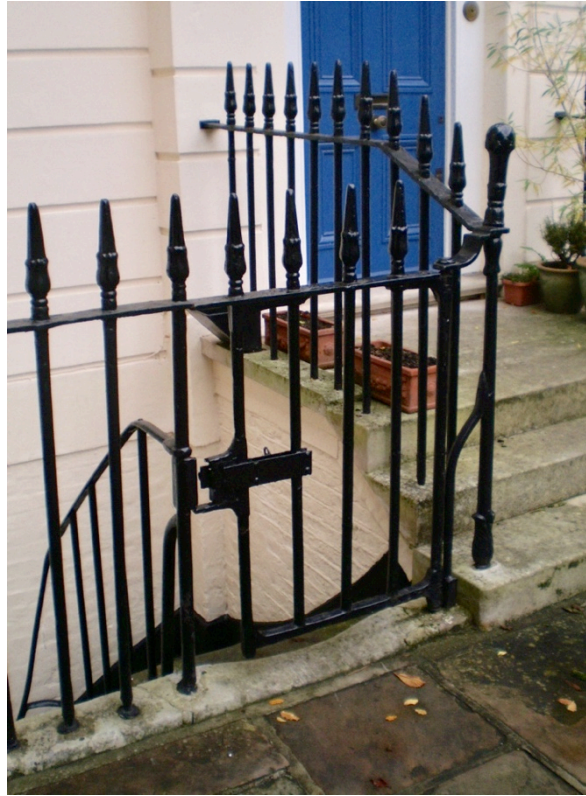
Original Basement lightwell and entrance step's railings & gate to basement steps - High Significance.

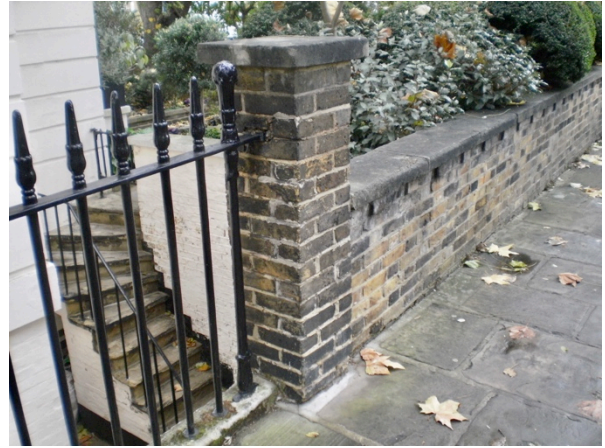
Original Basement lightwell railings terminated at a brick pillar. Original brick garden wall to No. 1 with brick dentils and Portland stone coping - High Significance.

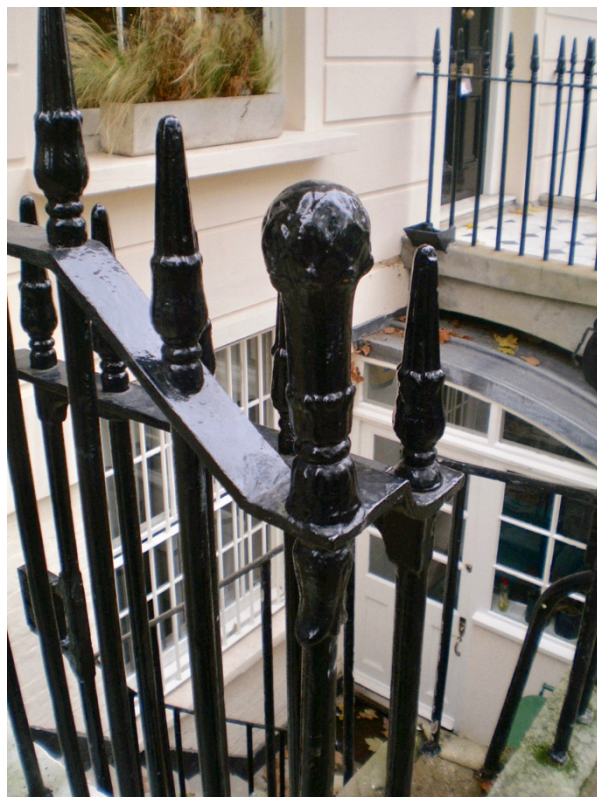
Foliated pointed finials to common rails and ball tipped foliated finial to queen post - High Significance.

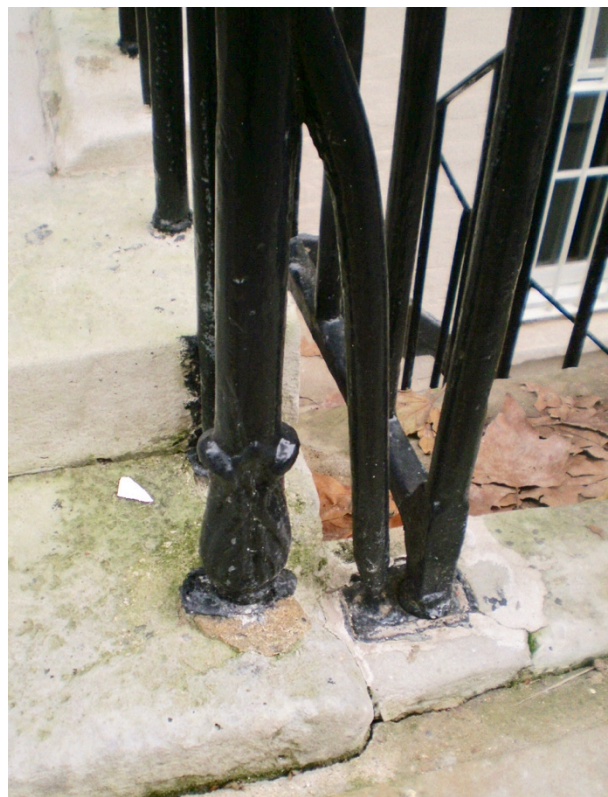
Foliate moulding to queen post - High Significance.
