St. Pancras Cruising Club New Clubhouse and Visiting Boaters Facilities

Bat Check Report

April 2017

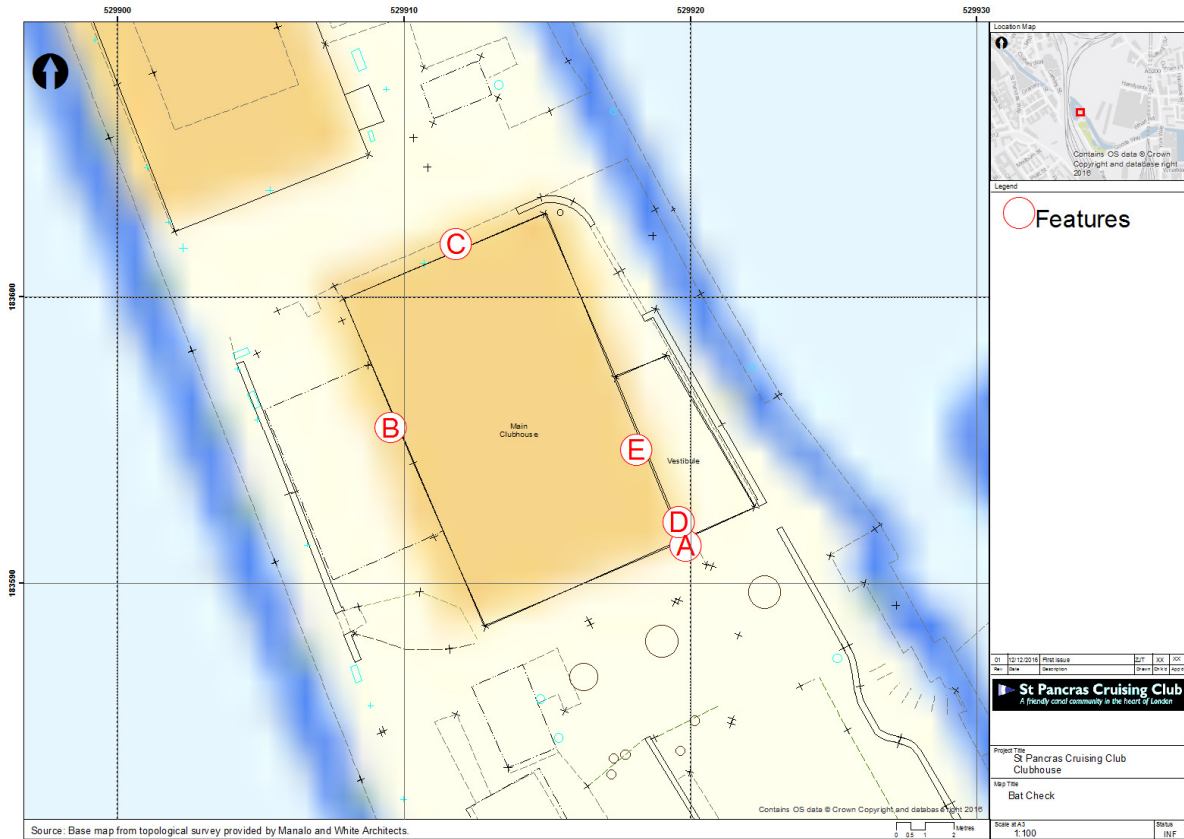
Appendix A. Map showing features

The features which were identified (on November 26th 2016) with suitability for bats are described in Table 3.1. Their locations are shown on the map in Appendix A.

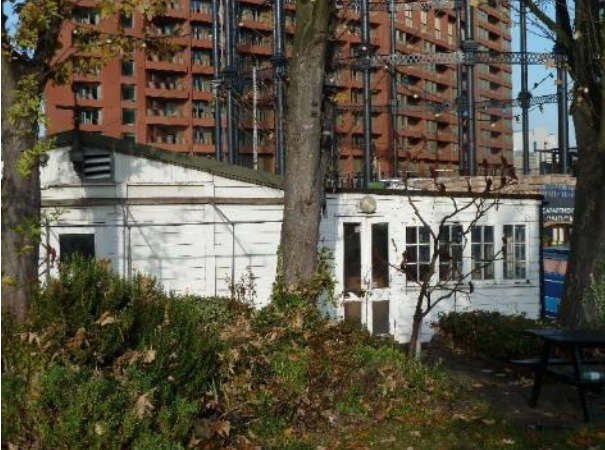
Feature	Description	Photograph
General photo of clubhouse and vestibule	External

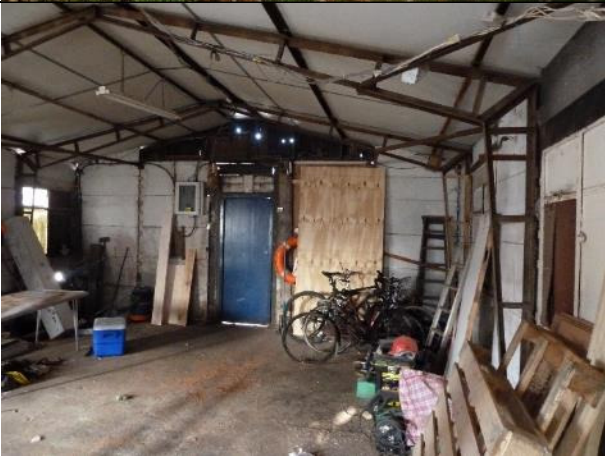
General photo of clubhouse	Internal

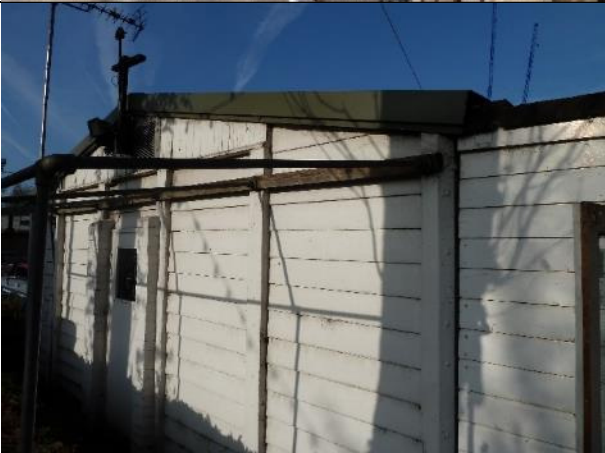
The external features were re-inspected on April 1st and an inspection was made for further features. No further features were found and none of the features previously identified had any sign of bats being present. Feature A had extensive cobwebs, indicating bats are not present. It was also brightly lit on the evening of April 1st by a string of multi-coloured lights around the gardens.

A	Gap between main club house and vestibule.
