Arboricultural Impact Assessment

1 East Heath Road
Hampstead
London
NW3 1BN

Survey Date: 20th May 2016
Report Date: 28th June 2017
Project no: 895

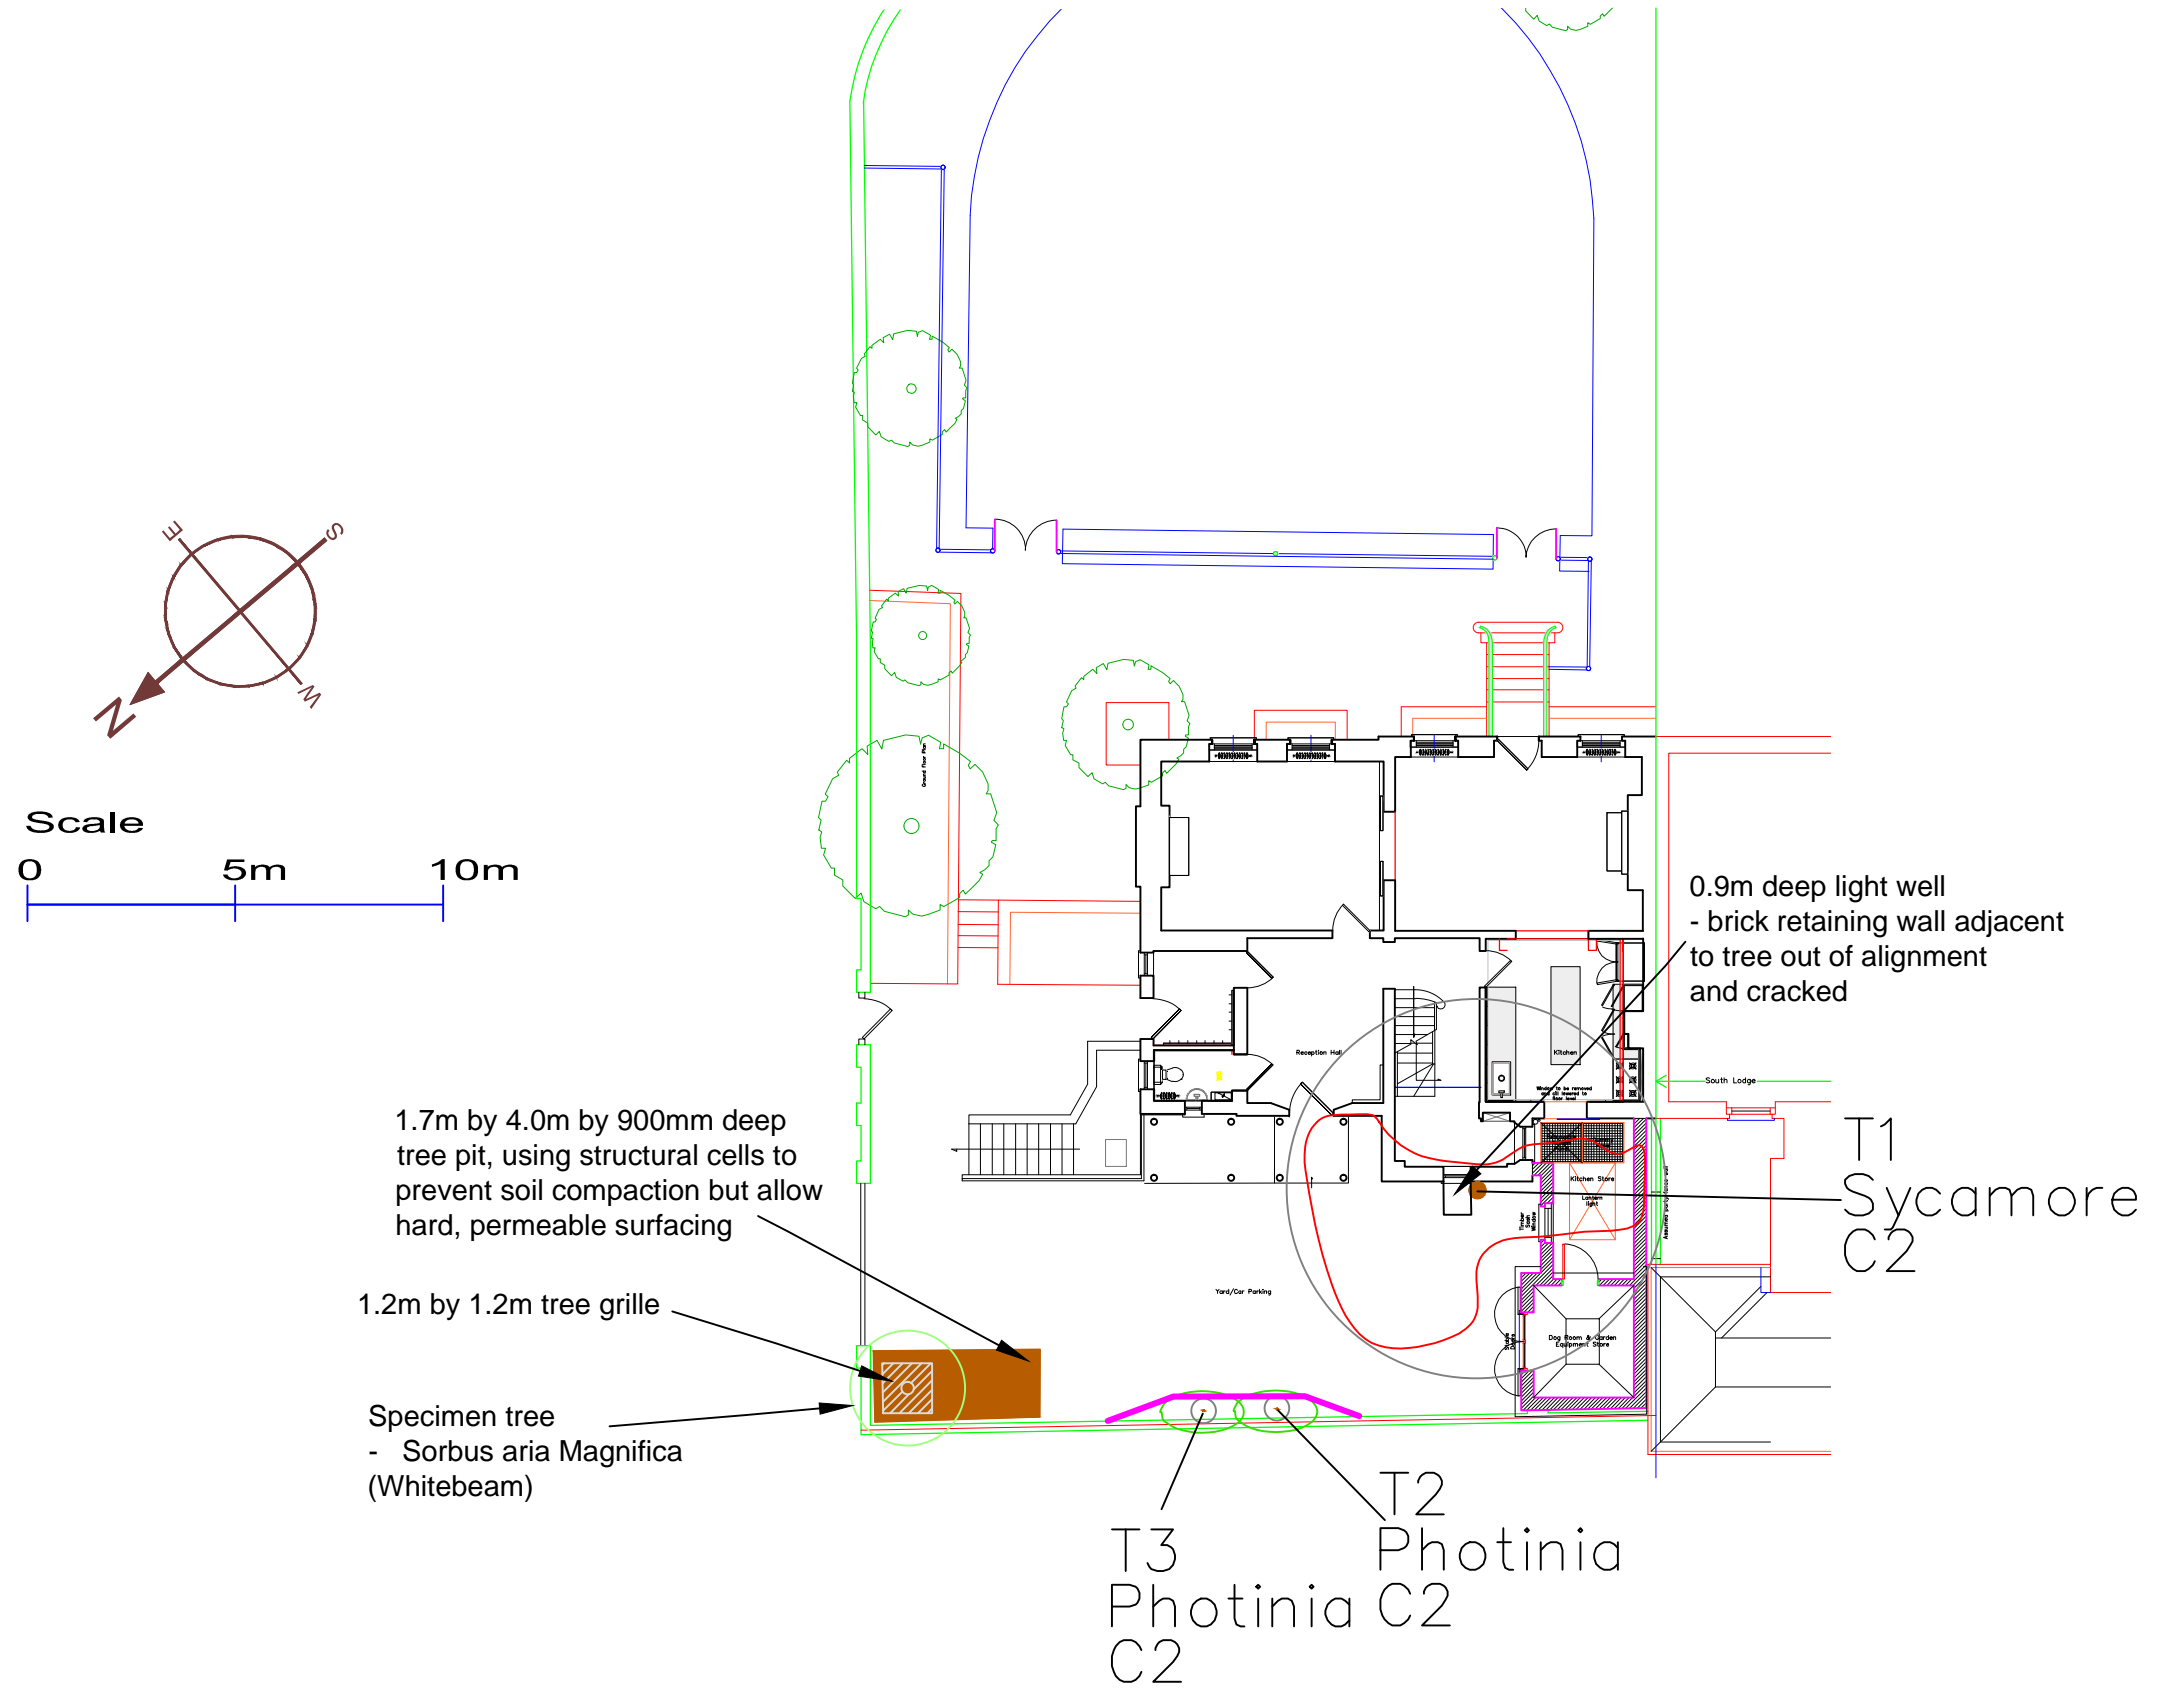
DRAWING NUMBER 895-01	REV A
---------------------------------	-----------------

- 4.4.1 Root Protection Areas are shown for all trees in the tree schedule attached as Appendix B. They are also shown for all retained trees, as circular areas centred on the trunk, on the plan enclosed as Appendix A. This shows the distance that construction must normally be kept back from a tree, to provide the Root Protection Area recommended in BS 5837.
- 4.4.2 The proposed location of Tree Protection Fencing is shown on the Tree Protection Plan attached as Appendix A. This provides full protection of the Root Protection Areas of T2 and T3.

- 4.4.3 Tree Protection Fencing must be from weldmesh panels, at least 2m high, securely fixed, with wire or scaffold clamps, to a rigid framework. This framework must be constructed from scaffold tubes with vertical tubes, at a maximum interval of 3m and driven into the ground at least 0.6m. The structure must be well braced to resist impacts, constructed as per Figure 2 of BS 5837:2012, which is reproduced as Appendix D.

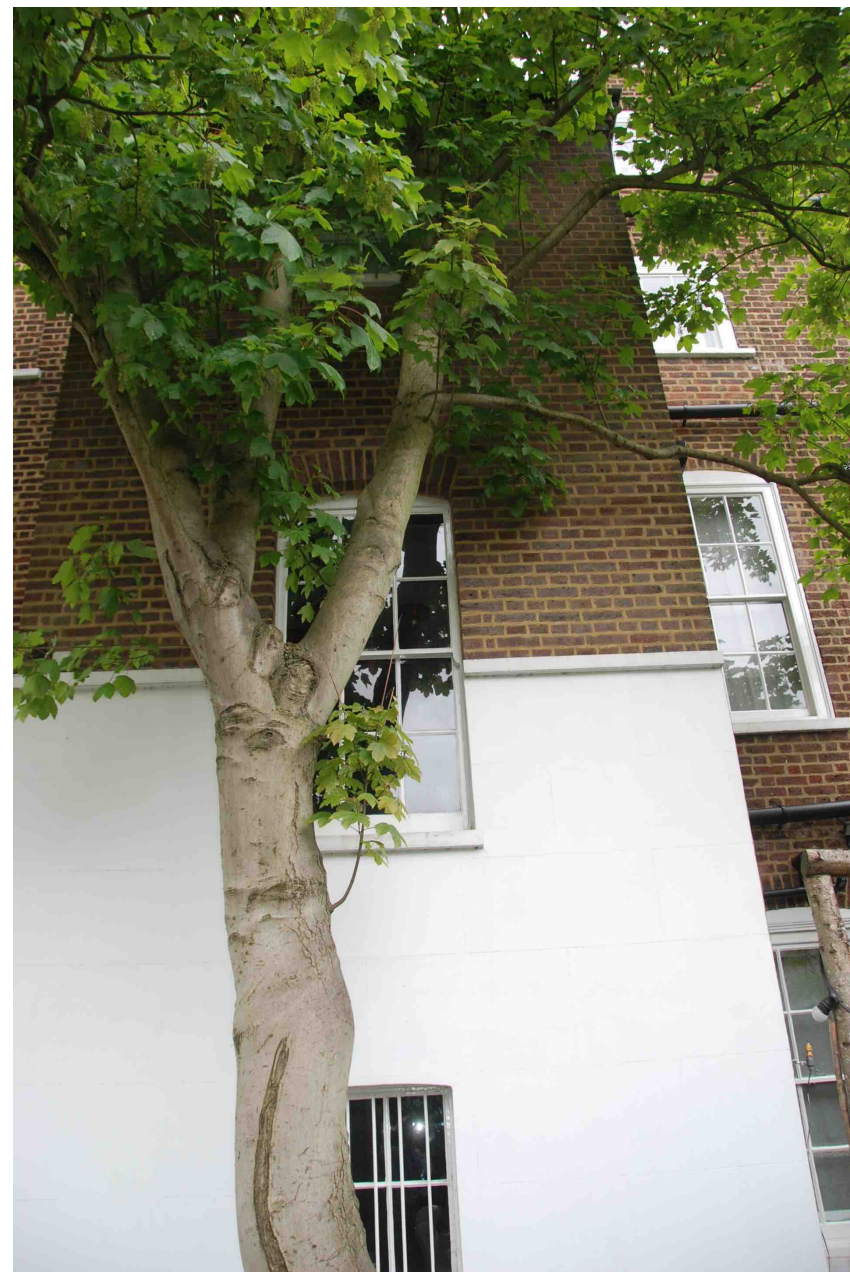
T1

- 4.1.1 The proposal is to construct an extension to the house, where shown on the Tree Protection Plan attached as Appendix A.
- 4.1.2 The new extension will be close to the sycamore (T1), shown in the photos in Appendix Ei). Branches from the tree are hitting the listed building and the trunk is growing immediately adjacent to the basement wall to the house and very close to the brick retaining wall at the edge of the adjacent window recess. This wall has been damaged by the tree, having been pushed out of alignment and cracked, as shown on the photo in Appendix Eii).

- 4.1.3 The tree is not sustainable in this position. Structural damage to the light well has already occurred. Although damage to the upper storeys of the house could be avoided by annual pruning, as the base of the tree expands, structural damage to the basement wall is highly likely.
- 4.1.4 Although the tree does not need to be removed to allow construction of the extension, this project provides an opportunity for removing the tree and planting a new, large growing specimen tree further from the house, where it can grow to maturity and provide greater amenity value in the future.

- 5.2** The sycamore (T1) is currently providing some amenity value, although due to the proximity of the building it has an asymmetric crown and poor structure.

- 4.3.1 Details of proposed tree works are included in the Tree Schedule included as Appendix B.
- 4.3.2 The sycamore, T1, is proposed for removal.
- 4.3.3 All tree work should be undertaken to the standards set out in BS 3998:2010 Tree work – Recommendations.

- 5.1** As detailed in section 4.4.5 and 4.4.6 above, it would be possible to build the proposed extension while retaining the sycamore, T1. However, growing so close to a listed building, this tree is very likely to cause damage to existing structures in the future and will not be able to grow to maturity. The tree is, therefore, proposed for removal and a new specimen tree planted instead.
