Assessment of Heritage Assets

25 Old Gloucester Street (grade II)

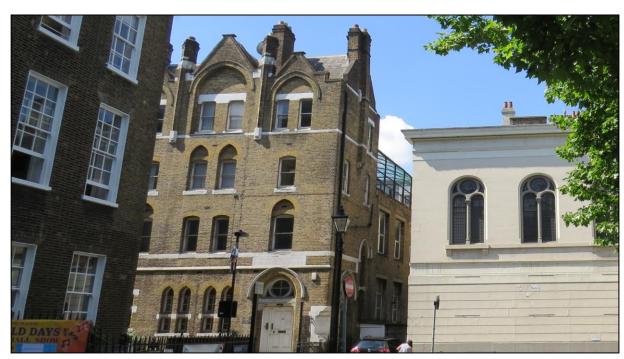
- 2.15 The front part of the building possesses historic and architectural interest as a late 19th century school building in the Early English style (**Figure 4.1**). The inscriptions above the main entrance door and on the northern corner provide evidence of the building's purpose and association with the adjacent church.

- 2.17 The historic appearance of the building is limited from certain perspectives by the visibility of the rear part of the building. The rear section does not contribute to the architectural or artistic interest of the former school, and is clearly legible as a different phase of construction. The steel cage structure above the flat roof is a negative feature which detracts from the appreciation of the historic building.

Figure 4.1: the north elevation of 25 Old Gloucester Street, showing the contrast between the front and rear portions of the building.

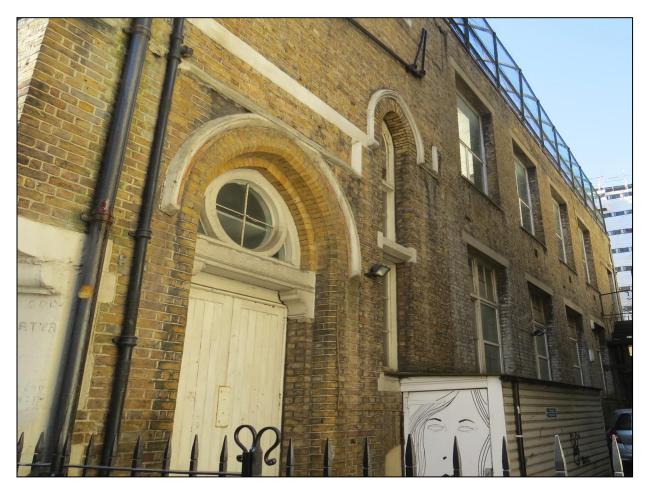
Figure 4.3: view of the north elevation from passageway between the Church and no. 25, with view of window height disparity, change in brickwork, corrugated structure adjacent, and caged structure to rear

- Whilst faced in stock brick, the extension is utilitarian and the banded cornice detailing present of the former school building is truncated at the adjoining point between these two parts of the property (Figure 4.3). The elevational treatment is much simpler, with no ornamentation, and rectangular window openings with lintels above. There is a disparity between the height of the second storey fenestration in the front and rear sections of the building, the openings to the rear are set higher into the wall and extend above the third floor in the front portion.

- Situated alongside the north-eastern elevation are large corrugated structures which accommodate services (**Figure 4.3**). A large metal fire escape has been added to the rear of the building within the passageway. These later additions detract from the appearance of the historic building. Further, the passage is presently in poor condition, with litter and graffiti, which are negative features in the setting of both the former school and the adjacent church.

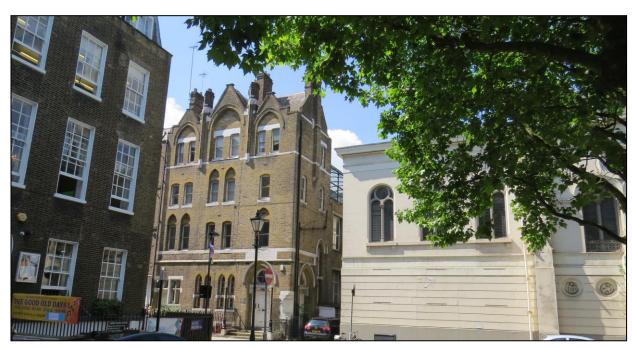
Figure 4.4: Oblique views of the rear portion of the building from Queen's Square

- 2.21 The passageway between 25 Old Gloucester Street and the Church of St George the Martyr allows for oblique views of the side elevation of the building from Queen's Square and Old Gloucester Street (**Figure 4.4**). These are, however, limited due to the close proximity of the buildings. When seen from the Square, the four storey front portion makes a positive contribution to the streetscape and the setting of surrounding listed buildings. The rear extension does not contribute to the building's architectural interest or the character of the streetscape.

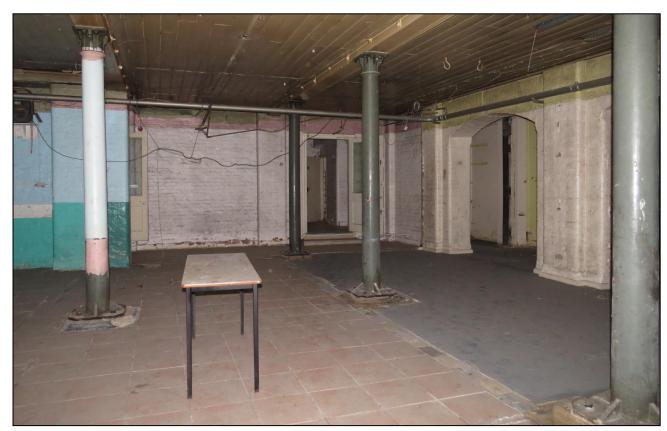
- 2.31 The main room at ground floor level is situated above the large basement room, and occupies the same footprint (Figure 4.5). The metal framed windows in the south wall are set high, whilst larger, rectangular openings punctuate the north elevation. Dado panelling with some enclosed columns are situated on the southern side. Modern light fixtures have been installed hanging from the ceiling and windows.

Figure 4.5: the interior at basement level

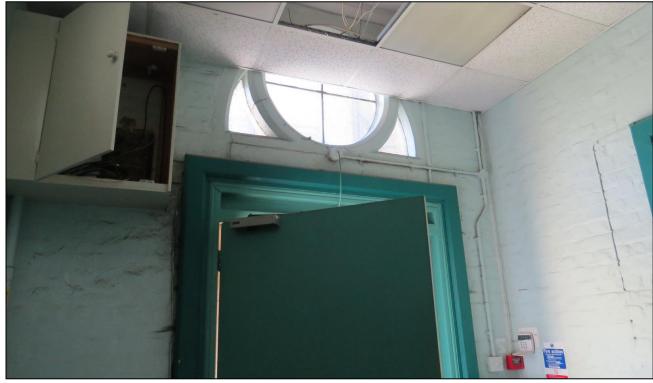
- 2.30 The entrance hall retains some simple detailing that is reflective of its school use. The space has been significantly altered however through the addition of modern joinery, a suspended ceiling, and modern staircase (**Figure 4.6**).

Figure 4.6: The interior of the entrance, showing modern suspended ceiling and services
