## Design and Access Statement

### Underground vaults

88 Albert Street, London NW1 7NR

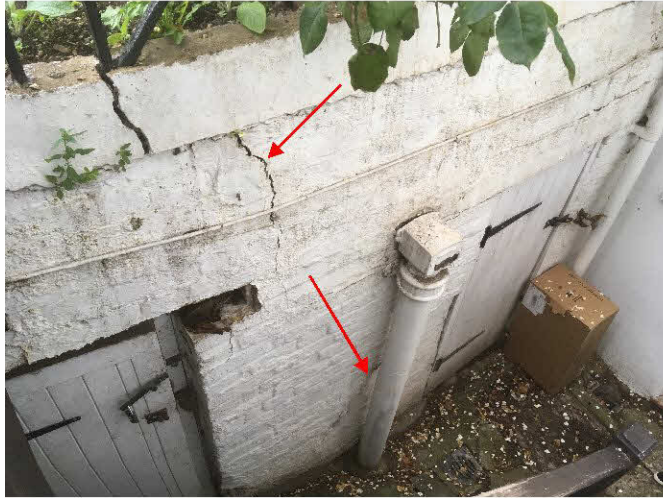
The vaults are constructed in brickwork. They are accessed from the light well by timber doors set in the wall opposite the front of the house which also acts as a retaining wall. The wall has a significant bow and cracking caused by the earth pressures behind the wall. It is thought that the movement is progressive. The doors are in poor condition. The timber lintels have rotted.

Figure 1: From top of steps. Note missing lintel on LH door, crack through brickwork and capping stone above door

It is considered that the wall is not able to be stabilised and therefore it is proposed that it is rebuilt. It is thought that the existing bricks are in too poor a condition to be re-used, so replacement bricks will be used. It is proposed to repaint the brickwork in white, as existing. The doors will be replaced with similar doors or repaired if considered feasible. The timber lintels will be replaced with precast concrete lintels.

It is proposed to install bedjoint reinforcement to tie the new front wall back to the vaults. A similar exercise was successfully carried out recently at Cumberland Lodge Mews in Windsor Great Park.

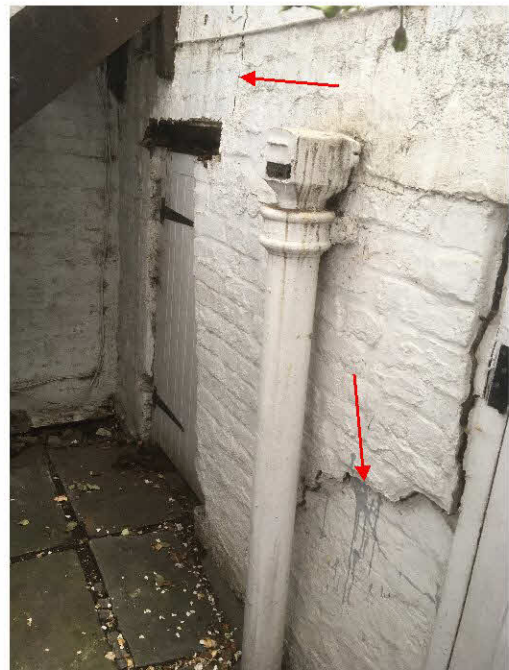
Figure 2: Note crack left of RH door

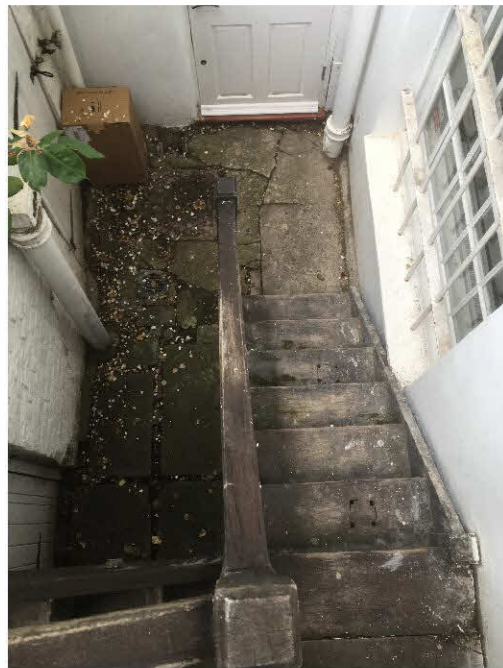
A drain run passes through the light well. Ongoing cracking in the front elevation of the house suggests foundation movement which might be caused by softening of the subsoil by a broken drain. The drain is to be investigated and appropriate repairs carried out. The existing paving is a mixture of flags and concrete. The flags will be reinstated.

Figure 2: From top of steps. Front elevation of house and basement window on right

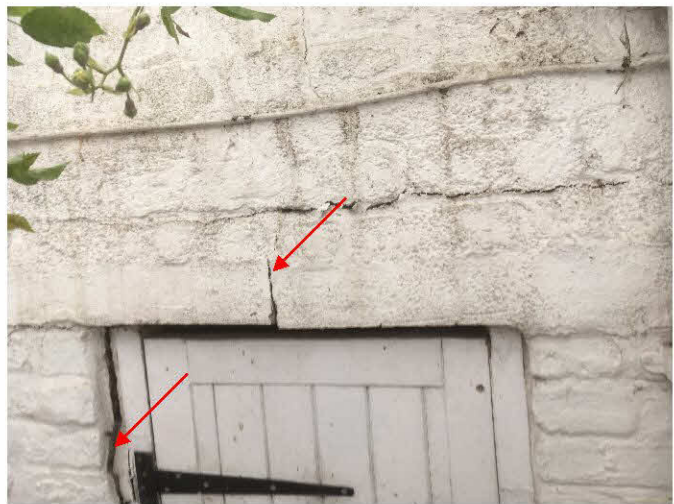
Figure 4: RH door to vault
