Addendum To Arboricultural Impact Assessment

Gloucester Lodge, Gloucester Gate, Regents Park,
London, NW1 4HA

Iconic Properties Limited

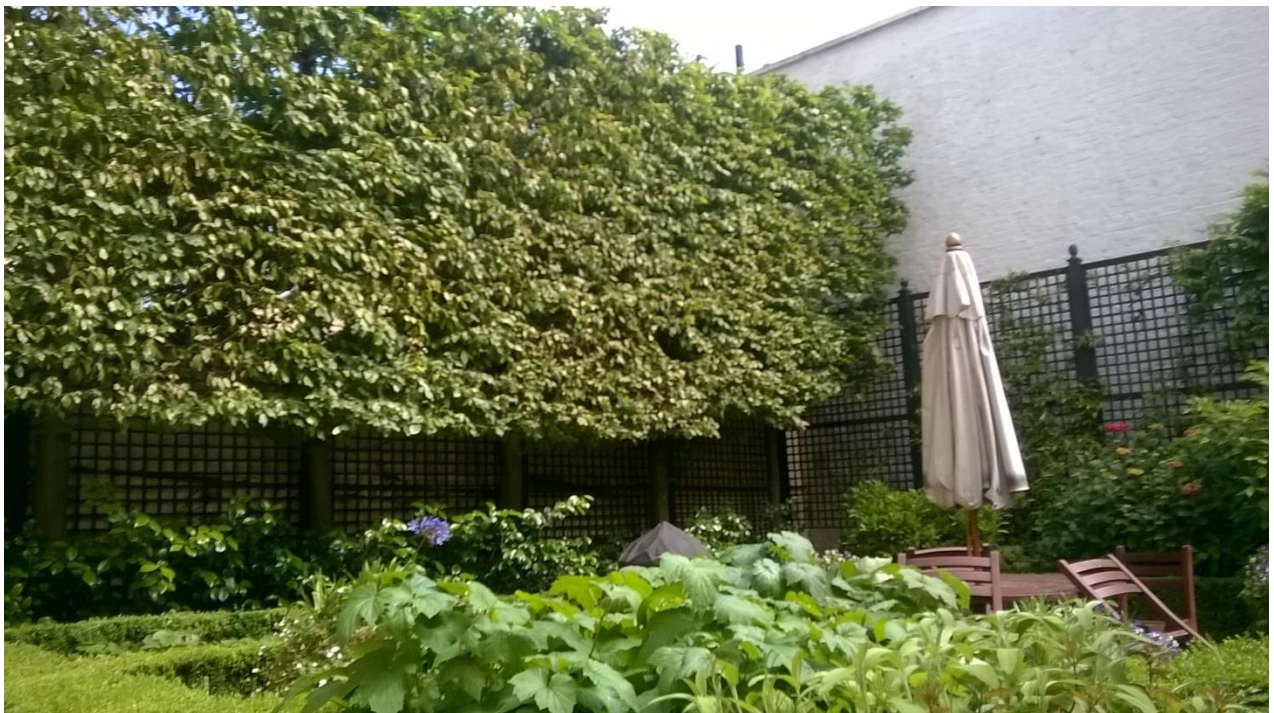
- 2.1 Following correspondence between the client and the LPA, a comment has been received about the impact of the rear basement and the removal of the pleached Hornbeam hedge (see below)

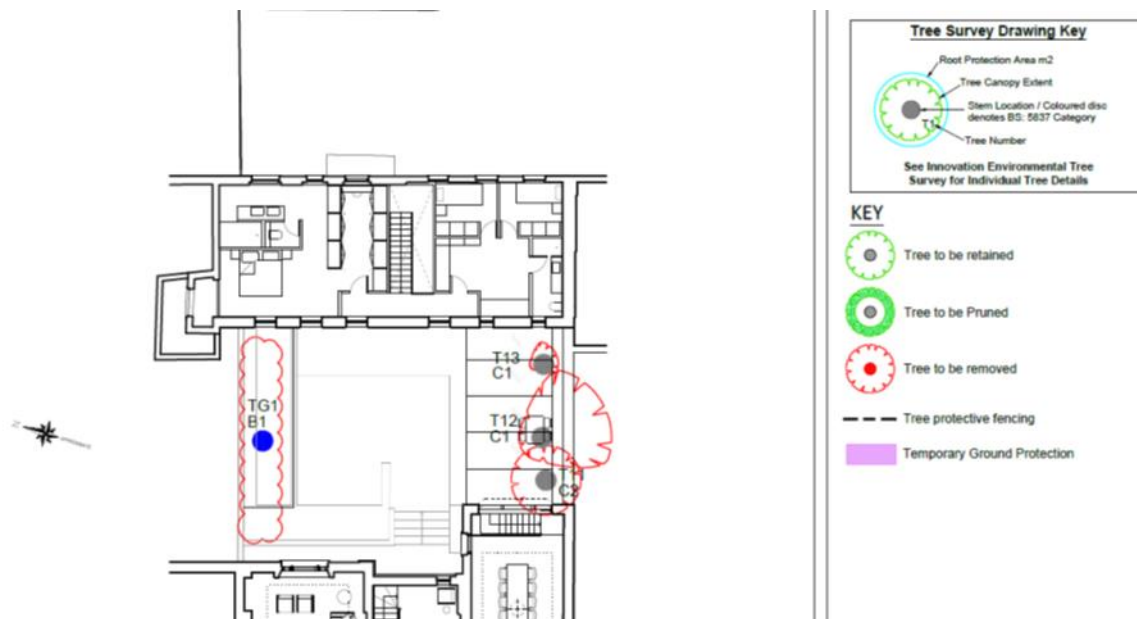
- 2.2 The removal of this hedge is shown on the extract below from the Tree Protection Plan as TG1 (shown in red for removal)

- 2.4 TG1 is a recently planted feature, with little visual amenity (as it can only be viewed from the rear of a small number of properties). Its removal would have no impact upon the streetscene, and would be unnoticed by the majority of people.

- 2.5 The rear basement does provide for boundary landscape treatments, and it would be very easy to replace the pleached trees once the basement was completed. These are commonly available as 'extra heavy' standards or even semi-mature trees, and once planted would immediately replace the screen.

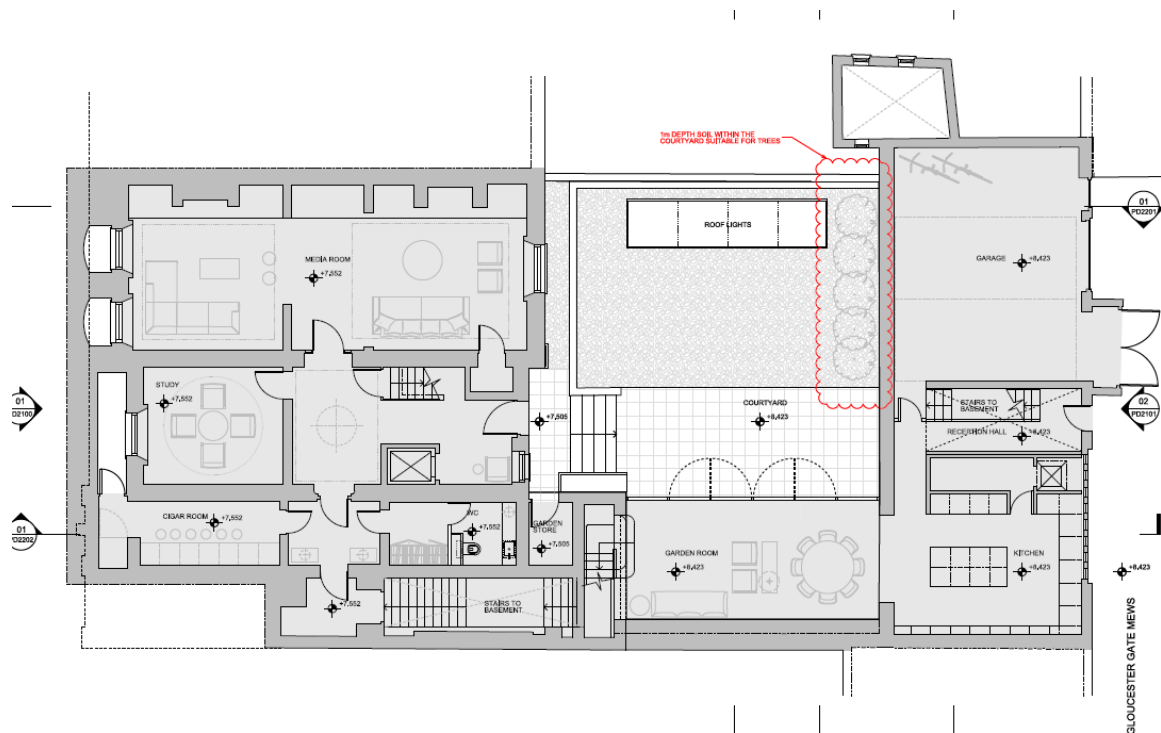
- 2.6 A revised landscape proposal has been produced (Ref PD199) which shows an alternative location for a replacement Hornbeam hedge to directly replace TG1. The soil depth is sufficient at this location to establish and sustain the hedge during its life-expectancy. An extract showing this alternative location (highlighted in red) is shown below;

- 2.7 The proposed planting location provides a soil volume of approx. 1.0m deep and up to 1.50m wide. An assessment of required soil volume was undertaken using the TSoil Volume Calculator (<http://greenleaf.co.uk/wp-content/uploads/2012/12/Calculating-Target-Soil-Volumes-for-Trees.pdf>) which gave the following required volume (per tree) assuming a canopy diameter of 1.5m when fully mature. The proposed planting location provides soil volume in excess of this requirement.

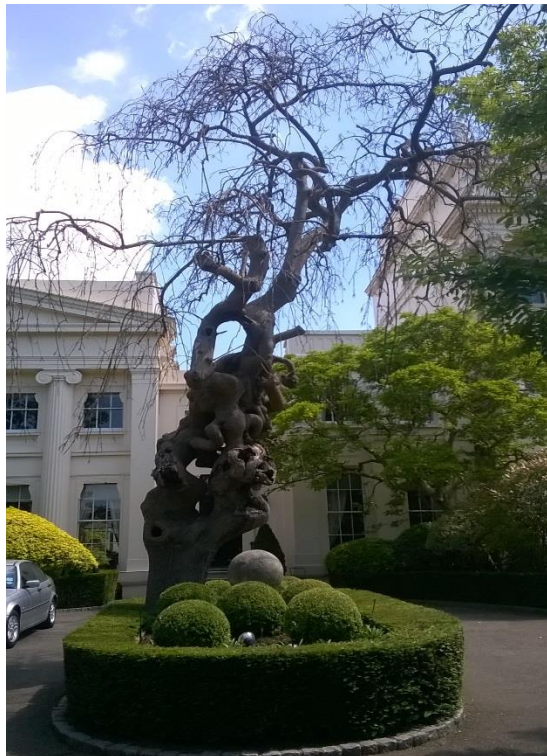
- 2.8 The proposed development provides an opportunity to replace the Weeping Ash located in the front garden (see image below)

This tree is a 'U' category tree and should be removed regardless of any development. The development provides an opportunity to replace this tree with a semi-mature, suitable specimen (exact species (to be agreed in advance with the LPA)).

- 3.1 The removal and direct replacement of the pleached Hornbeam hedge is achievable and sensible, considering the proposed development.
- 3.2 The Weeping Ash should be replaced with a suitable specimen
- 3.3 The Local Planning Authority is invited to secure the replacement of both the Hornbeam hedge and the Weeping Ash by way of a Condition of Planning.
