**THIRD FLOOR LEVEL**

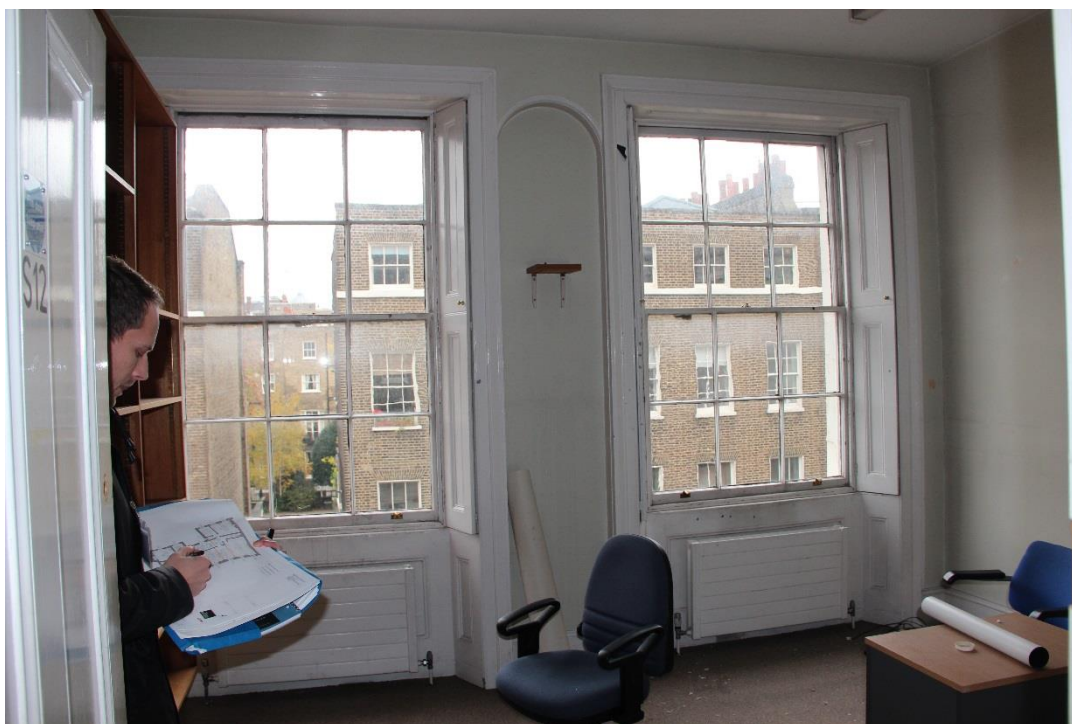
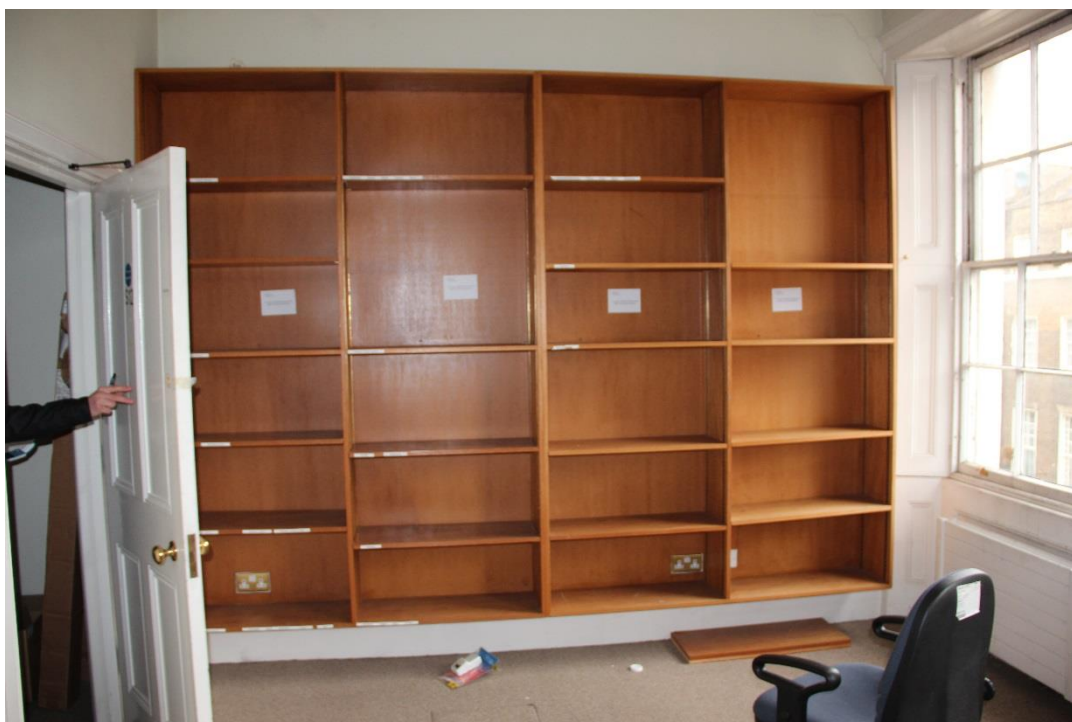
*Existing room 1AMS/4/012:  
Walls to be made good where necessary following removal of existing wall adjoining room 1AMS/4/014.  
Existing windows and shutters to undergo full overhaul to ensure good working condition and receive full redecoration*

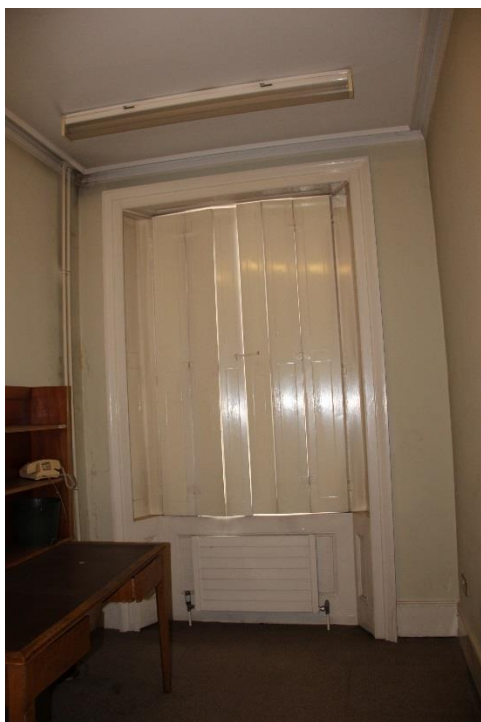
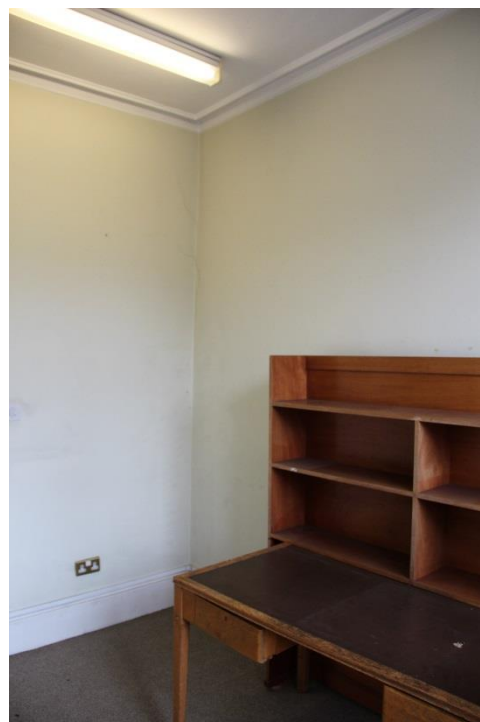
*Existing room 1AMS/4/013:*

*New opening to be created within room to become part of 1AMS/4/011. Adjoining walls to be made good where necessary. Existing window and shutters to undergo full overhaul to ensure good working condition and receive full redecoration*

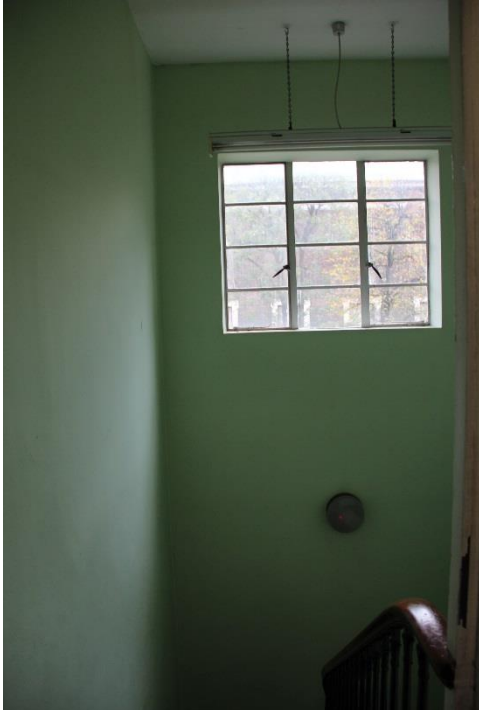
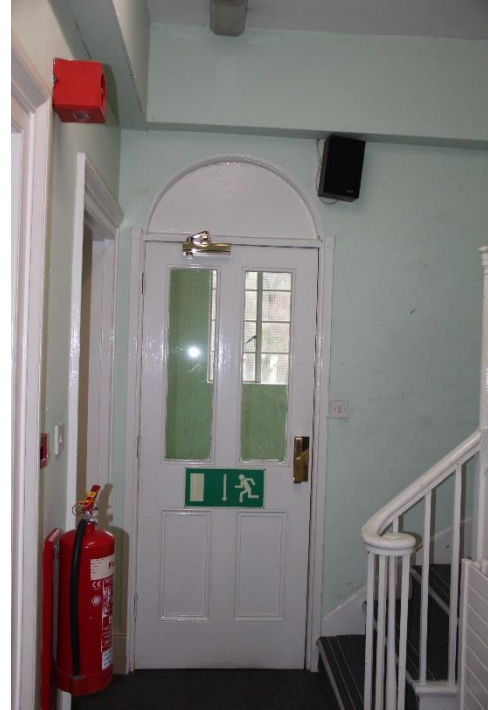
*Existing window to undergo full overhaul to ensure good working condition and receive full redecoration. Existing door to access stairs to first floor to be removed. Main stone stair to be redecorated.*

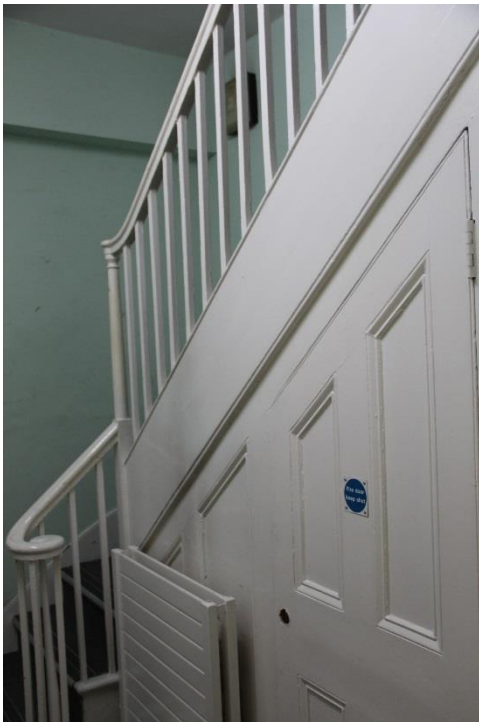
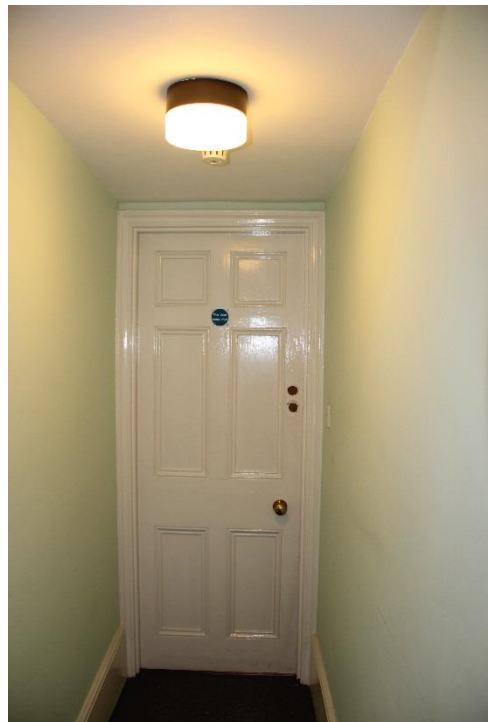
*Timber stair and associated panelling to be redecorated. Existing door linking 1MS to be upgraded to a 30min fire protected door. Panels adjacent to the door should be over clad on the fire side (non-stair side) with a fire resistant board that achieves 30 minutes fire protection.*

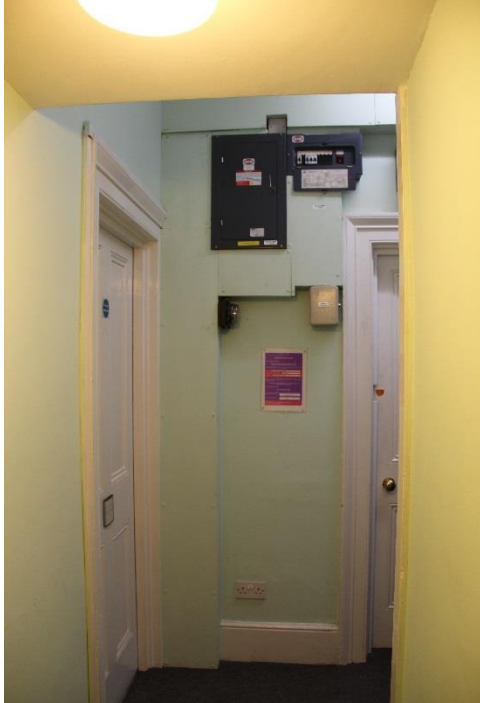
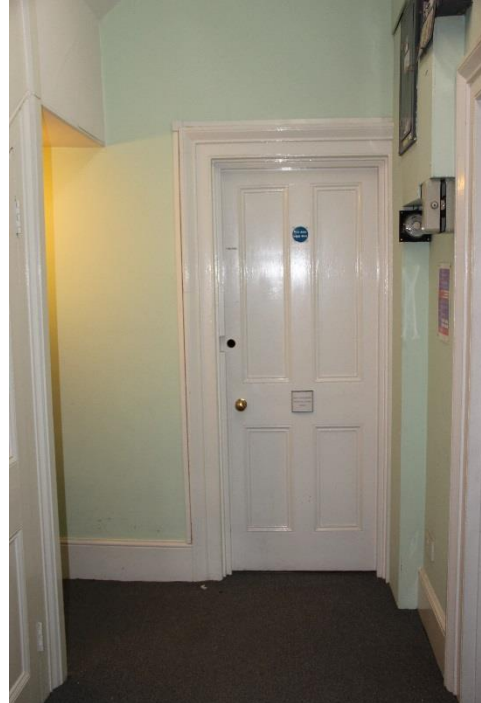
*Existing door openings to be infilled where necessary and finished to match adjoining walls*

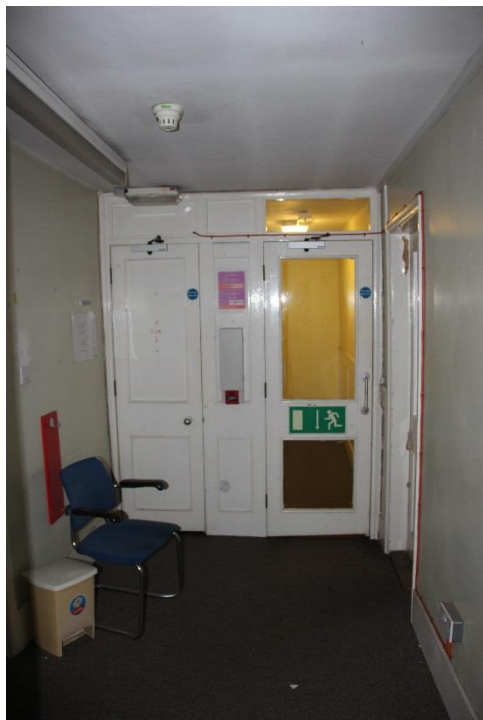
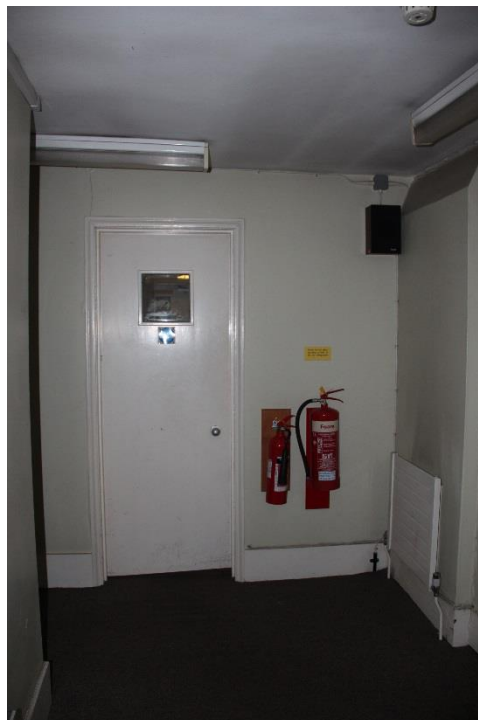
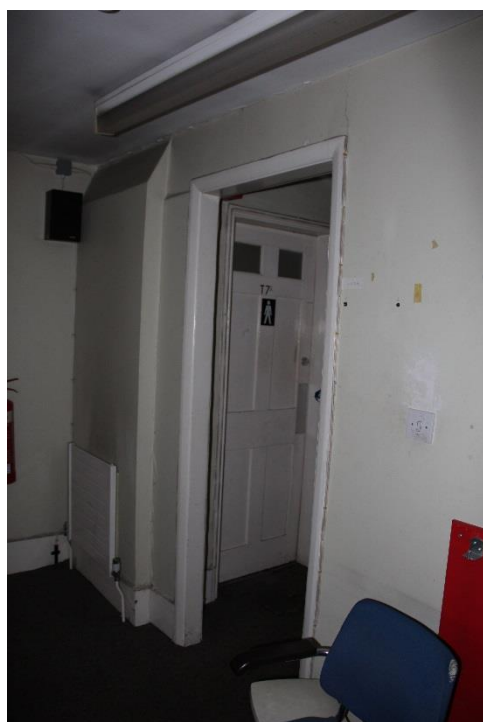
*Existing door to stairs 1MS/5/S02 to be removed and exposed wall to be made good. Existing doors to be retained to be upgraded for 30 min fire protection. Redecoration throughout*

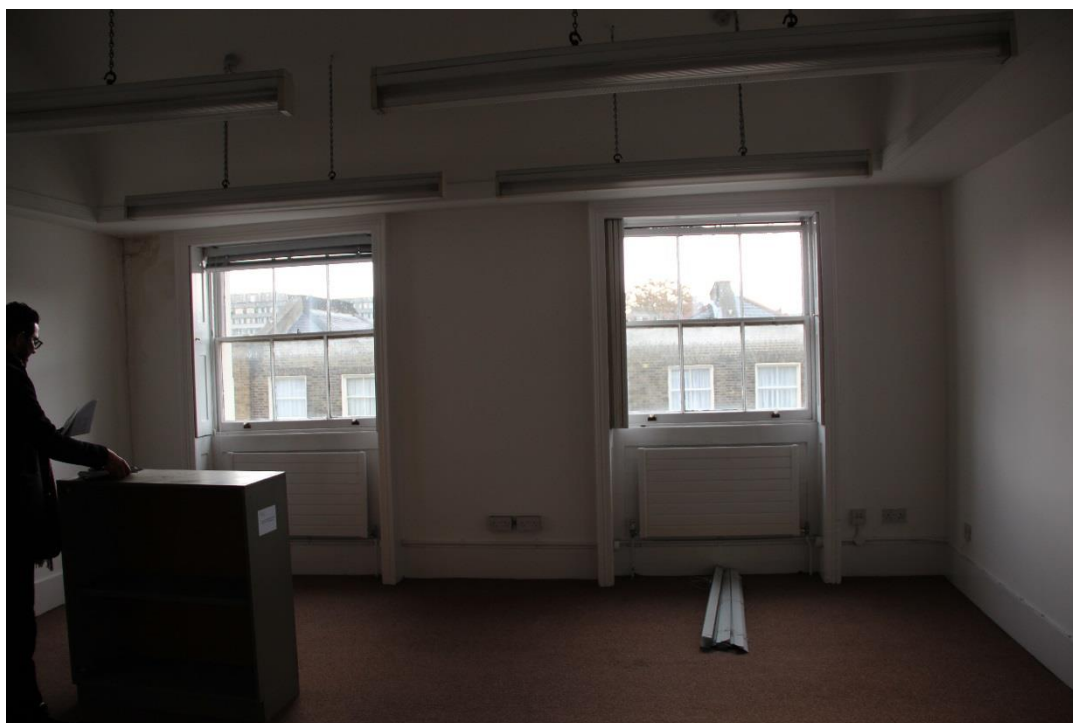
*Windows to undergo full overhaul to ensure good working condition and receive full redecoration.*

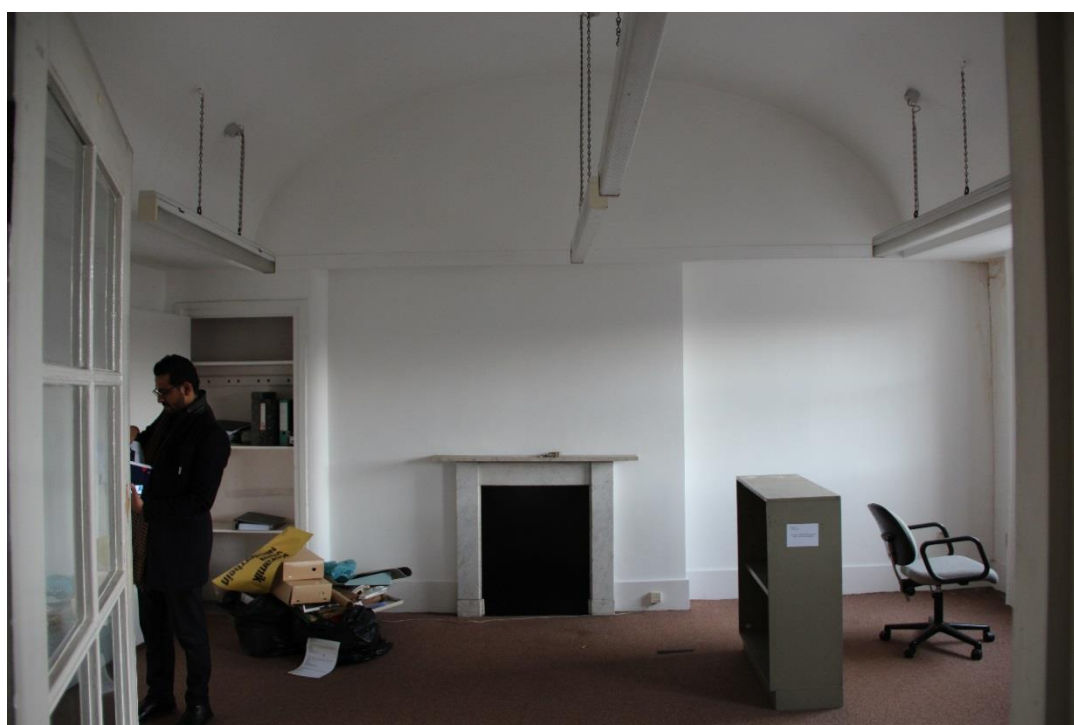
*Redecoration throughout. Fireplace to be cleaned.*

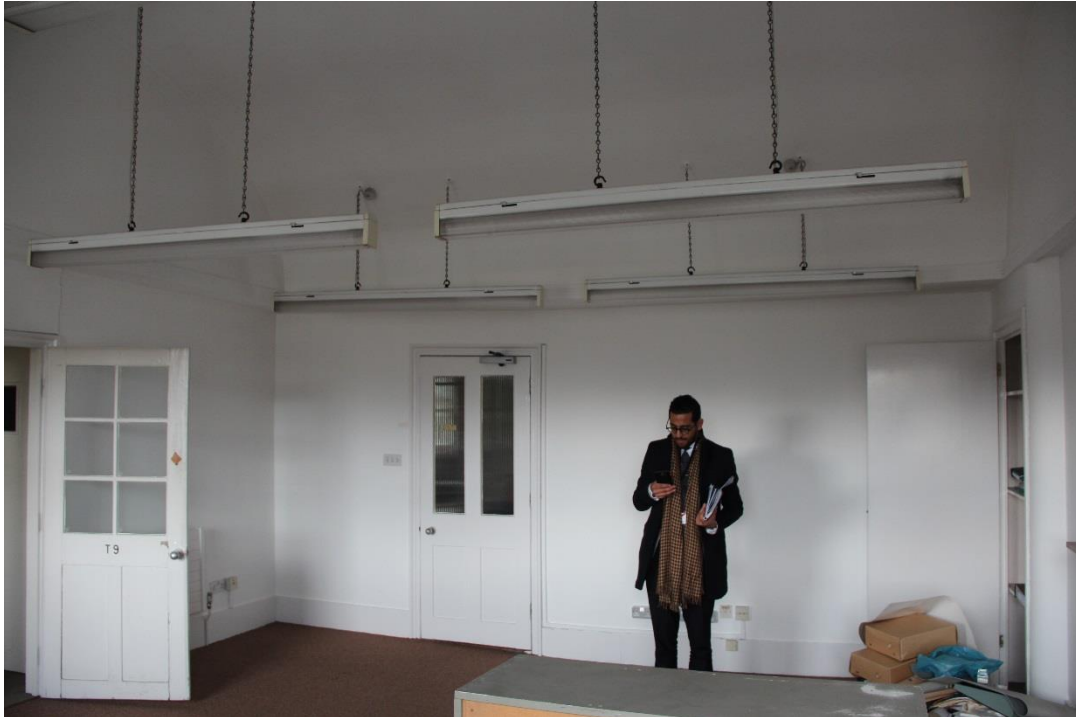
*Existing lighting to be removed and replaced. Refer to drawing (35)AP004. Ceiling to be repaired and made good following works.*

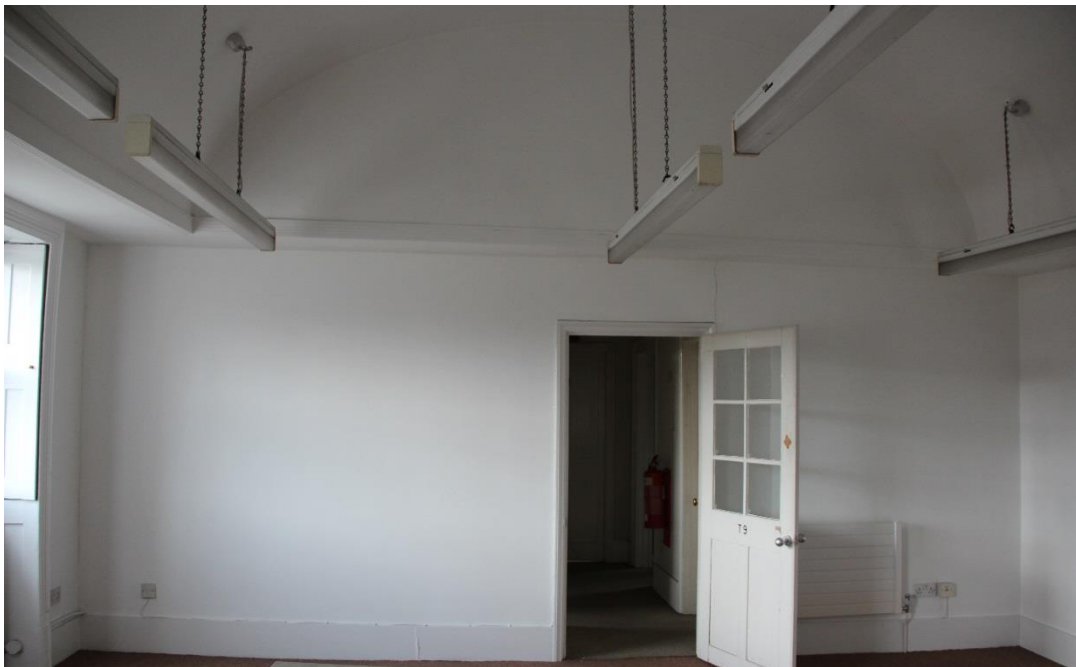
*Existing door to be removed and opening to be infilled. Finish to match adjoining walls*

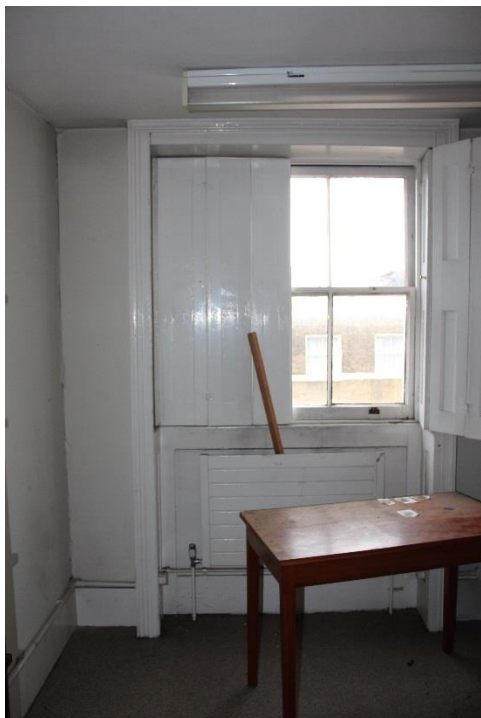
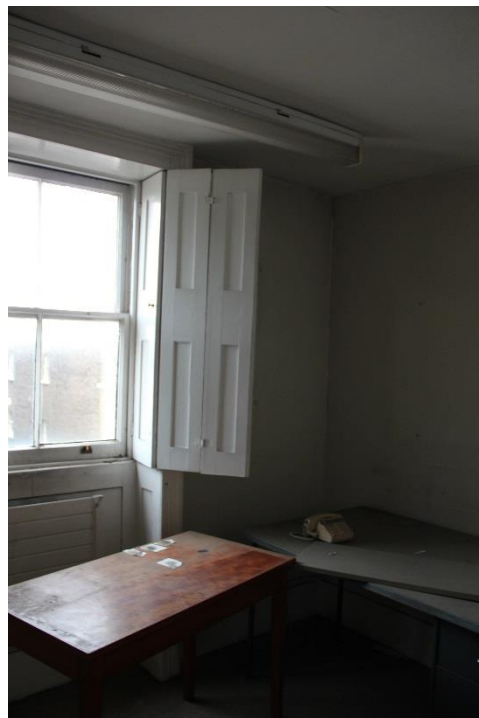
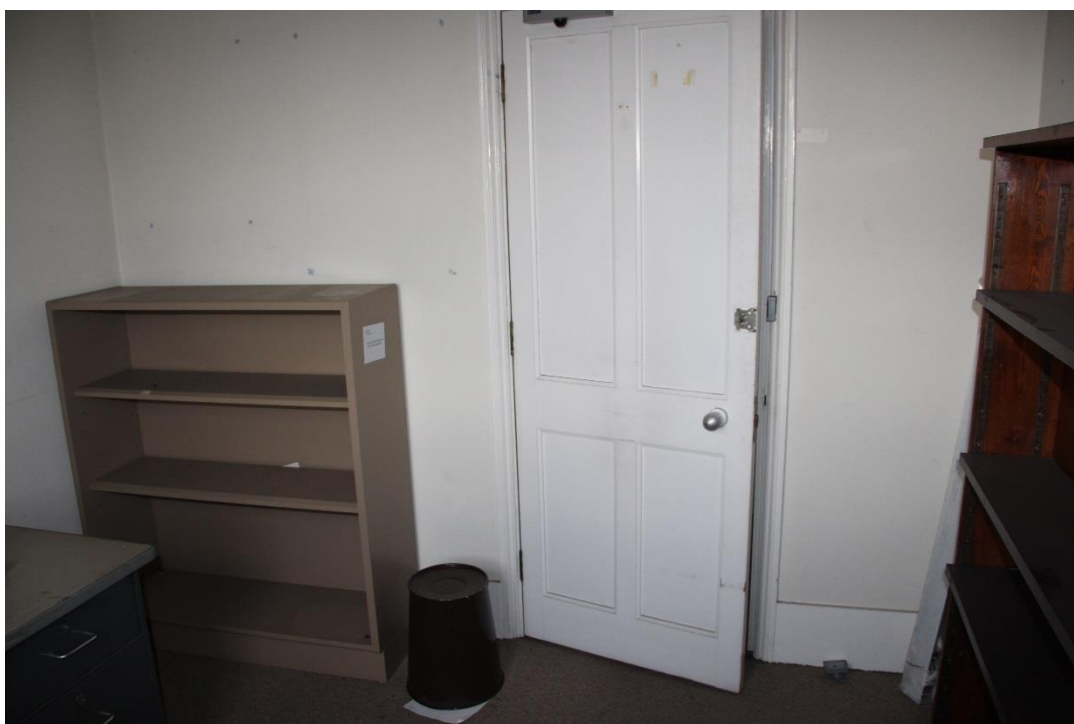
*Existing room 1MS/5/010:  
Existing fabric to be removed as per drawing (18)AP005. Remaining walls to be made good where necessary.  
Windows to undergo full overhaul to ensure good working condition and receive full redecoration.  
Redecoration throughout;*

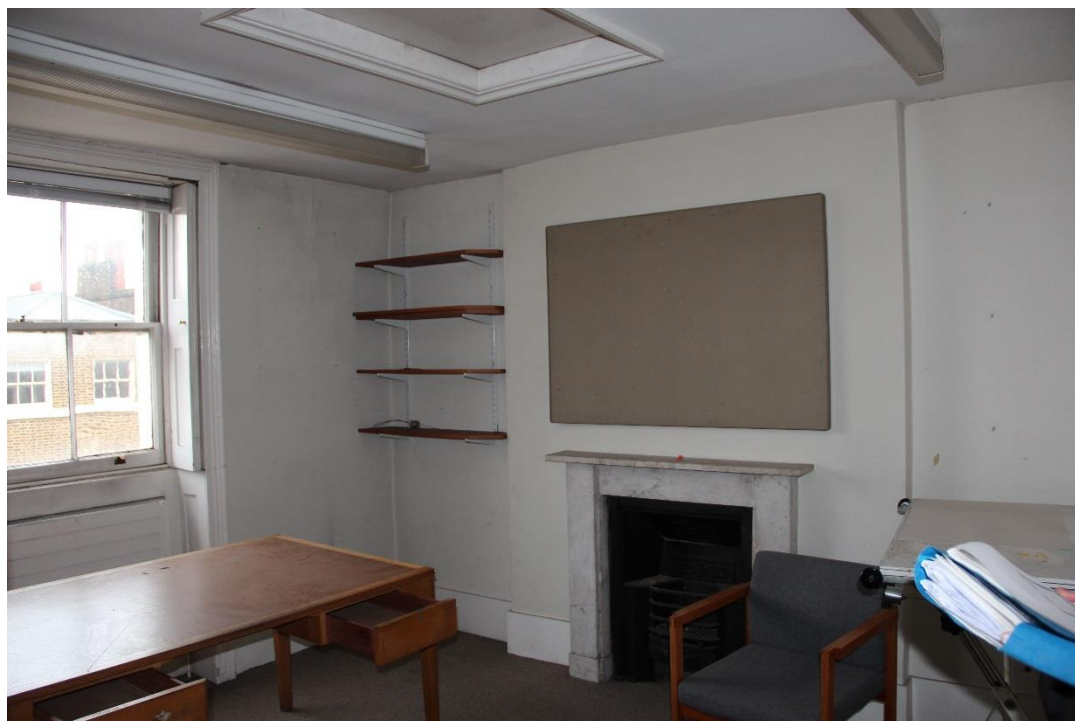
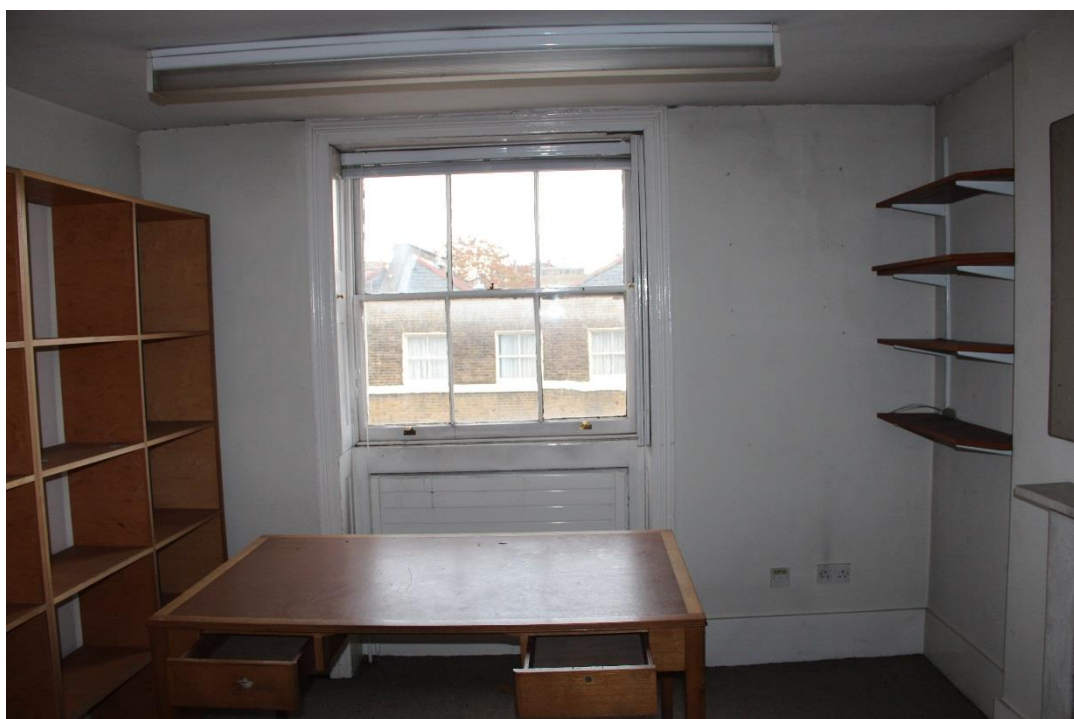
*Existing room 1MS/5/011:*

*Existing fabric to be removed as per drawing (18)AP005. Remaining walls to be made good where necessary. Windows to undergo full overhaul to ensure good working condition and receive full redecoration. Existing ceiling hatch to be enclosed. Redecoration throughout;*

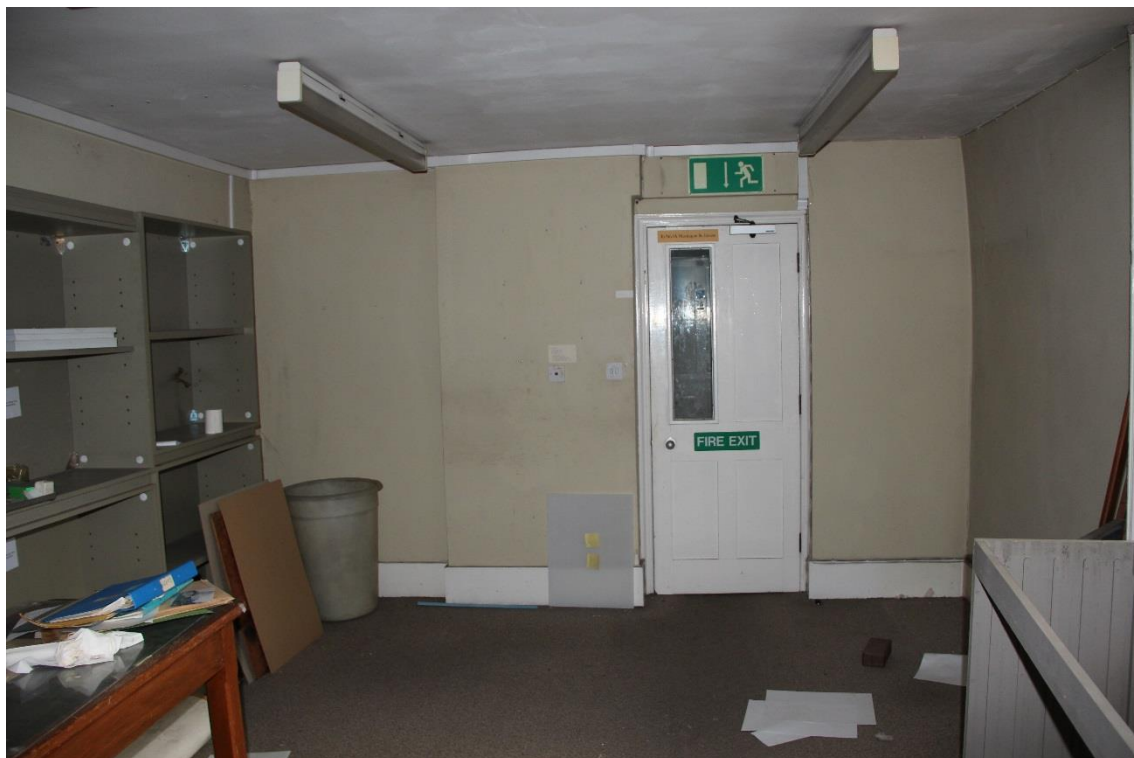
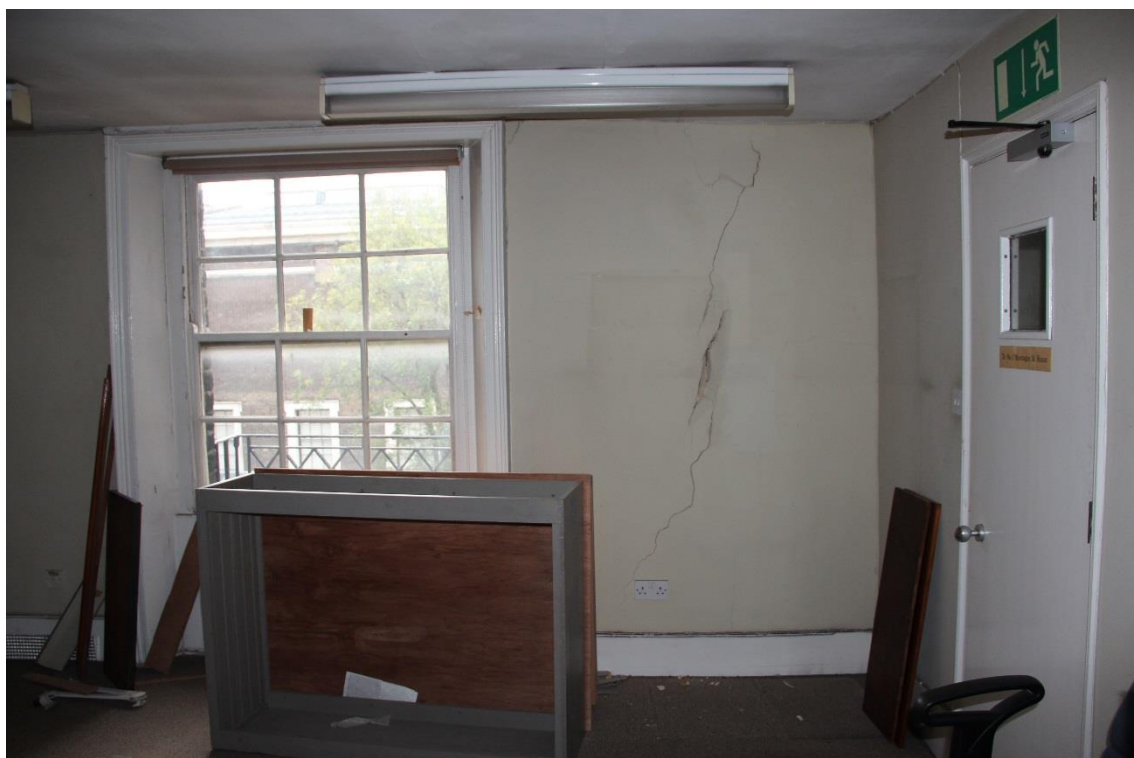
*Existing room 1MS/5/012:*

*Existing fabric to be removed as per drawing (18)AP005. Remaining walls to be made good where necessary.*

*Windows to undergo full overhaul to ensure good working condition and receive full redecoration.*

*Redecoration throughout;*

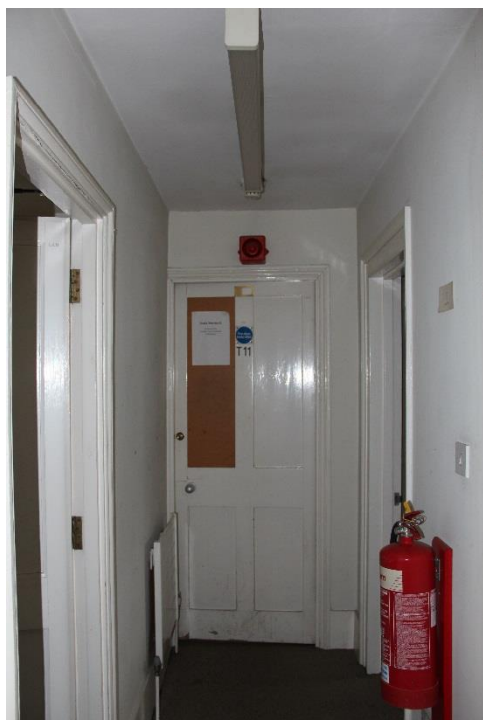
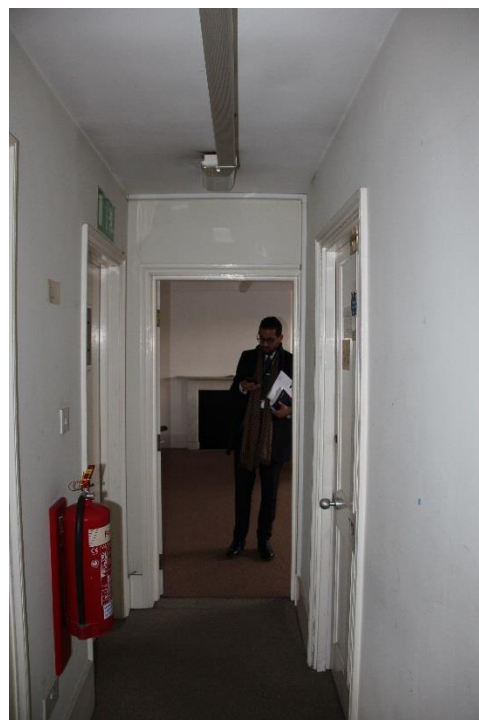
*Existing room 1MS/5/005:*

*Existing fabric to be removed as per drawing (18)AP005. Remaining walls to be made good where necessary.*

*Redecoration throughout;*

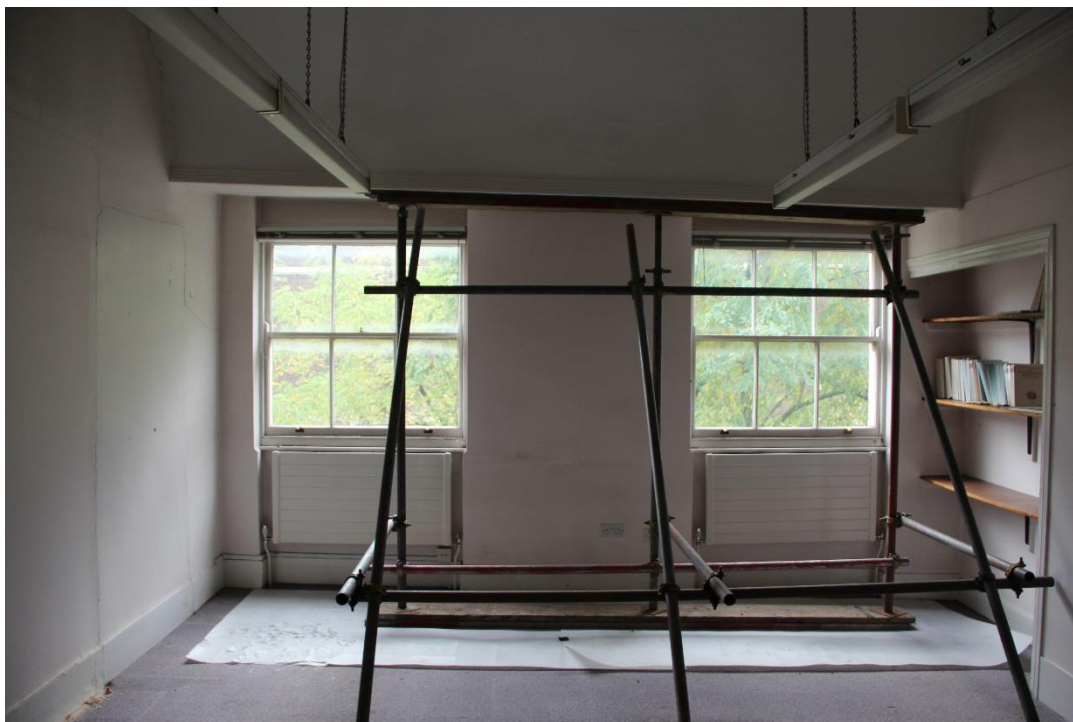
*Windows to undergo full overhaul to ensure good working condition and receive full redecoration. Redecoration throughout;*

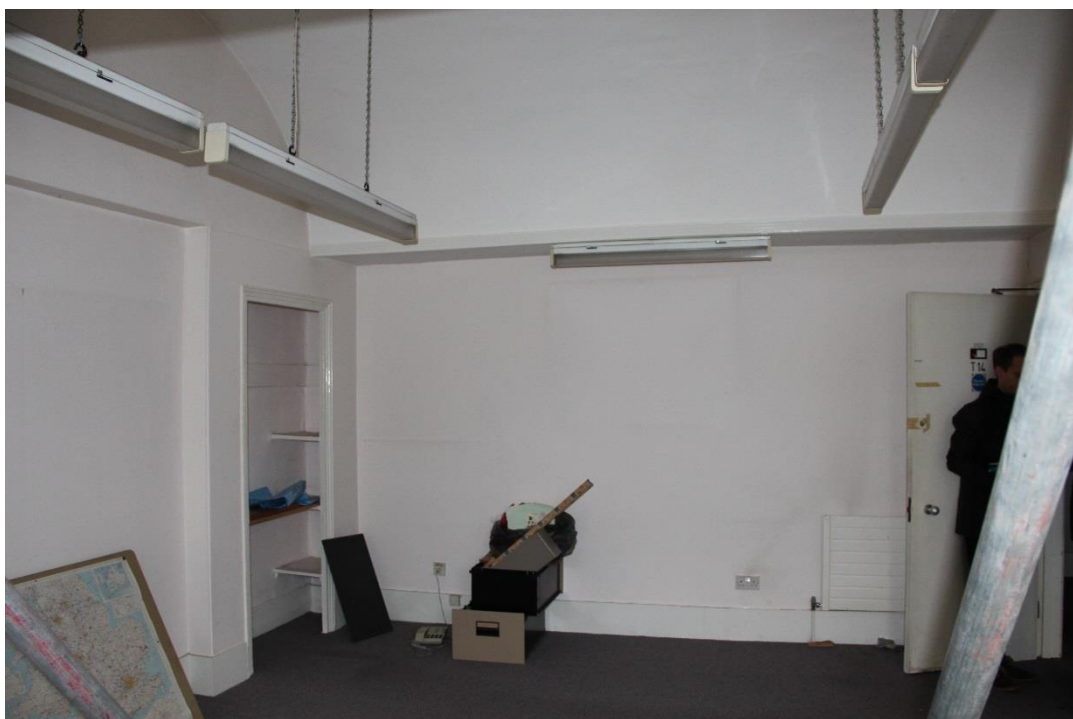
*Existing lighting to be removed and replaced. Refer to drawing (35)AP005. Ceiling to be repaired and made good following works.*

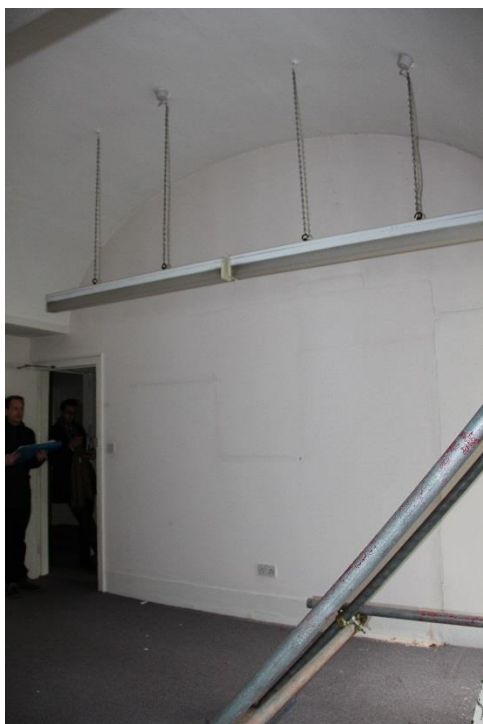
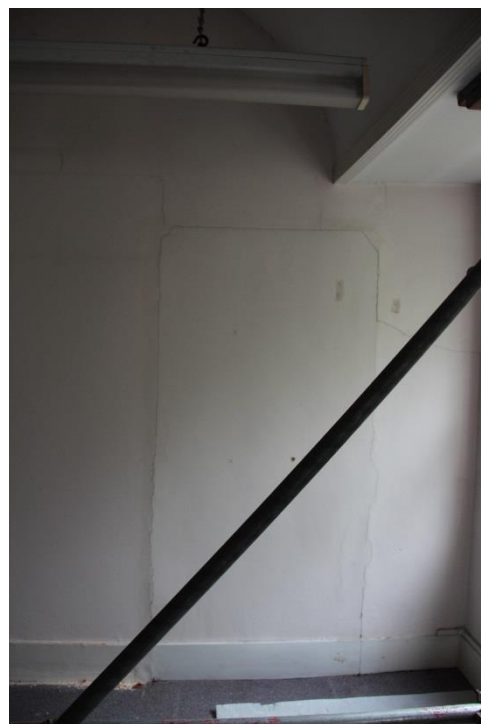
*New opening to be created within timber stud wall. Refer to detail drawings (70)AD031/032 and structural engineers information;*

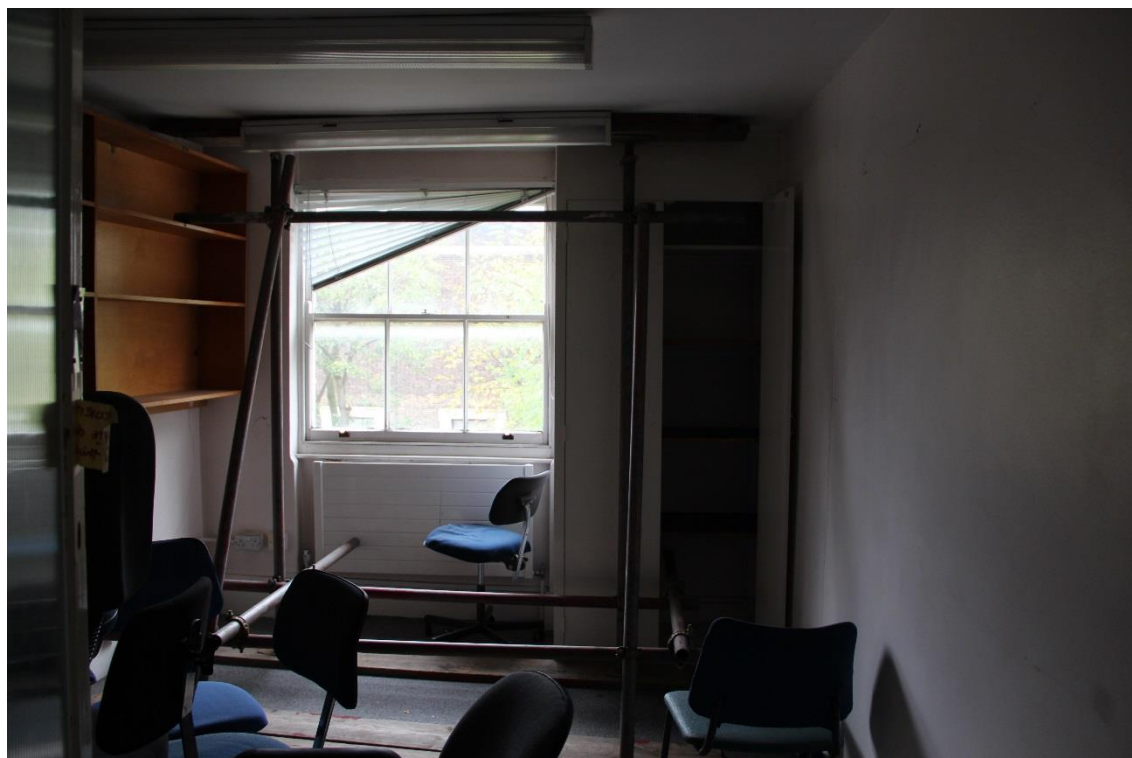
*Existing room 1MS/5/013:*

*Existing fabric to be removed as per drawing (18)AP005. Remaining walls to be made good where necessary. Windows to undergo full overhaul to ensure good working condition and receive full redecoration. Redecoration throughout;*

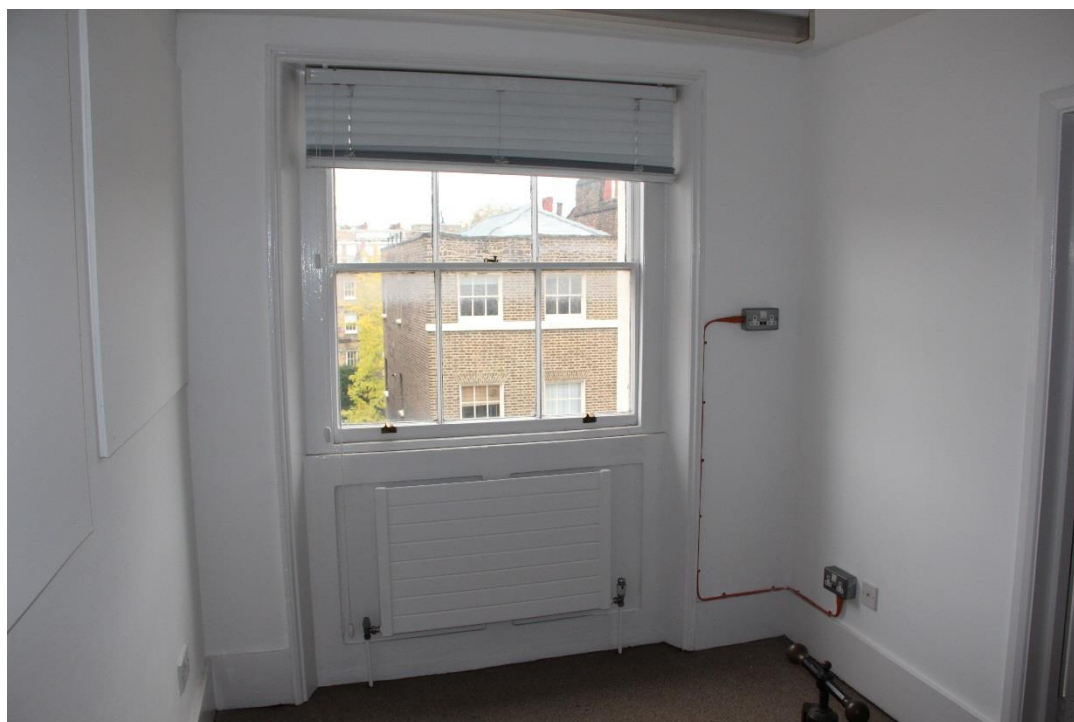
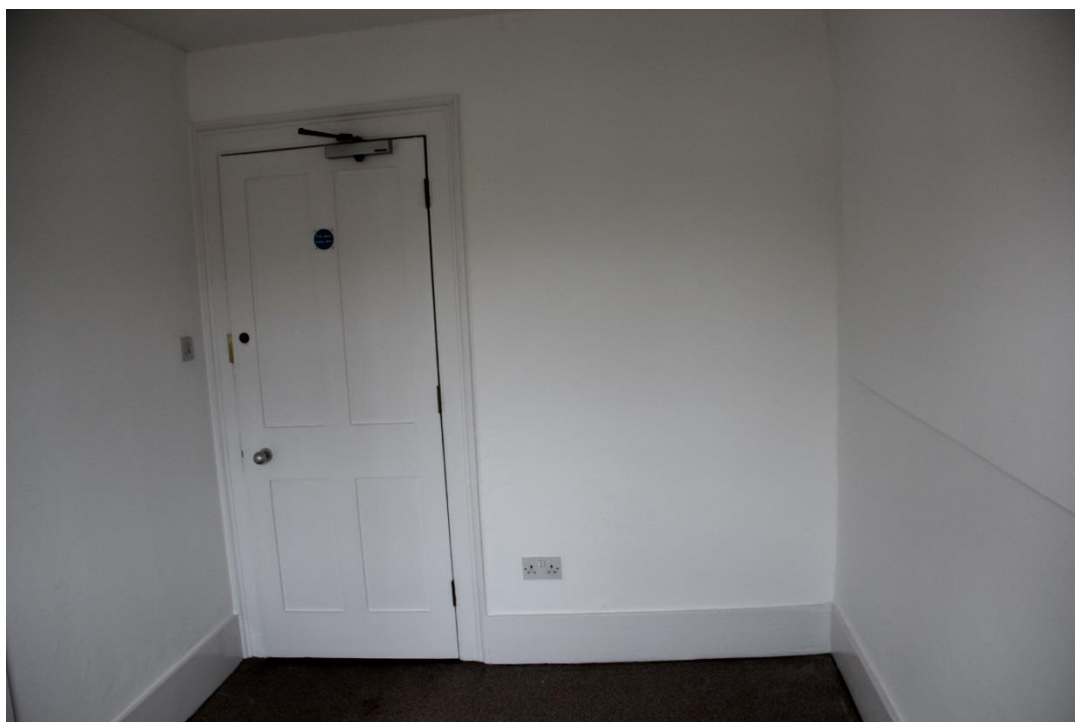
*Existing room 1AMS/5/002:*

*Existing fabric to be removed as per drawing (18)AP005. Remaining walls to be made good where necessary.*

*Existing door opening to be infilled and finished to match adjoining walls. Window to undergo full overhaul to ensure good working condition and receive full redecoration. Redecoration throughout;*

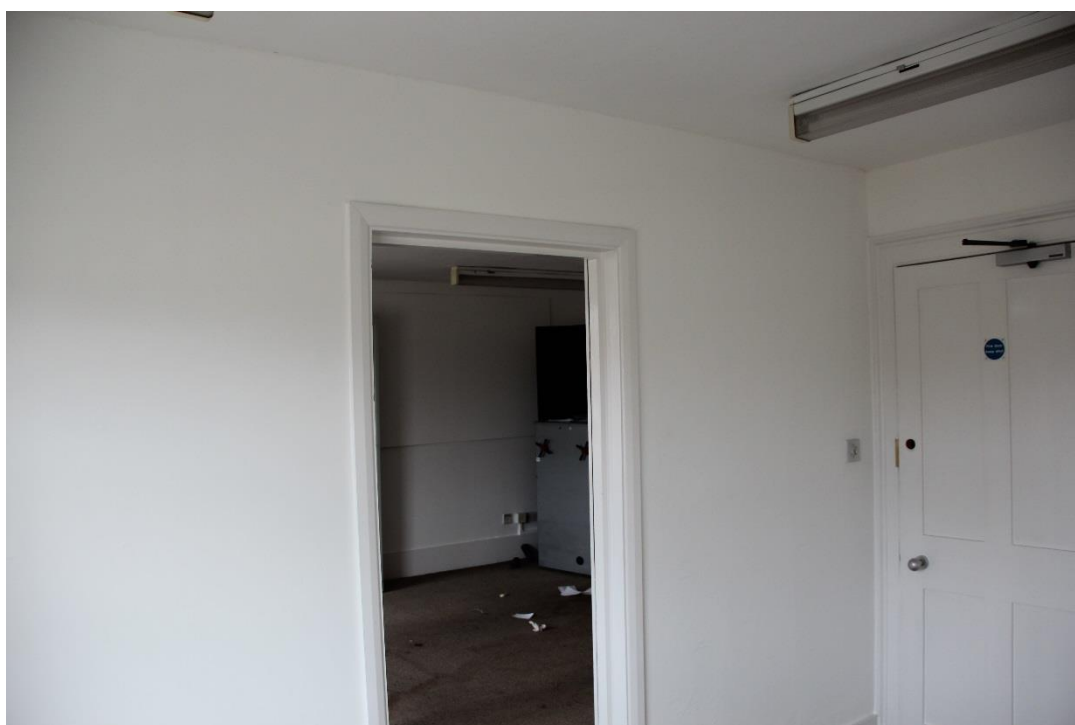
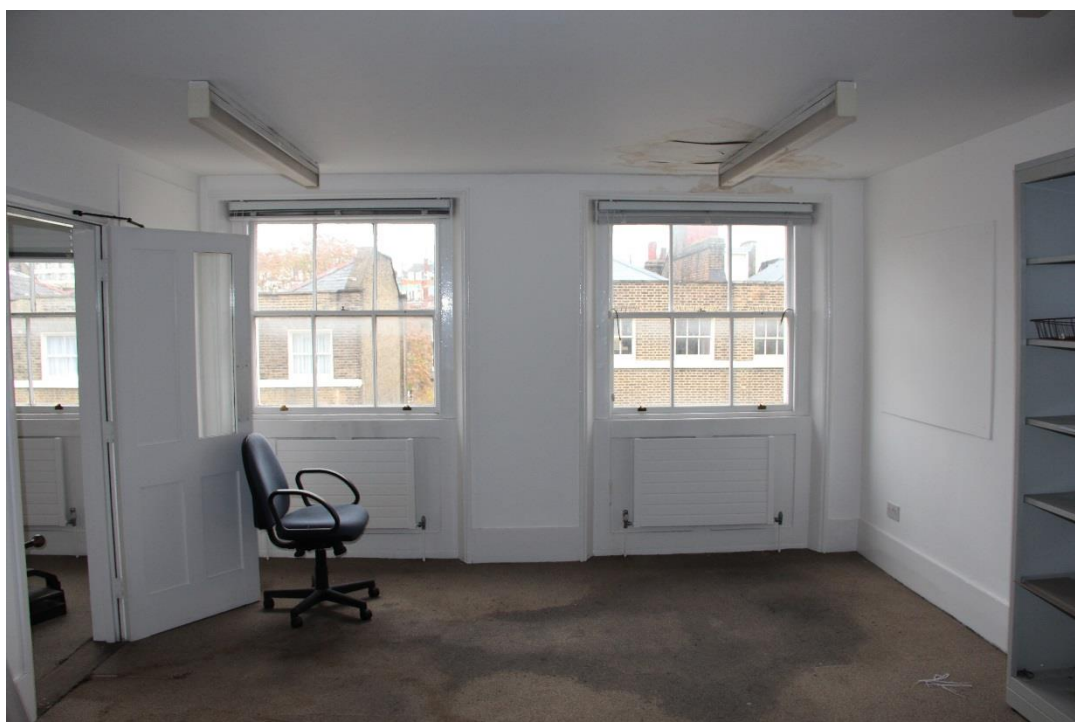
*Existing room 1AMS/5/002:*

*Existing fabric to be removed as per drawing (18)AP005. Remaining walls to be made good where necessary. Window to undergo full overhaul to ensure good working condition and receive full redecoration. Redecoration throughout;*

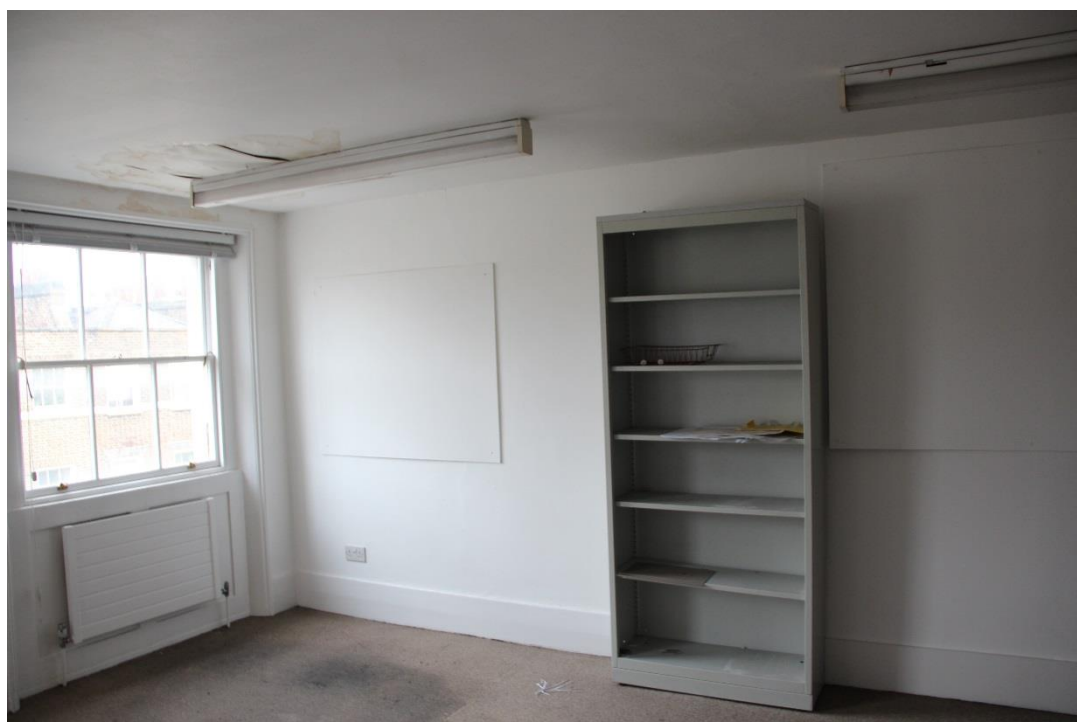
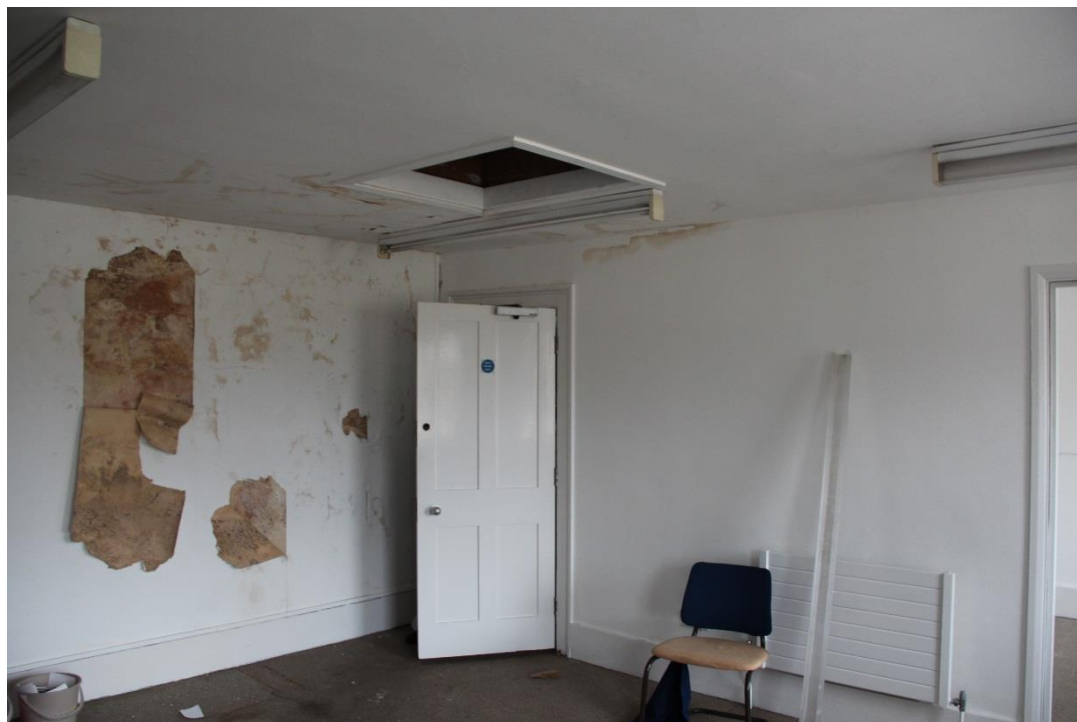
*Existing room 1AMS/5/003:*

*Where dampness exists, condition is to be assessed and repairs carried out as necessary. Redecoration throughout;*
