**THIRD FLOOR LEVEL**

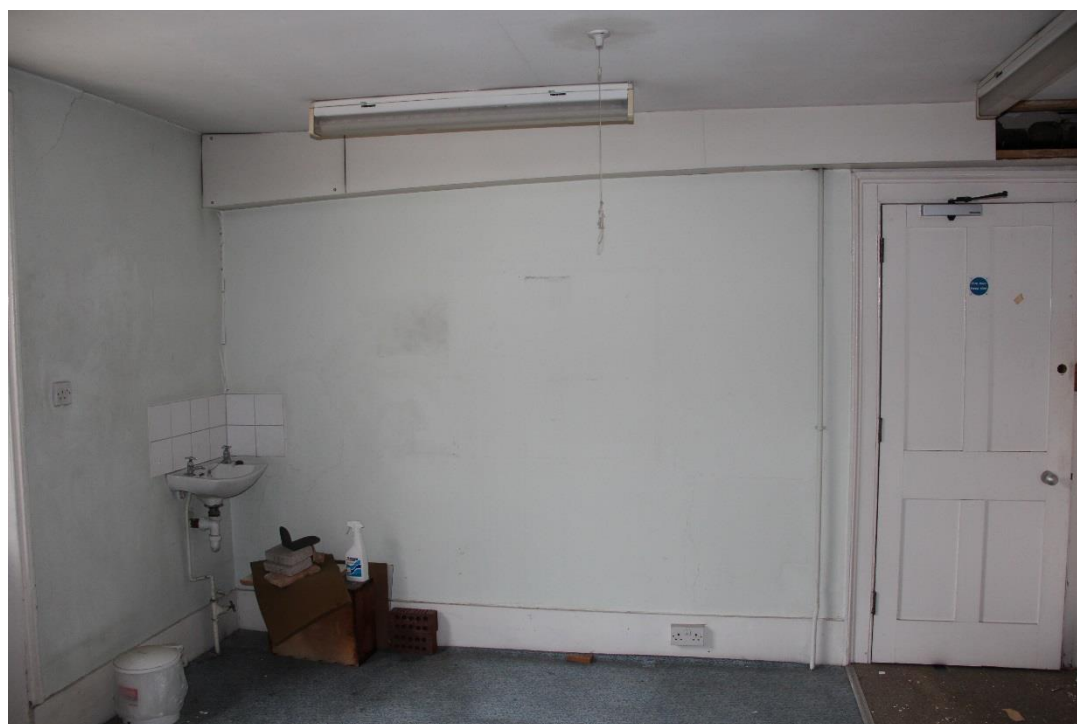
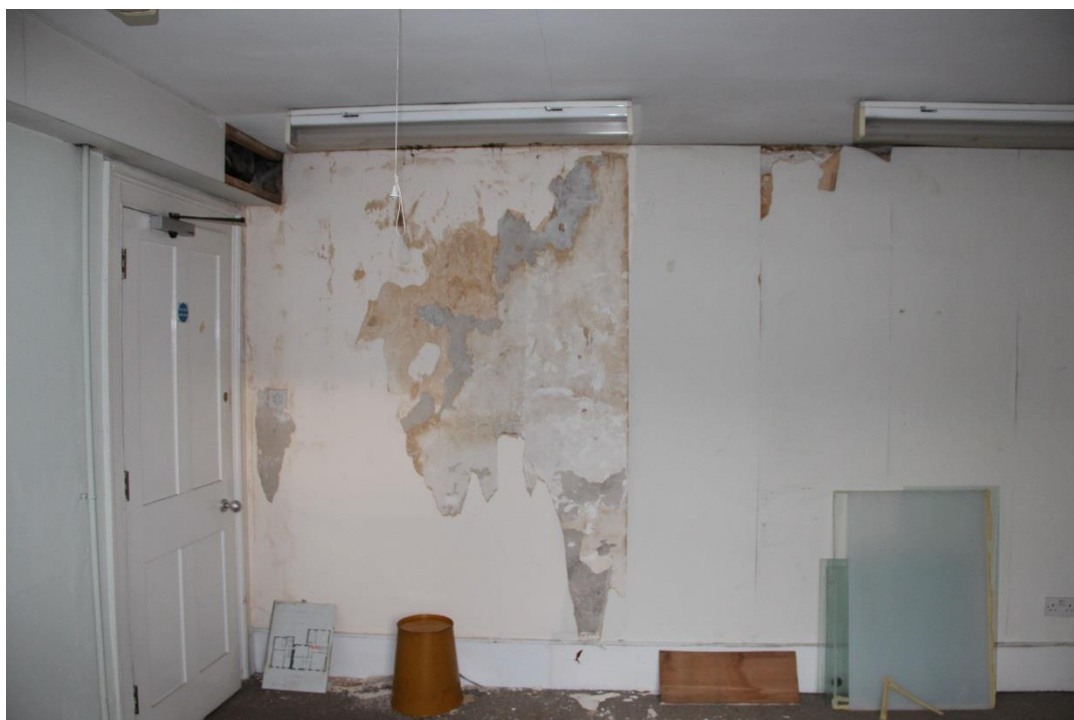
*Existing room 1AMS/5/004:*

*Existing fabric to be removed as per drawing (18)AP005. Remaining walls to be made good where necessary. Where dampness exists, condition is to be assessed and repairs carried out as necessary. Redecoration throughout. Existing rainwater pipe to be retained and existing boxing in to be replaced with plasterboard enclosure.*

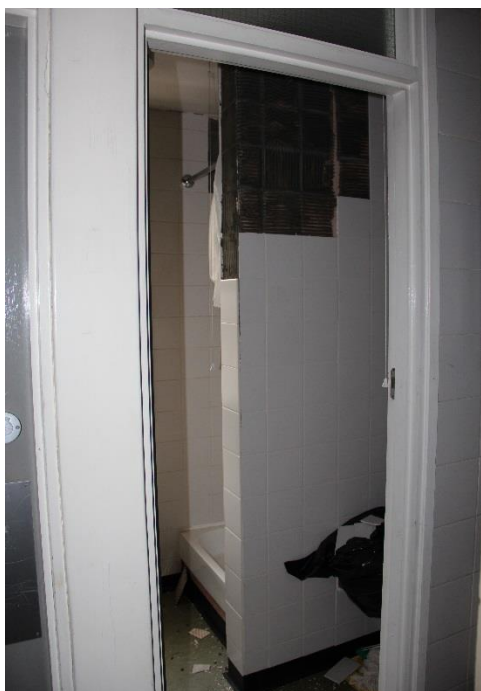
*Existing room 1AMS/5/001:*

*Existing fabric to be removed as per drawing (18)AP005. Remaining walls to be made good where necessary. Redecoration throughout;*

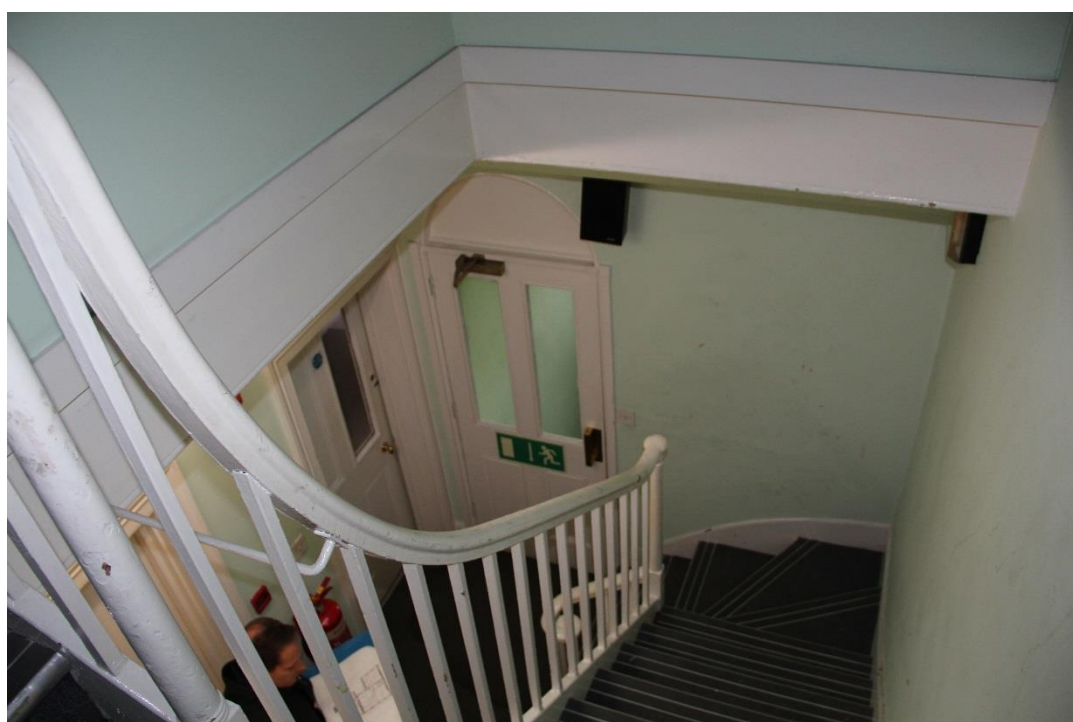
*Timber stair to be redecorated.*

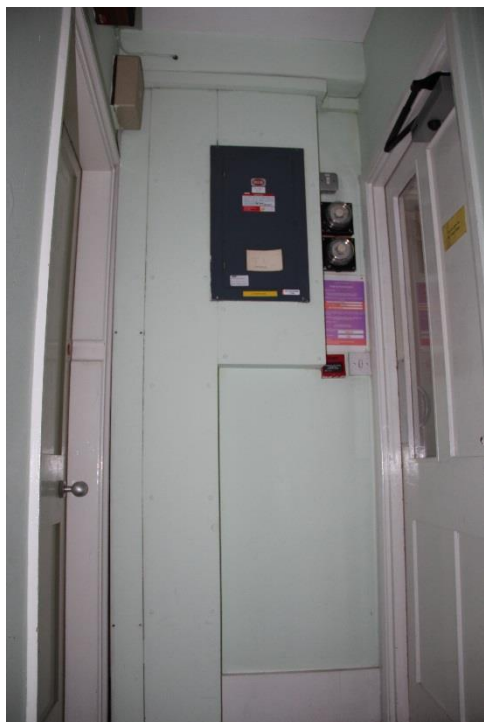
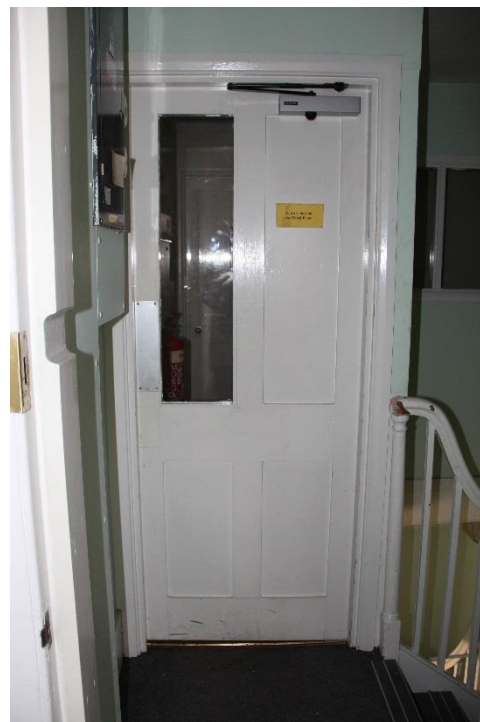
*Existing doors to be removed as per drawing (18)AP005. Existing door opening to room to be infilled and finished to match adjoining walls. Remaining existing doors to be upgrades for 30min fire protection;*

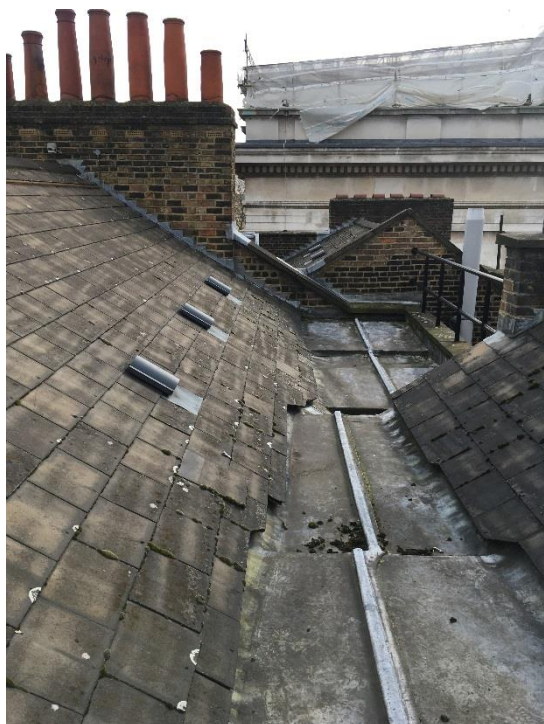
*Roof 1MS/6/X01*

All lead to gutters and cover flashing to be new in accordance to drawing (27)AP001.

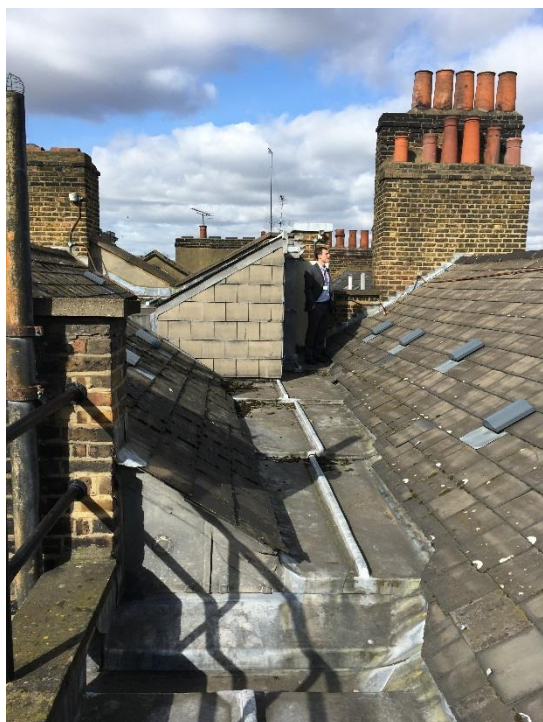
*Roof 1MS/6/X01*

Timber access door to be overhauled to ensure good working condition and redecorated with dulux weather shield.

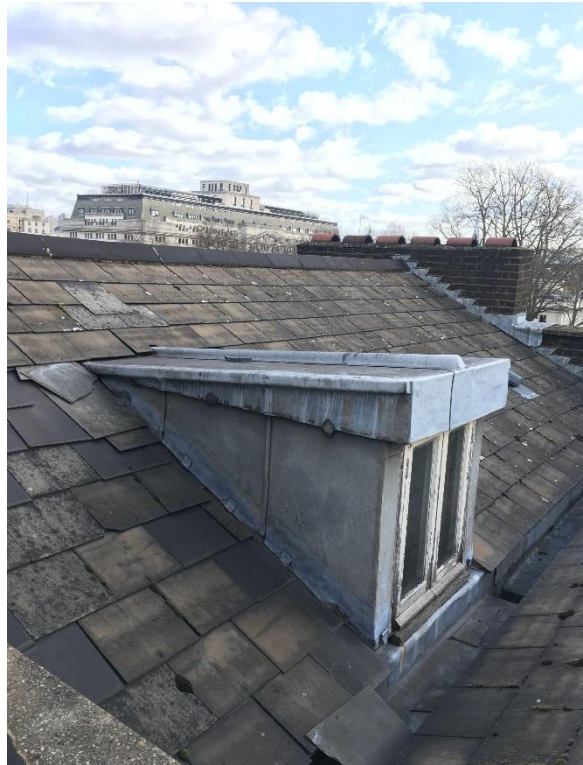
*Roof 1AMS/6/X01*

Existing roof access dormer to be removed. New timber and leadwork roof access dormer to match design and materials of existing

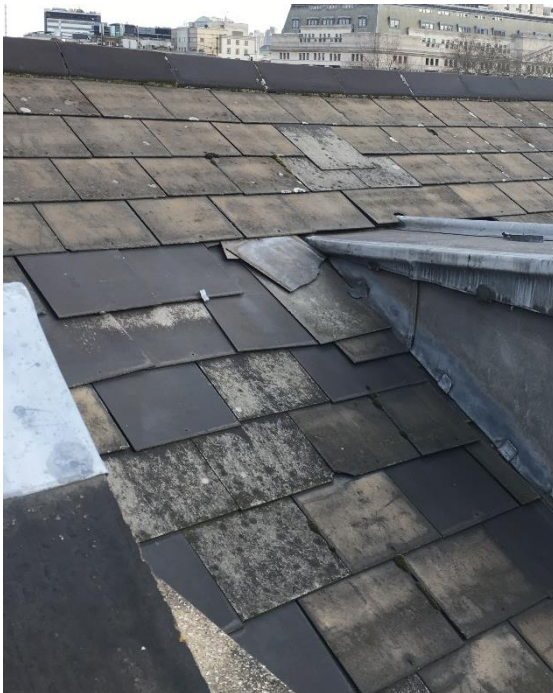
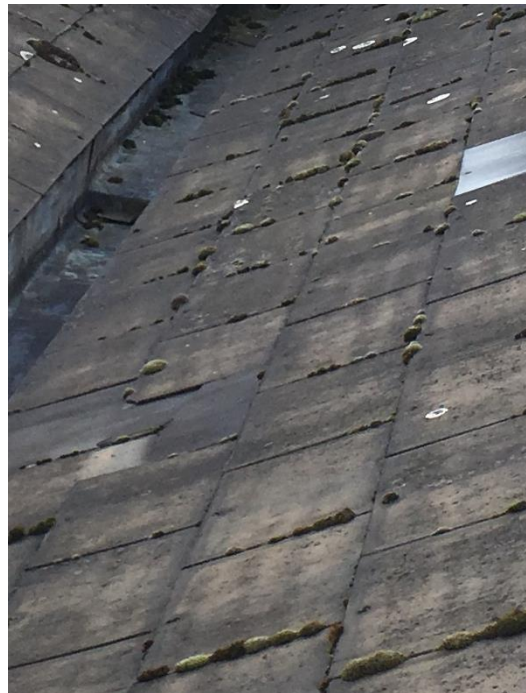
*Roof 1AMS/6/X01*

All existing slate and leadwork to be cleaned to remove any organic growth and loose debris. New natural slates to match existing where modern tiles have been fitted and where damage has occurred.

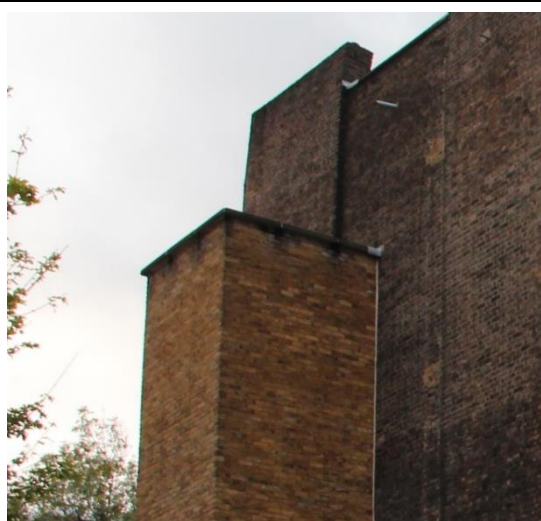
*Roof 1AMS/5/L313*

Existing lift shaft roof. Existing roof including parapet walls and copings to be repaired if necessary.
