DESIGN AND ACCESS STATEMENT & HERITAGE STATEMENT

15 GLOUCESTER AVENUE REAR BALCONY, LONDON, NW1

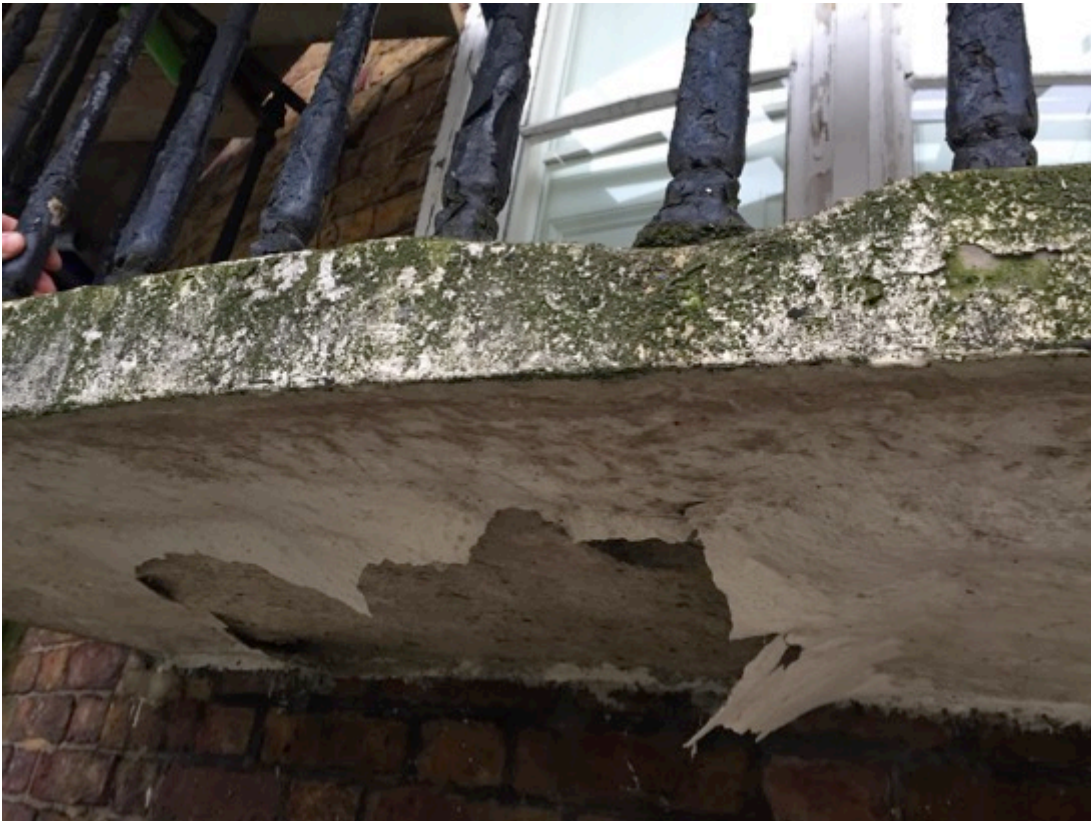
The metal fixings had loosened from the brickwork and caused the brickwork to crack, the concrete base of the balcony had eroded down to a few millimeters in parts and it was found that the entire balcony was simply being held in place by the brickwork on either end. Photographs 1 & 2 below show the unstable condition of the balcony.

Photograph 1 – Balcony in disrepair

The balcony was therefore removed.

An engineer has been engaged to design the structure and support for the replacement balcony. Rebuilding using existing materials would require major reconstruction works to the internal elements of the flat, including the floor, floor joists, existing beams and flat below in order to effectively counterweight the balcony. It has therefore been concluded that a lightweight metal cantilever design, ensuring the external finish of the balcony matches the original would create the least disruption to the flats and building fabric, whilst providing a safe balcony.

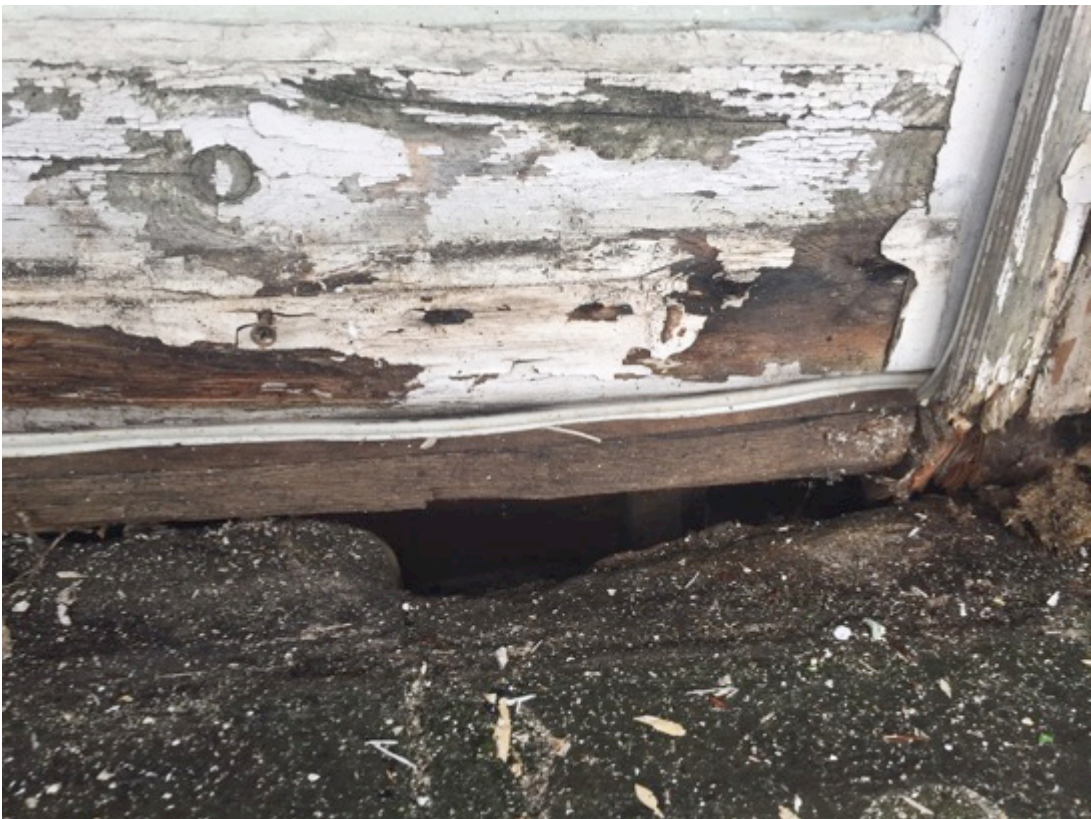
Photograph 2 – Large gap between the balcony and door above indicating lack of cantilever support and deemed an unsafe structure
