23rd January 2017 Ref: J3017-S-FN-0003

Birkbeck College - Removal of ground floor partition at 30 Russell Square

J3017-S-SK-0005

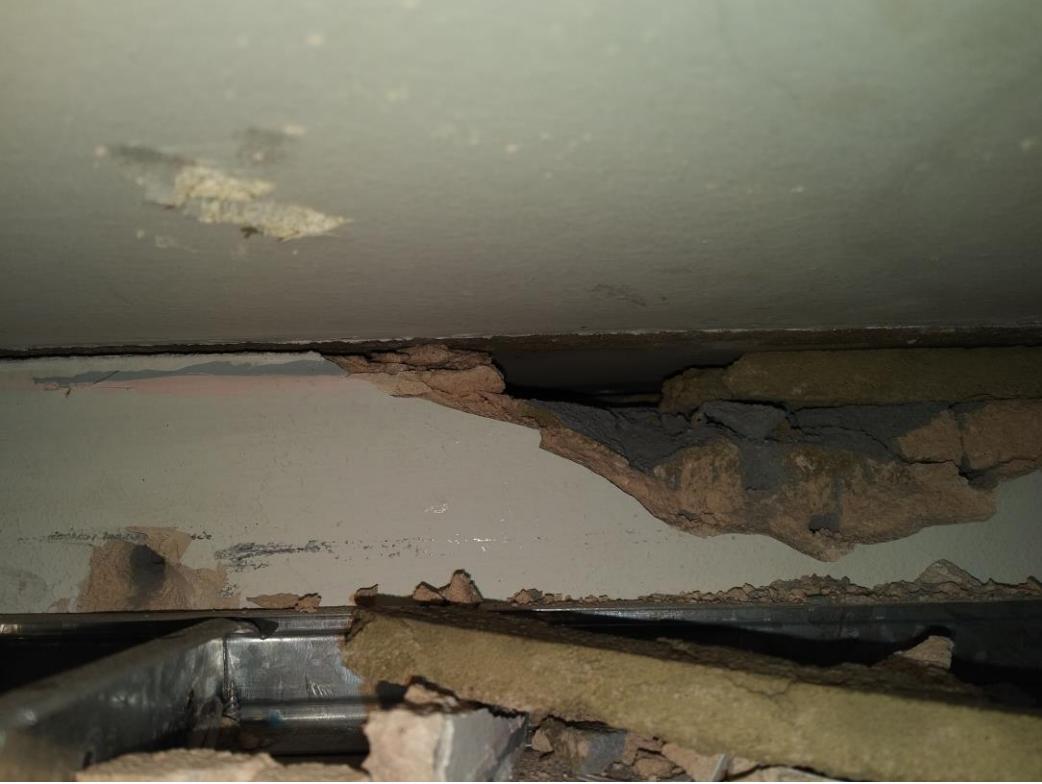
The inspection identified that the partition is constructed from brickwork, with a layer of mortar between the partition and the concrete floor slab above. Based on this information and the plans provided, we consider that the partition proposed for removal is non-load bearing brickwork can be removed safely by a competent contractor.

Figure 1: Top of partition wall at lining removal

- Remove the lining along the full length of the wall, on both sides, prior to full demolition of the wall. This will enable identification of any unexpected load bearing elements, such as reinforced concrete columns, within the partition.
- If at any time the brickwork cannot be simply removed due to a high compressive force on the wall, contact Webb Yates Engineers for further instruction.

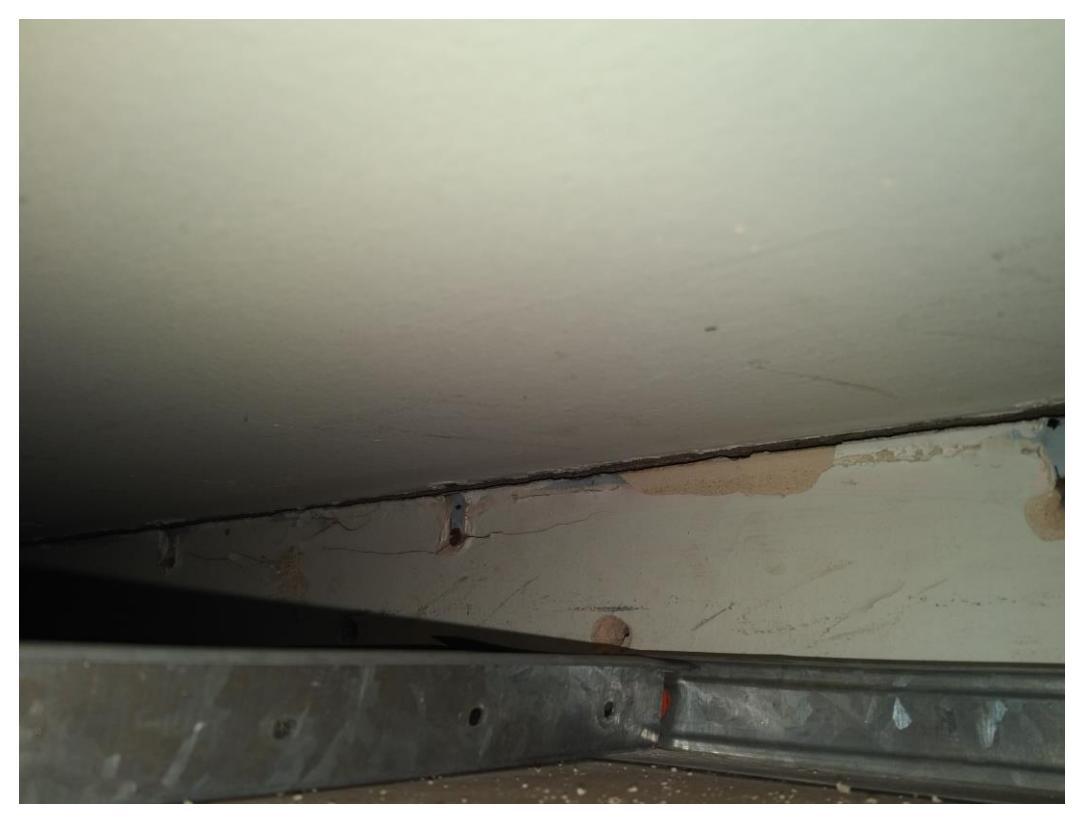
Figure 2: View along partition wall in ceiling void

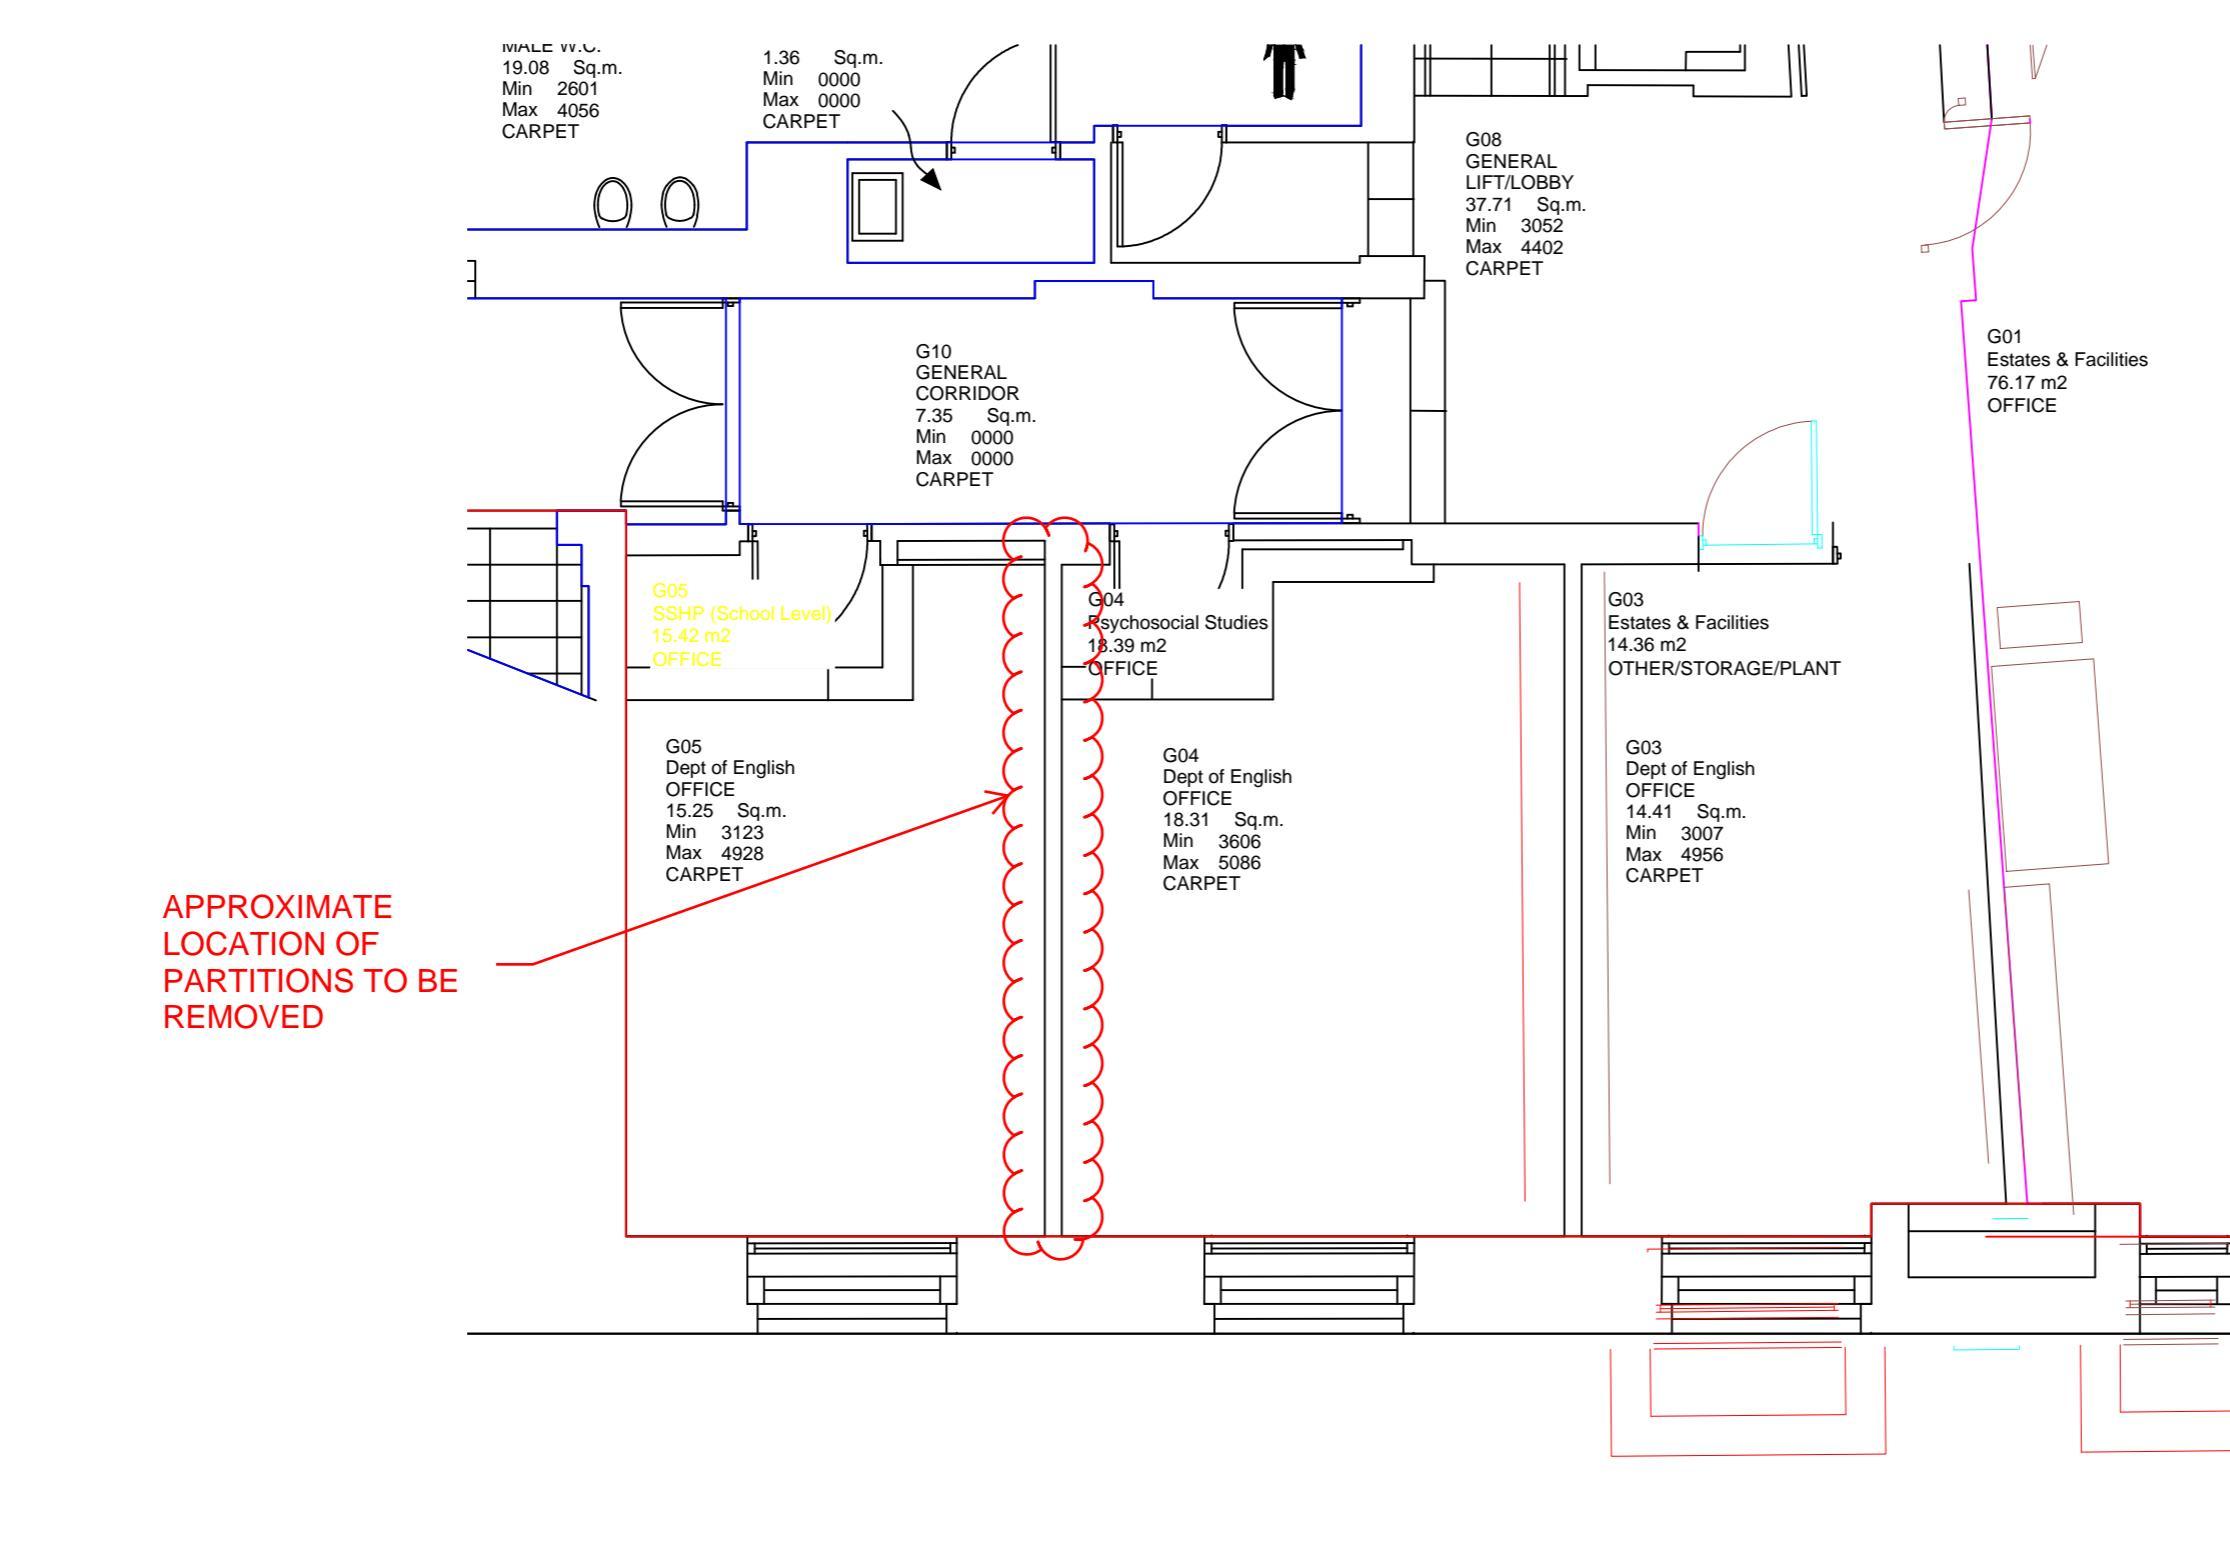
• Removal of existing partition walls (as marked on the appended plan)
