OMC Associates

BS 5837 Arboricultural Report for Development

CLIENT:	Vivien & Edmund Bradley
CONTACT:	Jun Kondo
SITE:	28 Belsize Lane, London, NW3
CLIENT REF:	N/A
OUR REF:	0789D/CJO/0612
INSTRUCTION REC'D:	2 December 2013
DATE OF REPORT:	6 December 2013

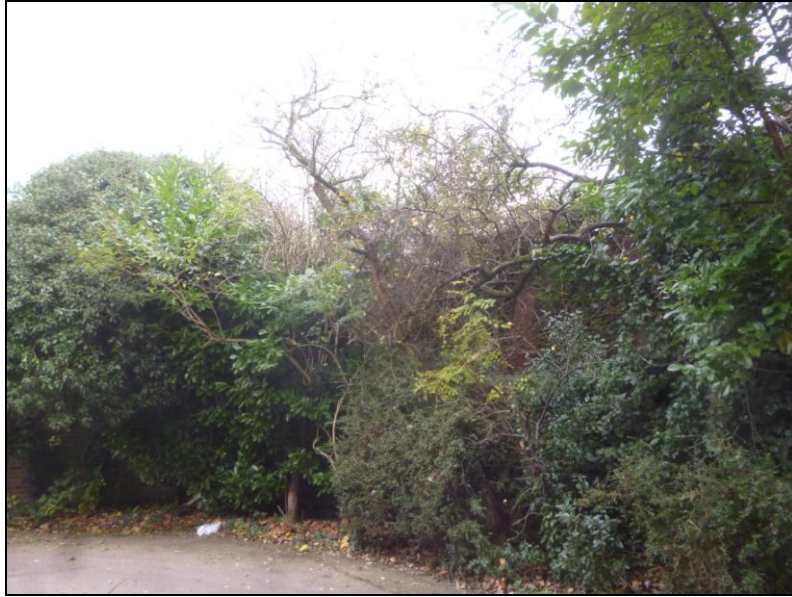
The same principle of root abatement applies due the depth of the foundation of this new wall to the other trees and vegetation, specifically the poor trees T8 & T9 and undergrowth grow along this western boundary.

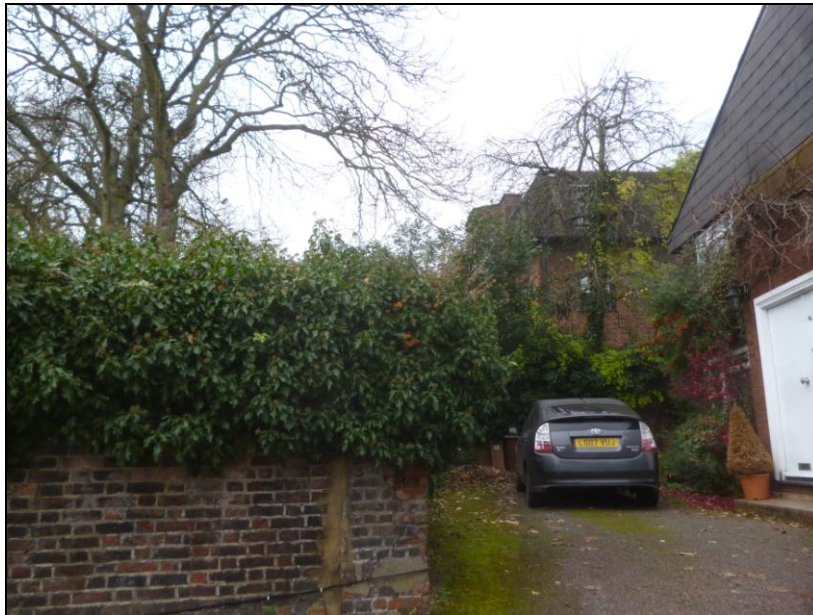
Tree T2 is a pear tree growing outside of the western boundary of the subject property near to the front of the existing house. It is visible from the public road but appears to have been pollarded in the past and has a relatively small crown.

It grows in a narrow strip of shrubbery and the ground on either side of the tree comprises asphalt. I understand from Dr Dobson's report of November 2005 that a brick boundary wall between the two properties was constructed 'recently'. Though foundation details are not known, it is probable that

some root encroachment has taken place but significant root severance at the time of construction is likely to have occurred.

The lowering of level may encroach upon the nominal RPA of tree T2 which is growing at a similar ground level to that at the front of the existing house but we understand from trial pits that the boundary wall provides an effective barrier to 1420mm. In view of the previous severance of the roots of this tree in association with this boundary wall it is unlikely that any significant roots are to be found on the subject property. In view of the pollarding of this tree, the full RPA as calculated from the stem diameter is a little disproportionate to the crown mass of this tree and in reality the roots are likely to occupy a lesser area and the RPA is annotated to reflect this. The lowering of the ground level on the eastern side of the tree is unlikely, therefore, to cause severance of any large (over 25 millimetres diameter) roots belonging to T2 but it is important that the ground within the area extending in a radial arc of 2m from the stem is lowered manually and carefully and all the procedures laid out in section 4.6 assiduously complied with.

Some minor facing back of the sections of crowns of T2, T8 & T12 overhanging the site to be developed is advisable to avoid possible mechanical damage to the crowns.
