Arboricultural Method Statement

77 Lawn Road, Camden NW3 2XB

Project Number: P2468.2.1

Date: 1 September 2017

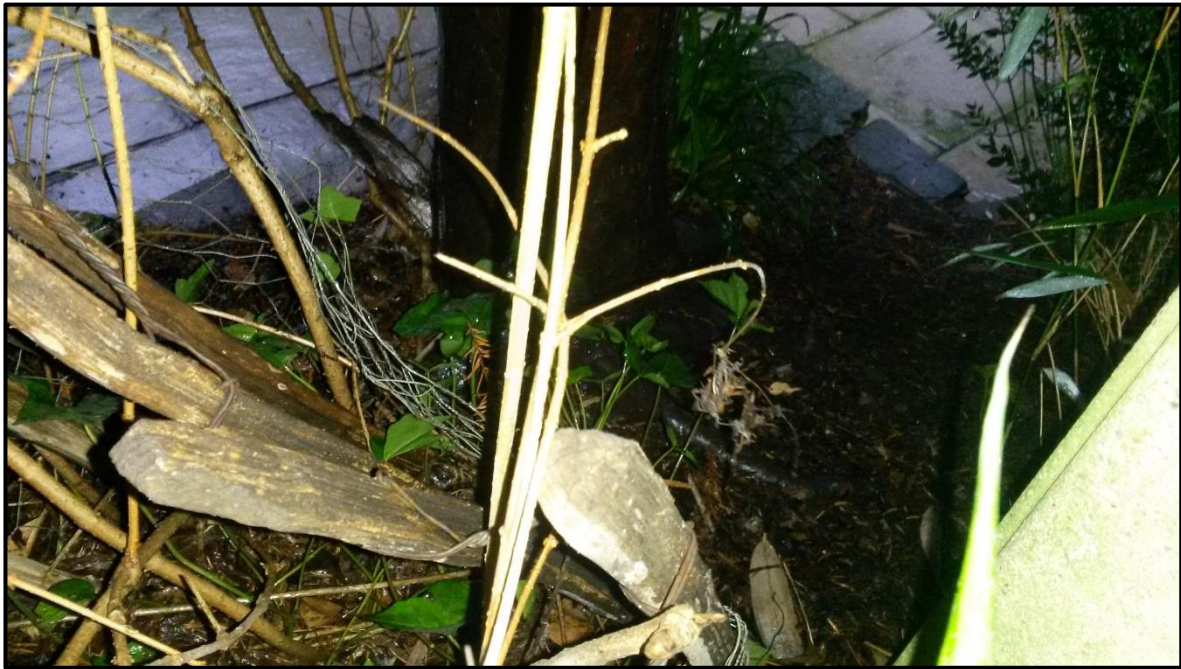
The height difference in ground levels between the site and the neighbouring property is 550mm. Ninety percent of tree roots are commonly found in the top 600mm below ground level. Roots may grow deeper, but not generally in abundance. The difference in ground levels is such that it is unlikely few, if any, roots would extend down beneath the ground level within the site.

Plate 1 (above). View looking beyond the northern site boundary showing the base of the trunk of T8, yew, relative to the garage wall on the boundary (far right), and the ground level in which the tree stands.

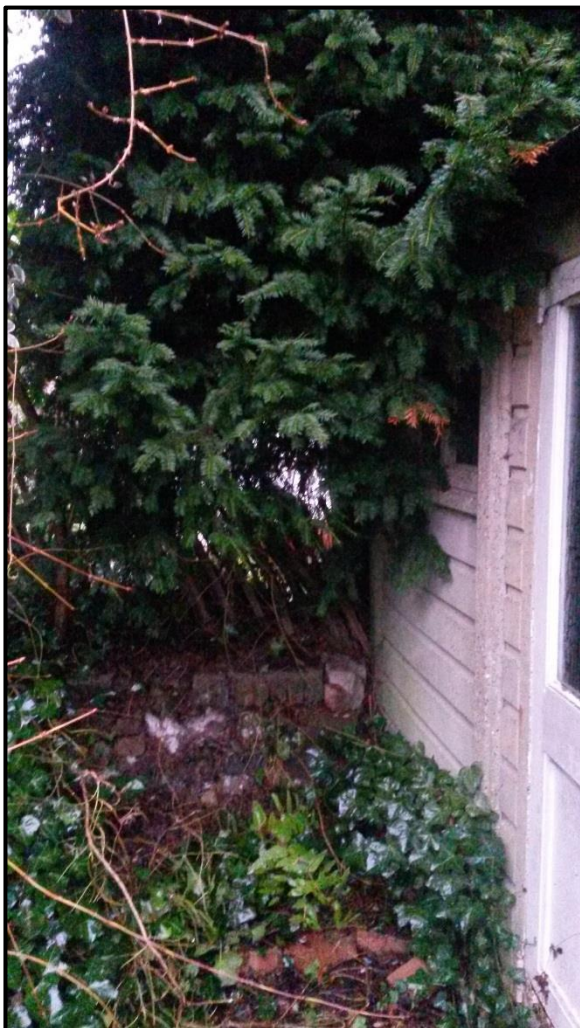
- Between the site and the neighbouring property to the north is a brick retaining wall, running along the boundary and extending to the west beyond the calculated Root Protection Area (RPA) of T8.
- This wall extends to 550mm above the ground level within the site;
- The tree stands approximately 550mm from this wall within the neighbouring property;
- Ground level within the neighbouring property is at the same height as the top of the boundary wall;
- A pre-fabricated garage stands immediately inside this boundary wall, with the north-western corner located such that the eastern section of the on-site RPA of T8 is beneath the garage base, with the garage wall extending along the boundary to the east beyond the calculated RPA;
- Ground within the site, both within and beyond the calculated RPA, is covered with hard surfacing, which has been in place for a considerable period.

Plate 2 (left). View looking to the north at the site boundary, showing the boundary retaining wall (left) and garage (right), with the level difference between the neighbouring property and the site visible, most clearly evident looking at the ground level by the garage door in relation to the top of the wall.
