Central Somerstown, Camden

Arboricultural Impact Assessment and Method

Statement

Report for Neilcott Construction

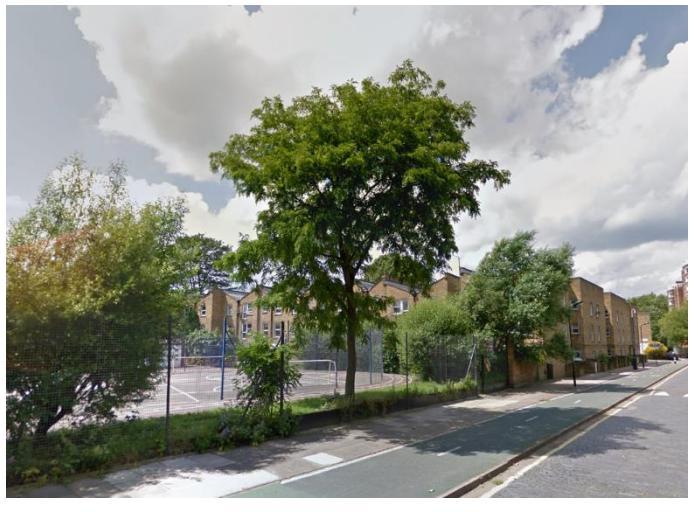
View looking northwest along Purchese Street towards false acacia tree T177 and group G4.

- 4.1 It is recommended that consideration be given to the removal of T177 prior to the commencement of works due to potential future hazard risks to the property, and preventing ongoing pruning works associated with future pressures to manage the tree upon completion of the development.

- 4.5 The temporary access road extending along the western site of Purchese Street has the potential to cause significant damage to the root system of T177. Specialist methods of construction will be required where the road encroaches into the RPA of the tree.

- A load bearing cellular confinement system (Cellweb or equivalent) as described in Appendix 5, and in accordance with an engineered specification shall be used to form the foundation of the temporary access road where it incurs into the RPA of T177. This shall remain in place for the duration of the works.

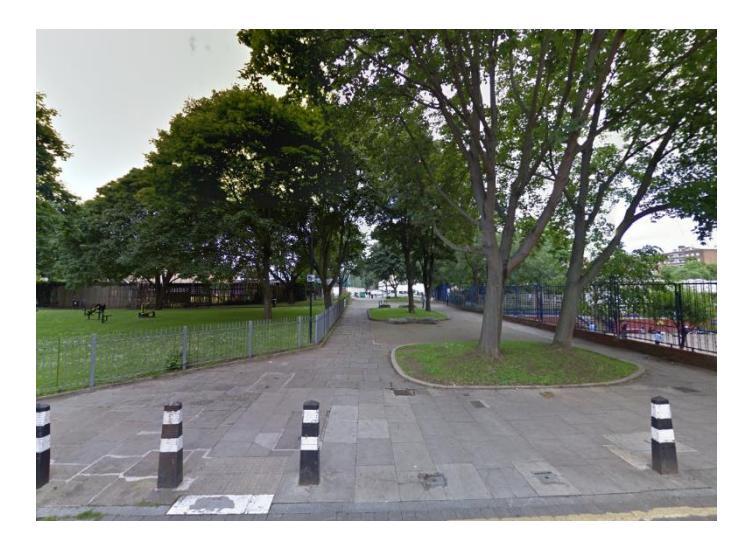
View northwest from the corner of Polygon Road and Ossulston Street towards trees Norway maple trees T250 to T253 and field maple T254.
