36 Great James Street
Design & Access Statement
September 2017

1.0 Planning History

5.0 Issues identified with refurbishment

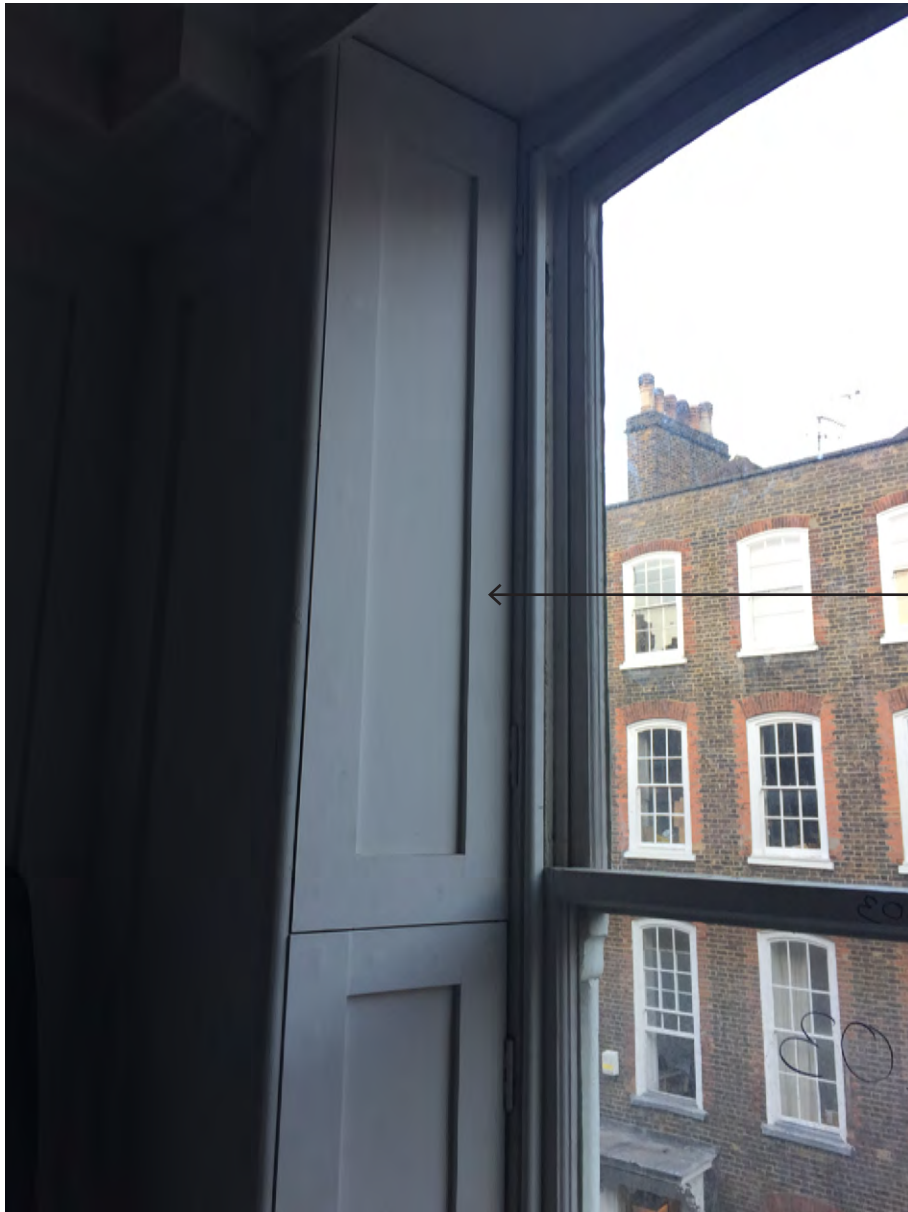
5.1 Issues identified with refurbishment

Modern MDF shutters
found on second floor
(W202, W203)

The applicant proposes to replace the damaged and non-original shutters on a like-for-like basis, with beadings and dimensions to match the existing. A full survey has been carried out of the existing shutters, and new shutters will be fabricated from softwood to match the existing details. These will be decorated with paint as per the rest of the panelling, and close flush into the existing recesses either side of the windows.

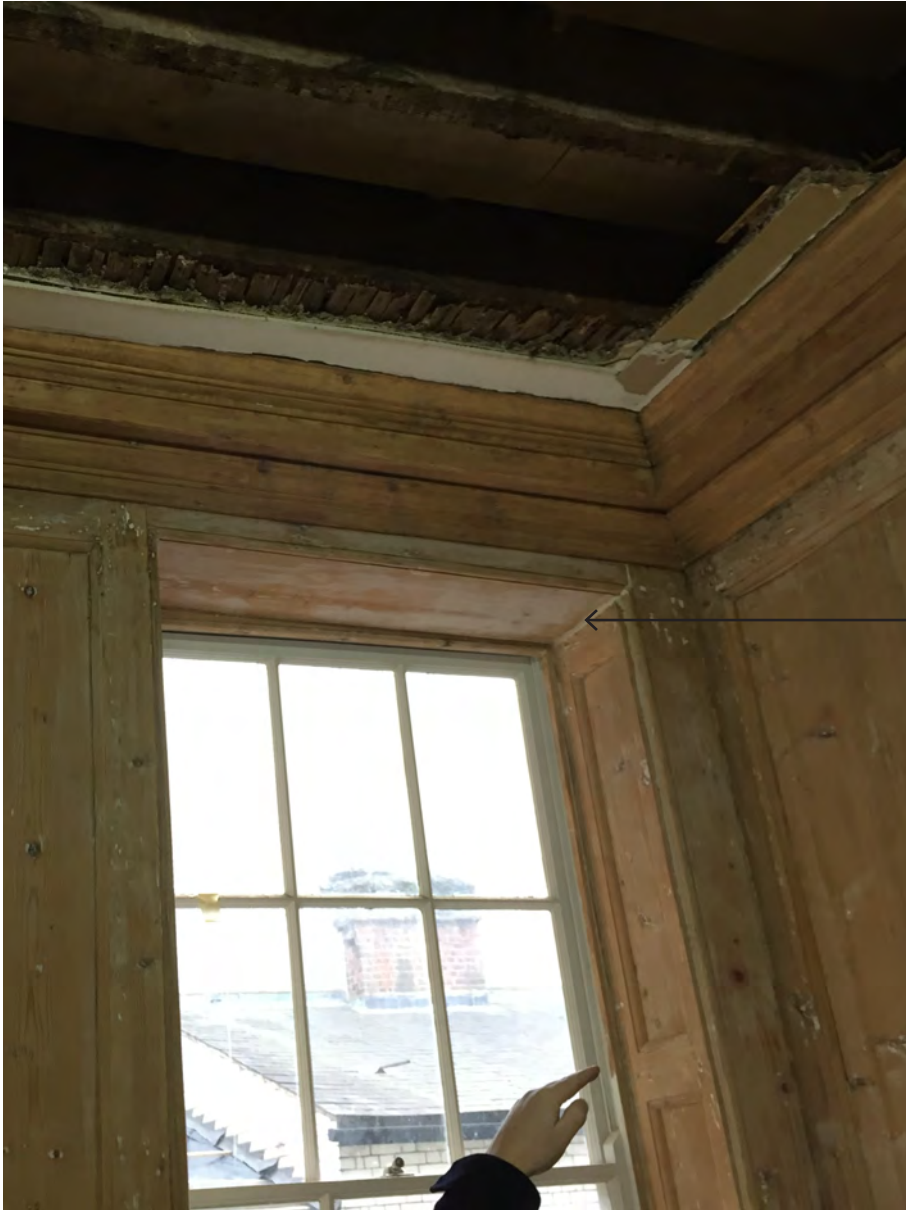
5.2 Issues identified with refurbishment

Shutters nailed shut and joints filled. Associated ironmongery or hinges not present. (W104, 105, 106, 204, 205).

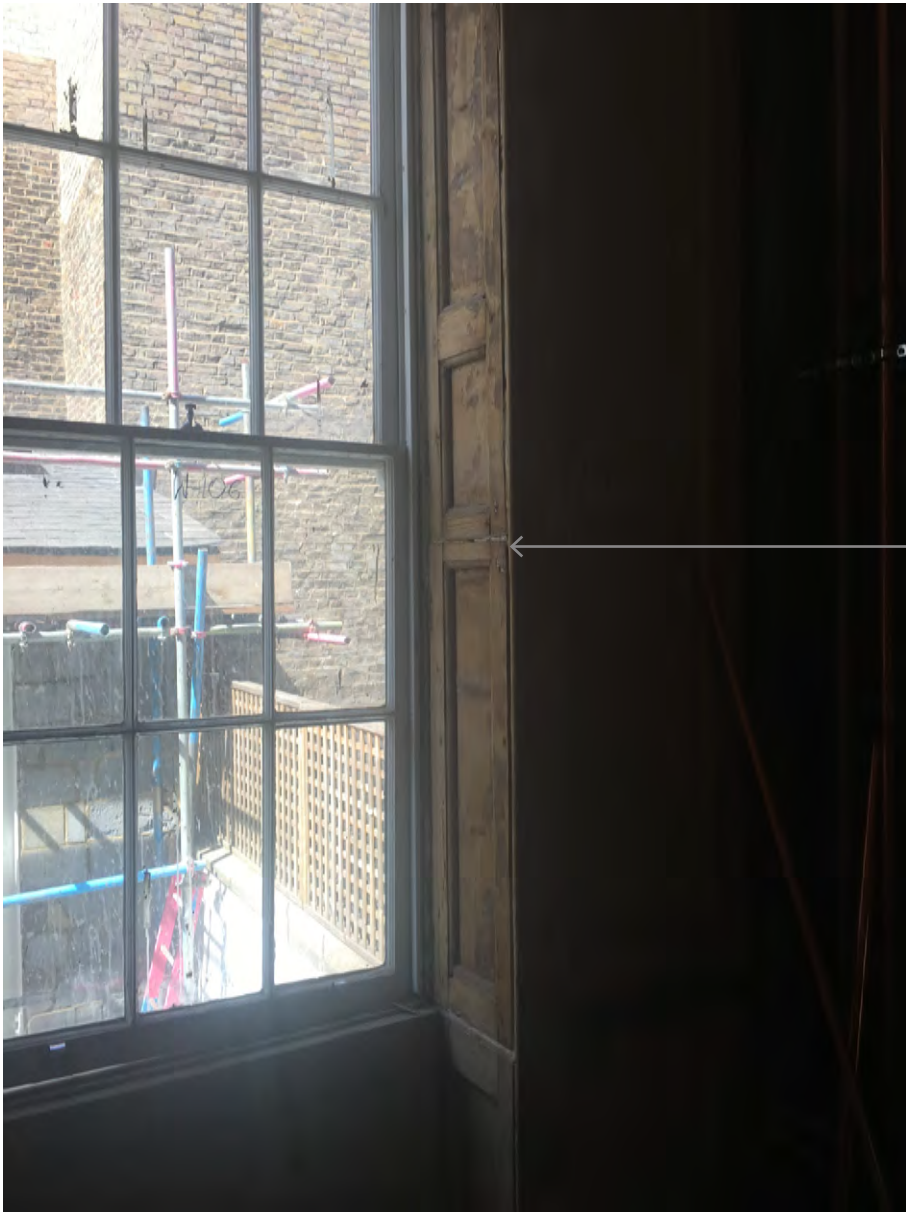
5.3 Issues identified with refurbishment

Shutters nailed shut and joints filled. Associated ironmongery or hinges not present. (W104, 105, 106, 204, 205).

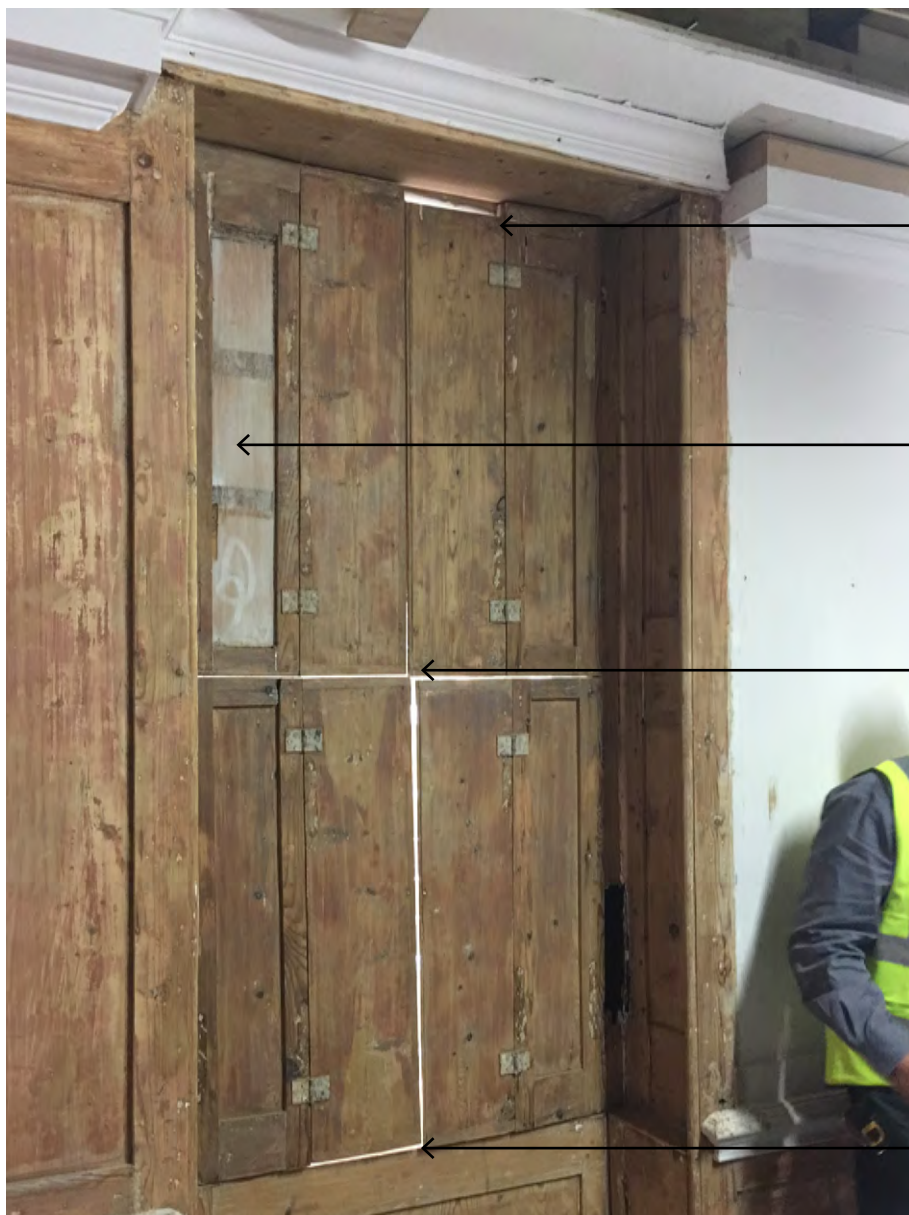
5.4 Issues identified with refurbishment

Pieces missing

Panels previously replaced

Panels no longer meet in closed positions

Panels cut in piecemeal fashion to suit movement of house resulting in staggered joints and misaligned shutters.

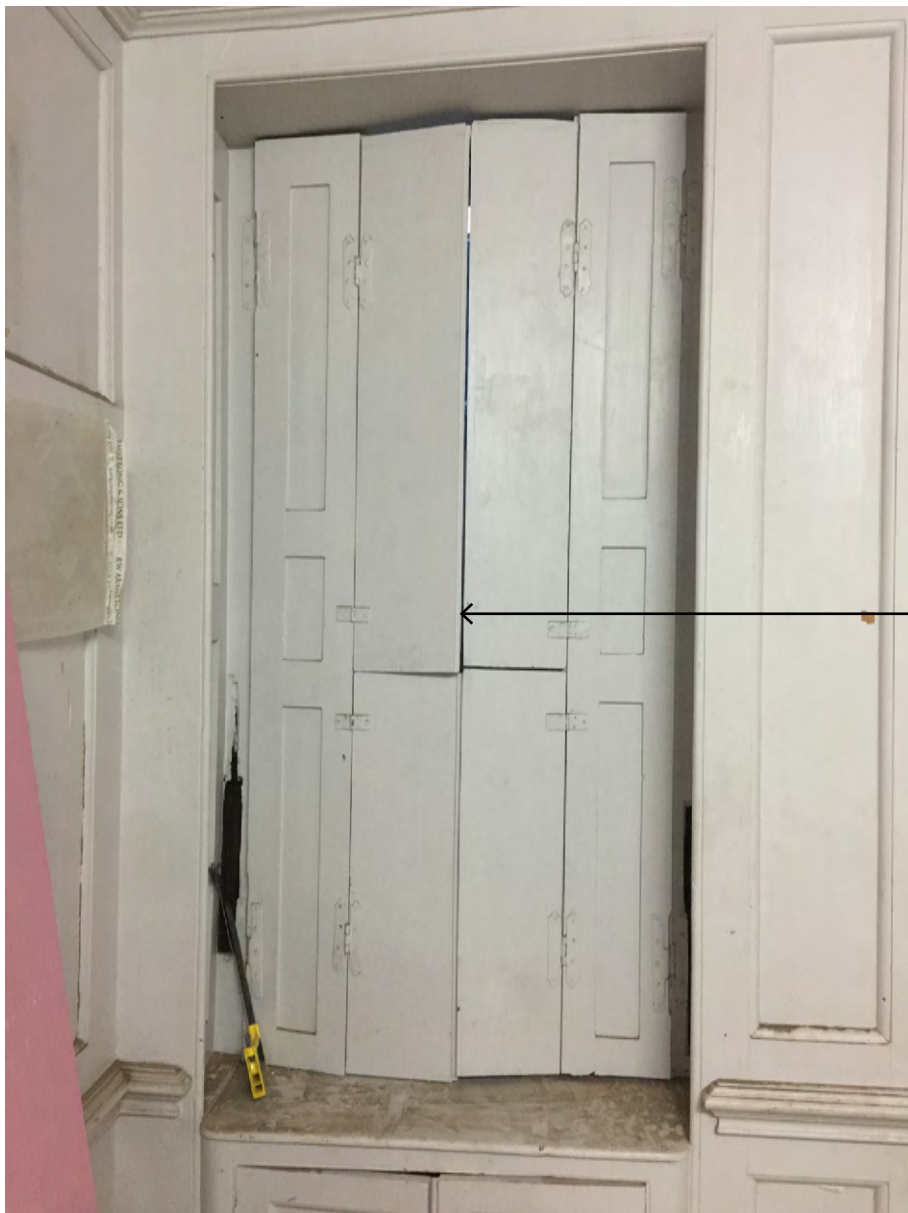
5.5 Issues identified with refurbishment

← Previous adjustment and cutting of shutters means they no longer align with those above and adjacent, leading to staggered joints and uneven frame widths.

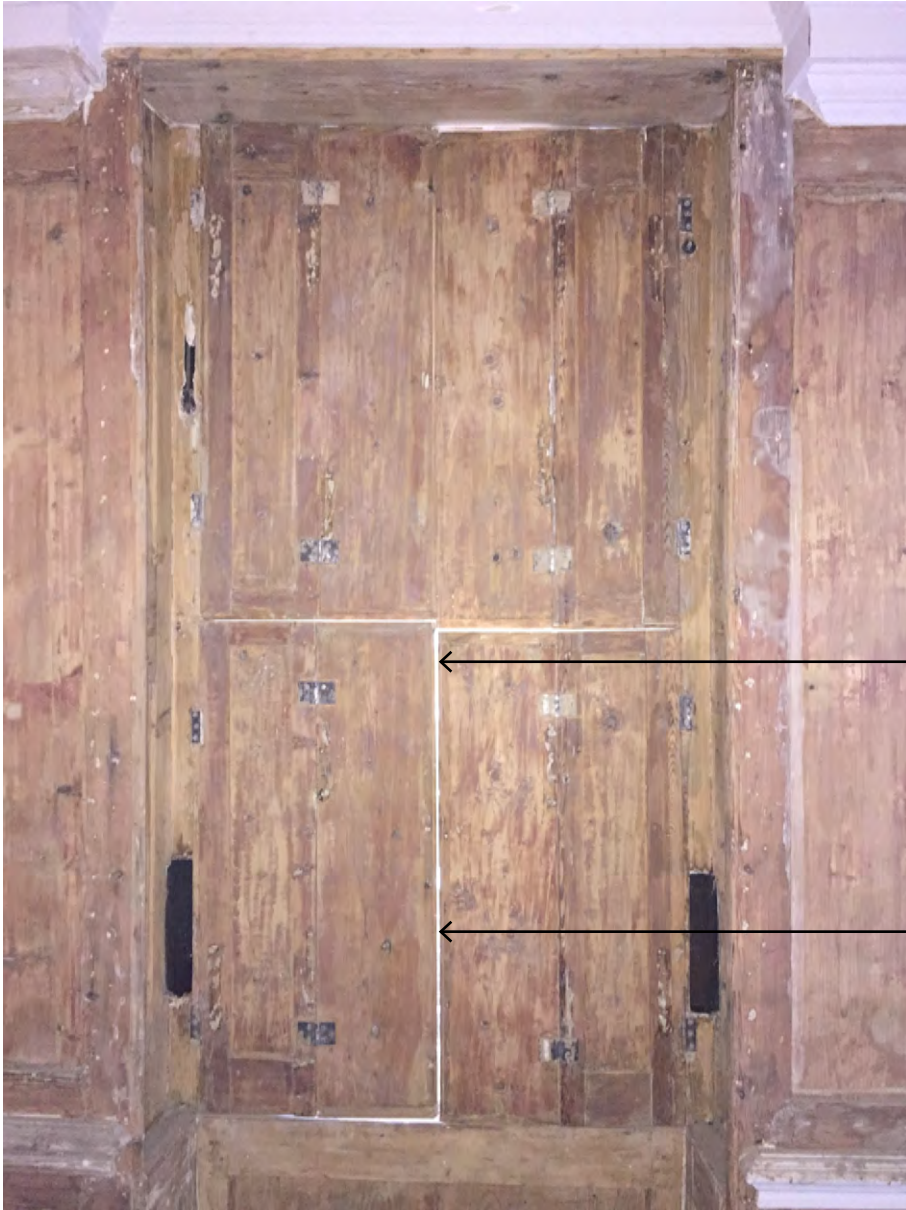
5.6 Issues identified with refurbishment

← Previous adjustment and cutting of shutters means they no longer align with those above and adjacent

← Panels no longer meet in closed positions

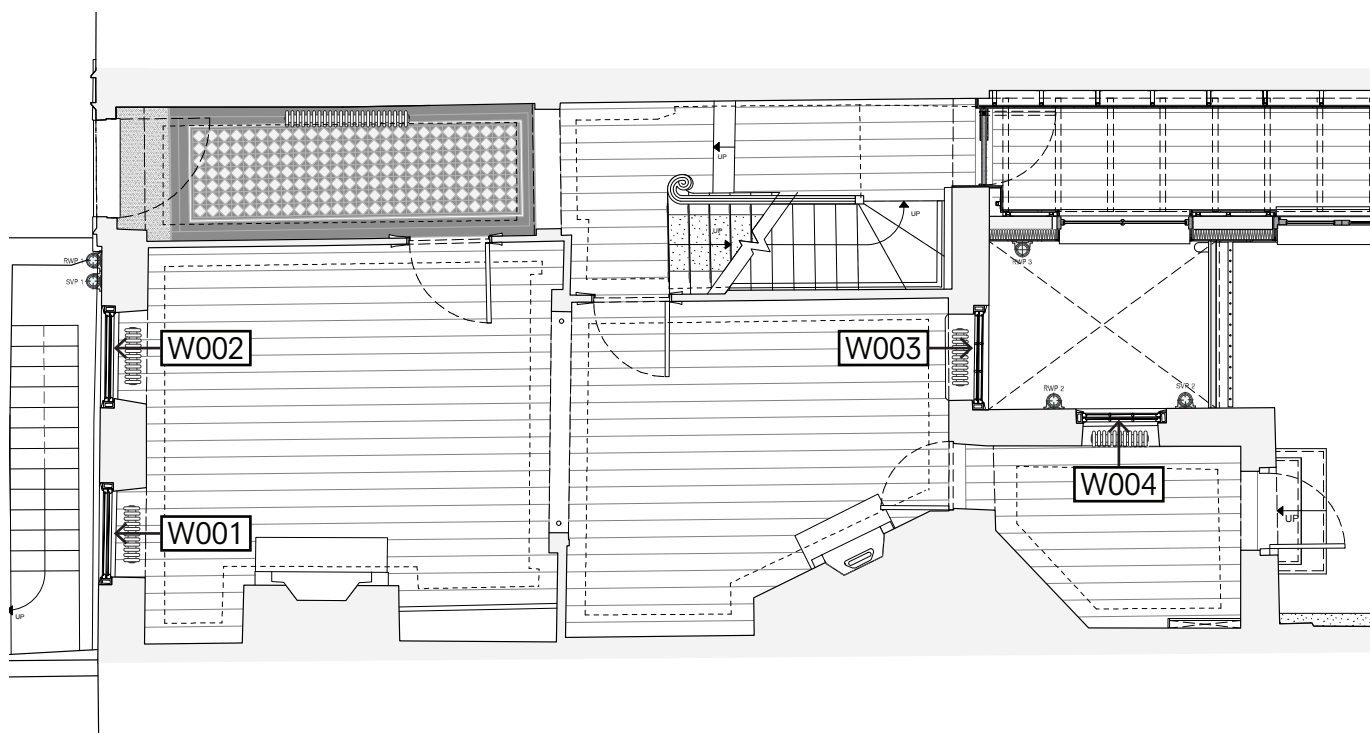
6.2 Ground Floor

Window W004 was fixed shut with joints sealed, and had no original ironmongery.

New shutters to windows W001 and W002 are proposed to have recessed central panels. These will be raised and fielded, to match the existing details and wall panelling adjacent. The original iron bar locking mechanisms will be retained and reinstated.

New shutters to windows W003 and W004 are proposed to have recessed central panels with a quarter round bead, to match the existing details and wall panelling adjacent.

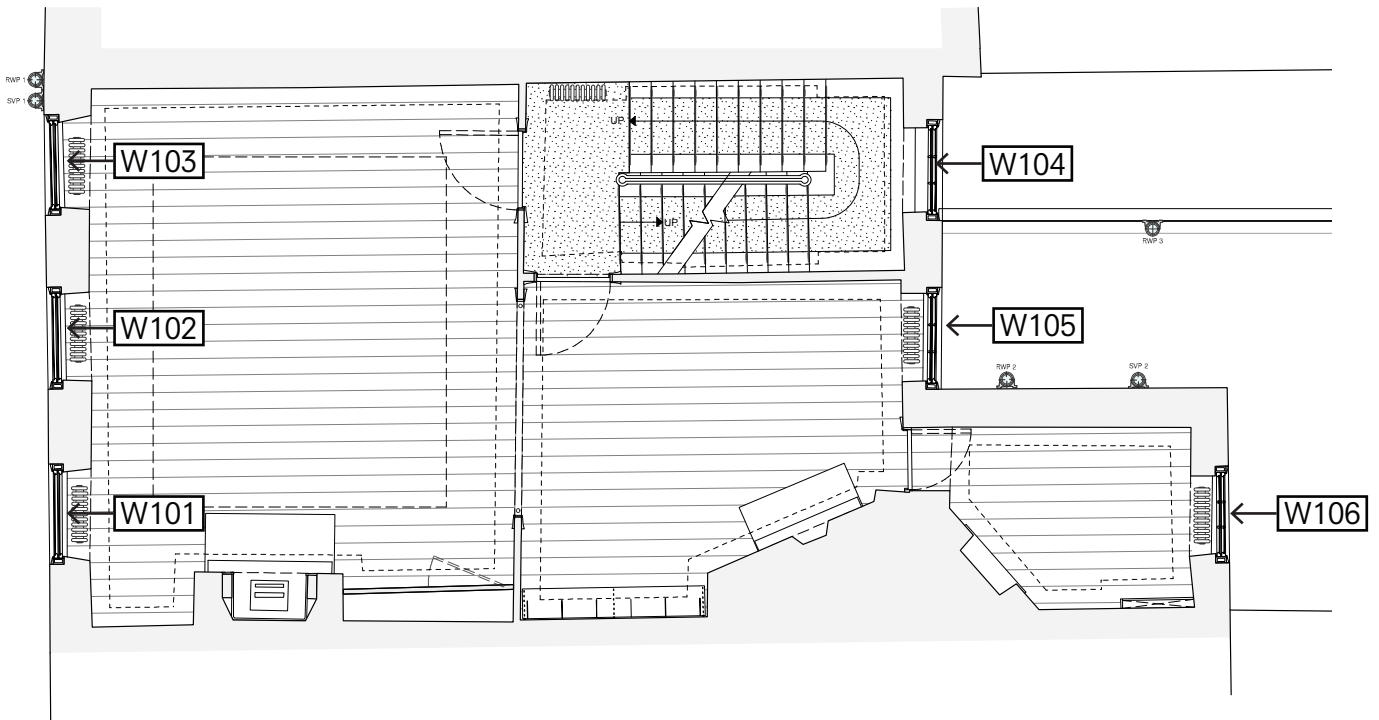
6.3 First Floor

Windows W104, W105 and W106 were fixed shut with joints sealed, and had no original ironmongery.

New shutters to windows W101, W102 and W103 are proposed to have recessed central panels. These will be raised and fielded on the outer shutters, and have a simple quarter round bead on the inner panels, to match the existing details.

New shutters to windows W104, W105 and W106 are proposed to have recessed central panels with a quarter round bead, to match the existing details and wall panelling adjacent.

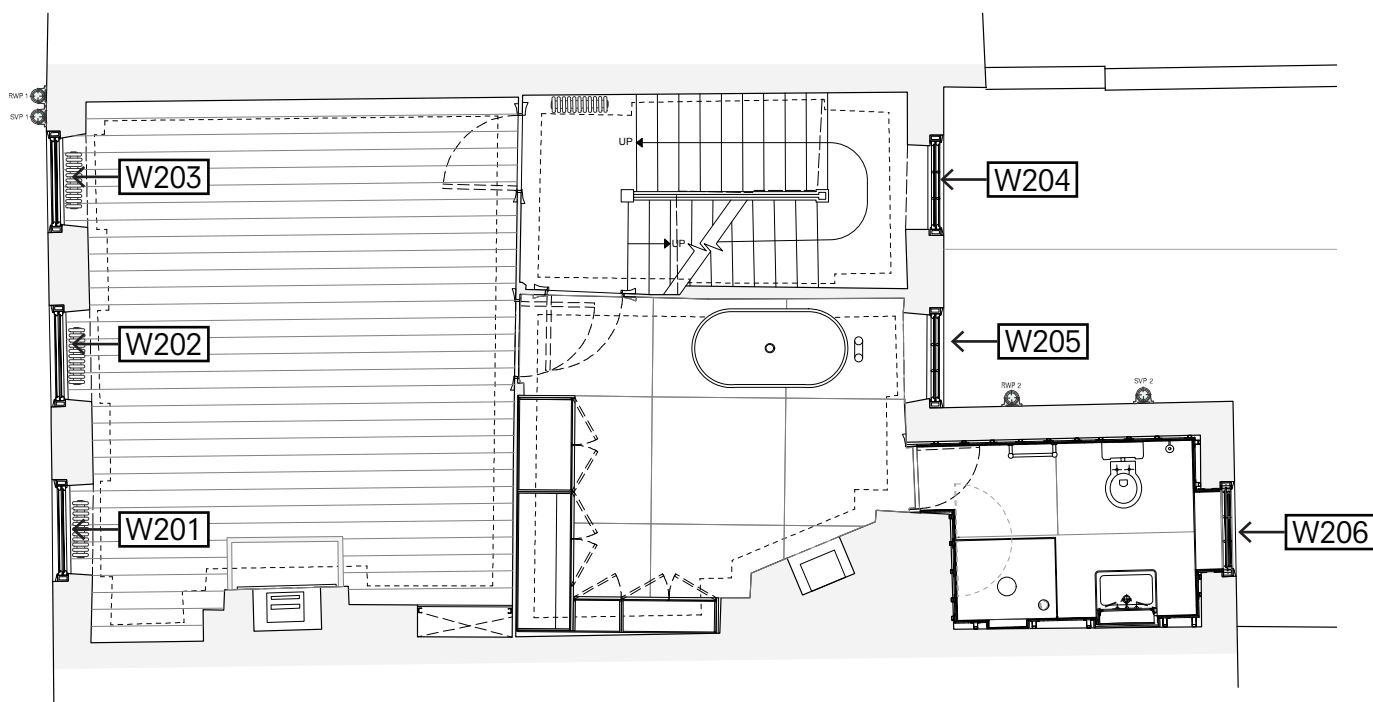
6.4 Second Floor

Window shutters W202 and W203 were found to be modern MDF replacements.

Windows W204 and W205 were fixed shut with joints sealed, and had no original ironmongery.

No shutters were present on window W206.

New shutters are proposed to be installed with recessed central panels, with no beading or raised section as per the original details and panelling adjacent.
