**Southwell House, 39 Fitzjohns Avenue , NW3 5JY**

**Tree Constraints Plan. September 2017**

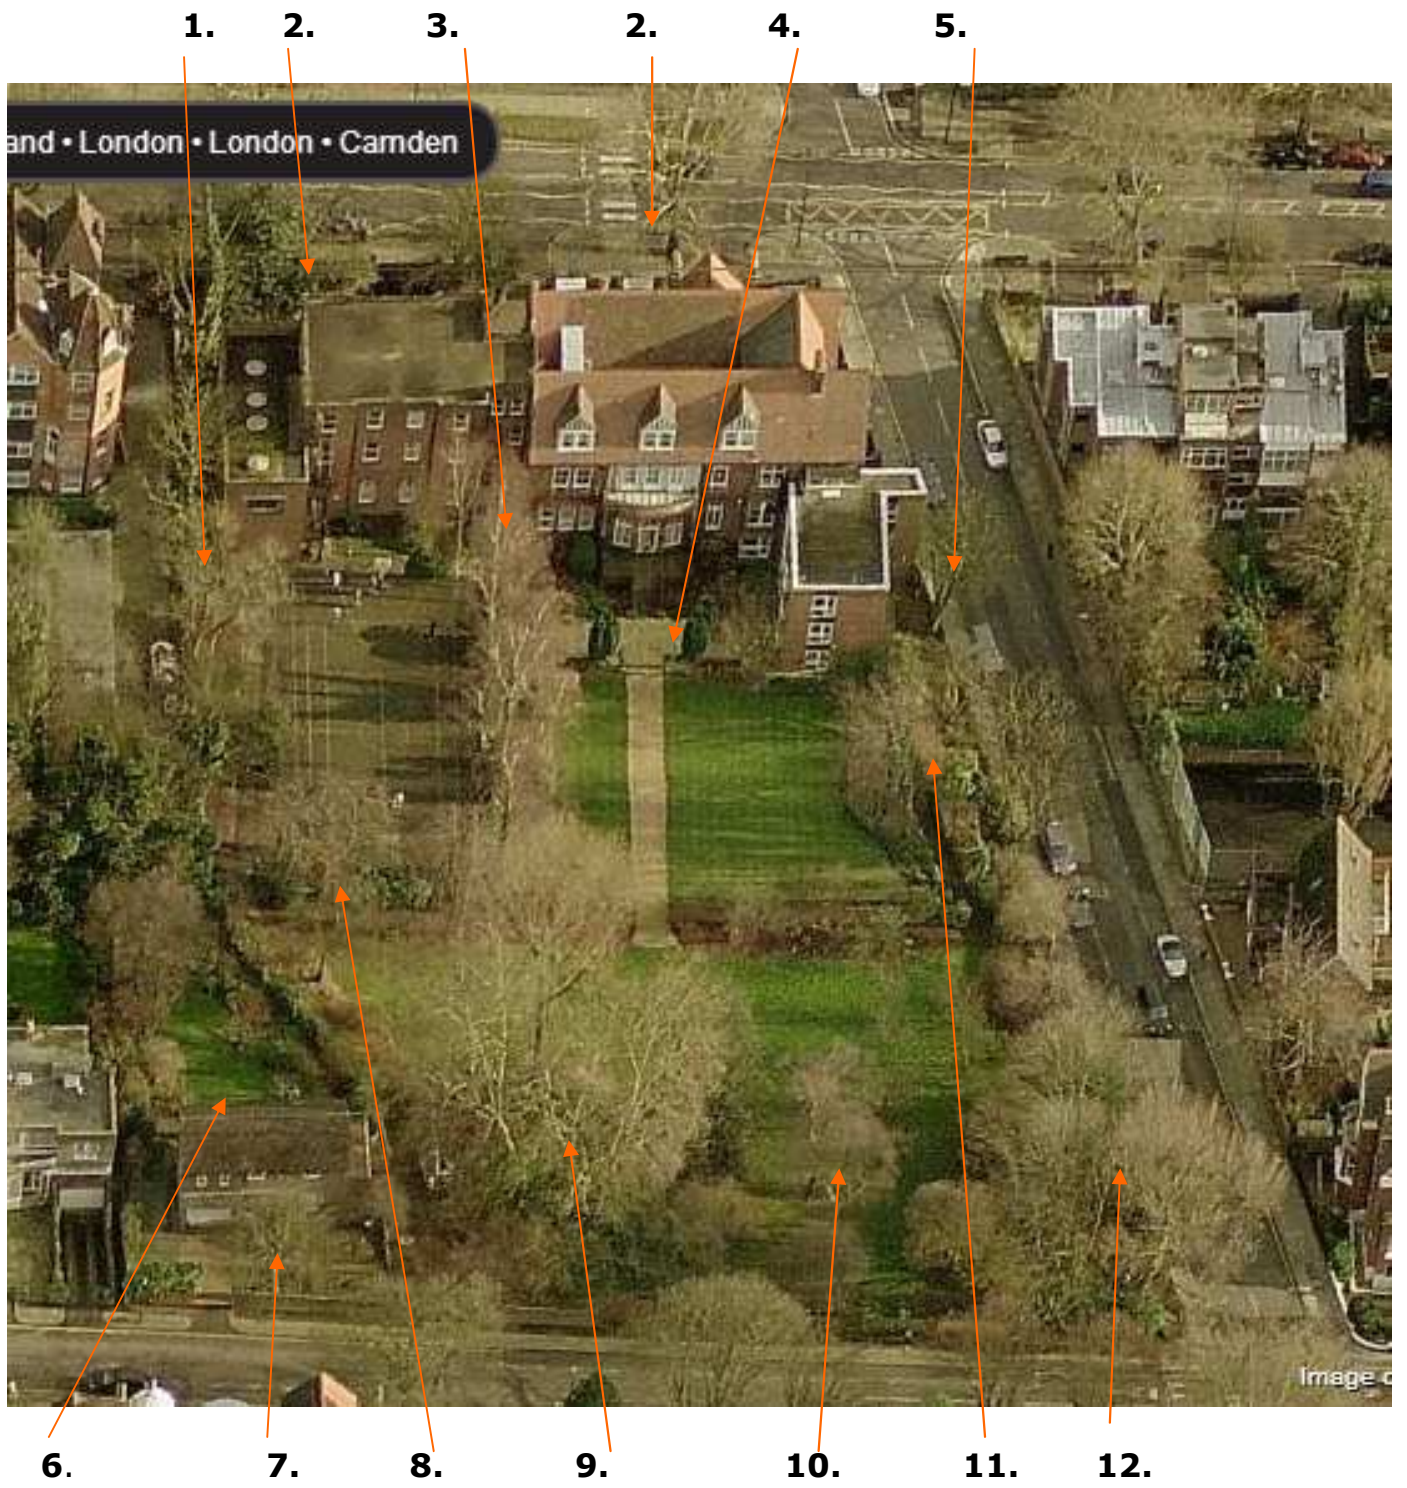
1. Neighbours extension on northern boundary has adversely affected trees.
2. Large trees roadside and in northern part of front garden preclude a basement extension to the east.

3. Row of Silver Birch have damaged tennis court. In the normal course of householder maintenance the tennis court could be resurfaced. It would be preferable to remove these trees.

4. Trees on rear terrace do not present a building constraint.
5. Chestnut T31 is a building constraint except where there is an existing footprint.
6. It should be possible to extend the existing footprint rearwards.

7. Old pollarded Horse Chestnut is reaching the end of its useful life and could be removed to construct a basement underneath the front garden.
8. Cherry T8 represents a building constraint.

9. Planes T1 & T2 represent a building constraint although adjacent retaining walls may be root barrier.
10. Silver Birch T52 & 53 could possibly be removed to build.

11. & 12 Trees will prevent building basements within root protection areas but will provide useful screen to any new above ground structure.

The site is flat- could build above ground close to trees on piles and cantilevers.

Basement excavations but would need to be out side "root protection areas" unless of course it can be demonstrated that there are significant root barriers.

Basement lids should be circa 1 metre below any area where it is hoped to plant replacement trees.
