### **Arboricultural Impact Assessment & Method Statement (to BS:5837 2012)**

**For**  
**26 West Hill Park, Highgate, London**  
**N6 6ND**

Date: 29<sup>th</sup> April 2017

Ref: TH 1408

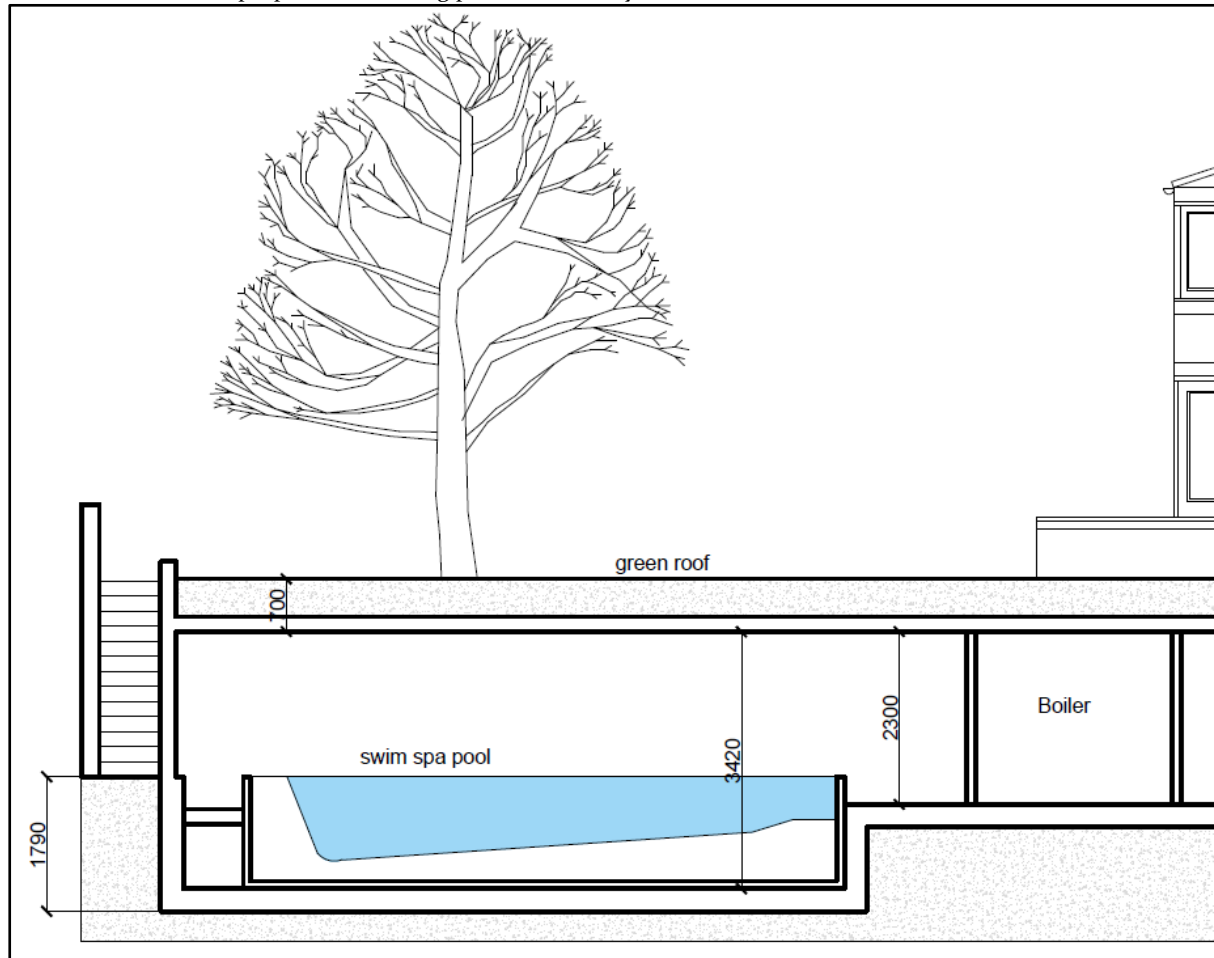
The Oak is situated on raised land contained by a 1.2m retaining wall. The proposed swimming pool building will be located to the side of this raised land (1.2m lower) and so will not affect the Oak's roots (its RPA has been adjusted to take into account the site conditions).

9.3.2 The two thirds of the rear garden that occupy the north-easterly side is at a higher level (by about 1.2 metres) than the westerly third. The north-eastern side of the proposed building will sit at the point where the level change occurs and so depth of excavation needed will be lessened by that level change, however further excavation will be required at that point which is 4.6 metres away from the oak tree. A deeper excavation for the pool itself will be required a further 3.5 metres away (8.1 metres away from the Oak).

**Figure 1:** A section diagram showing the Oak and proposals. The nearest wall of the proposed building is 4.6m away from the Oak and the proposed swimming pool is 8.1m away.

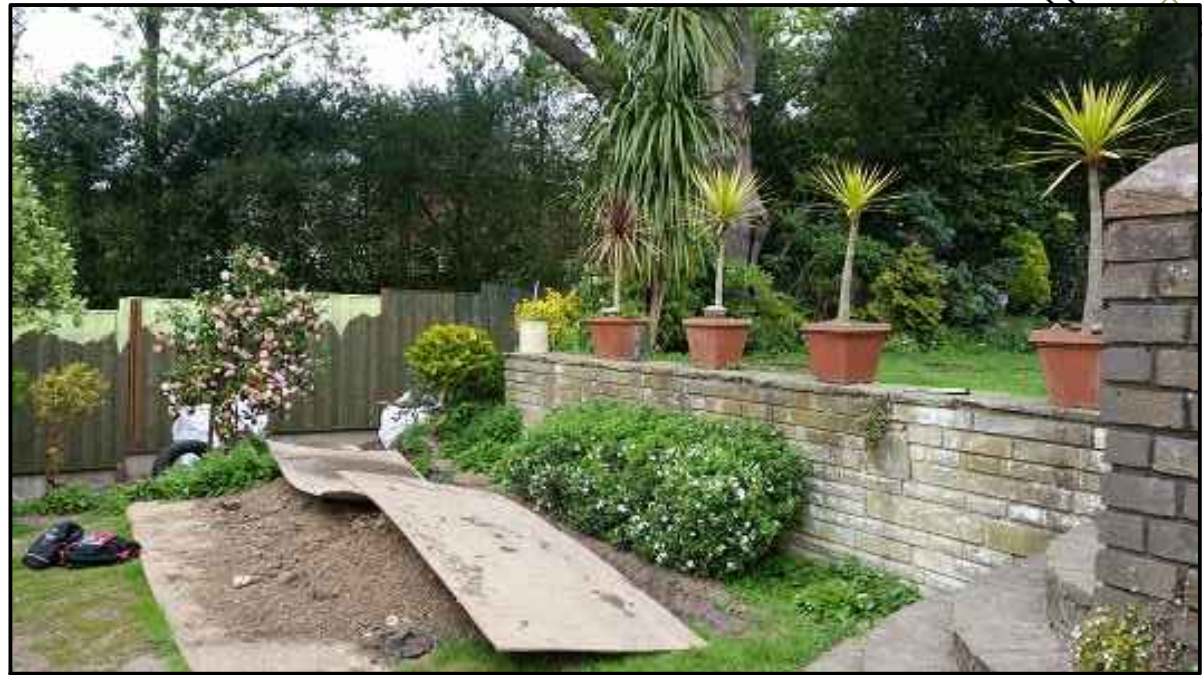
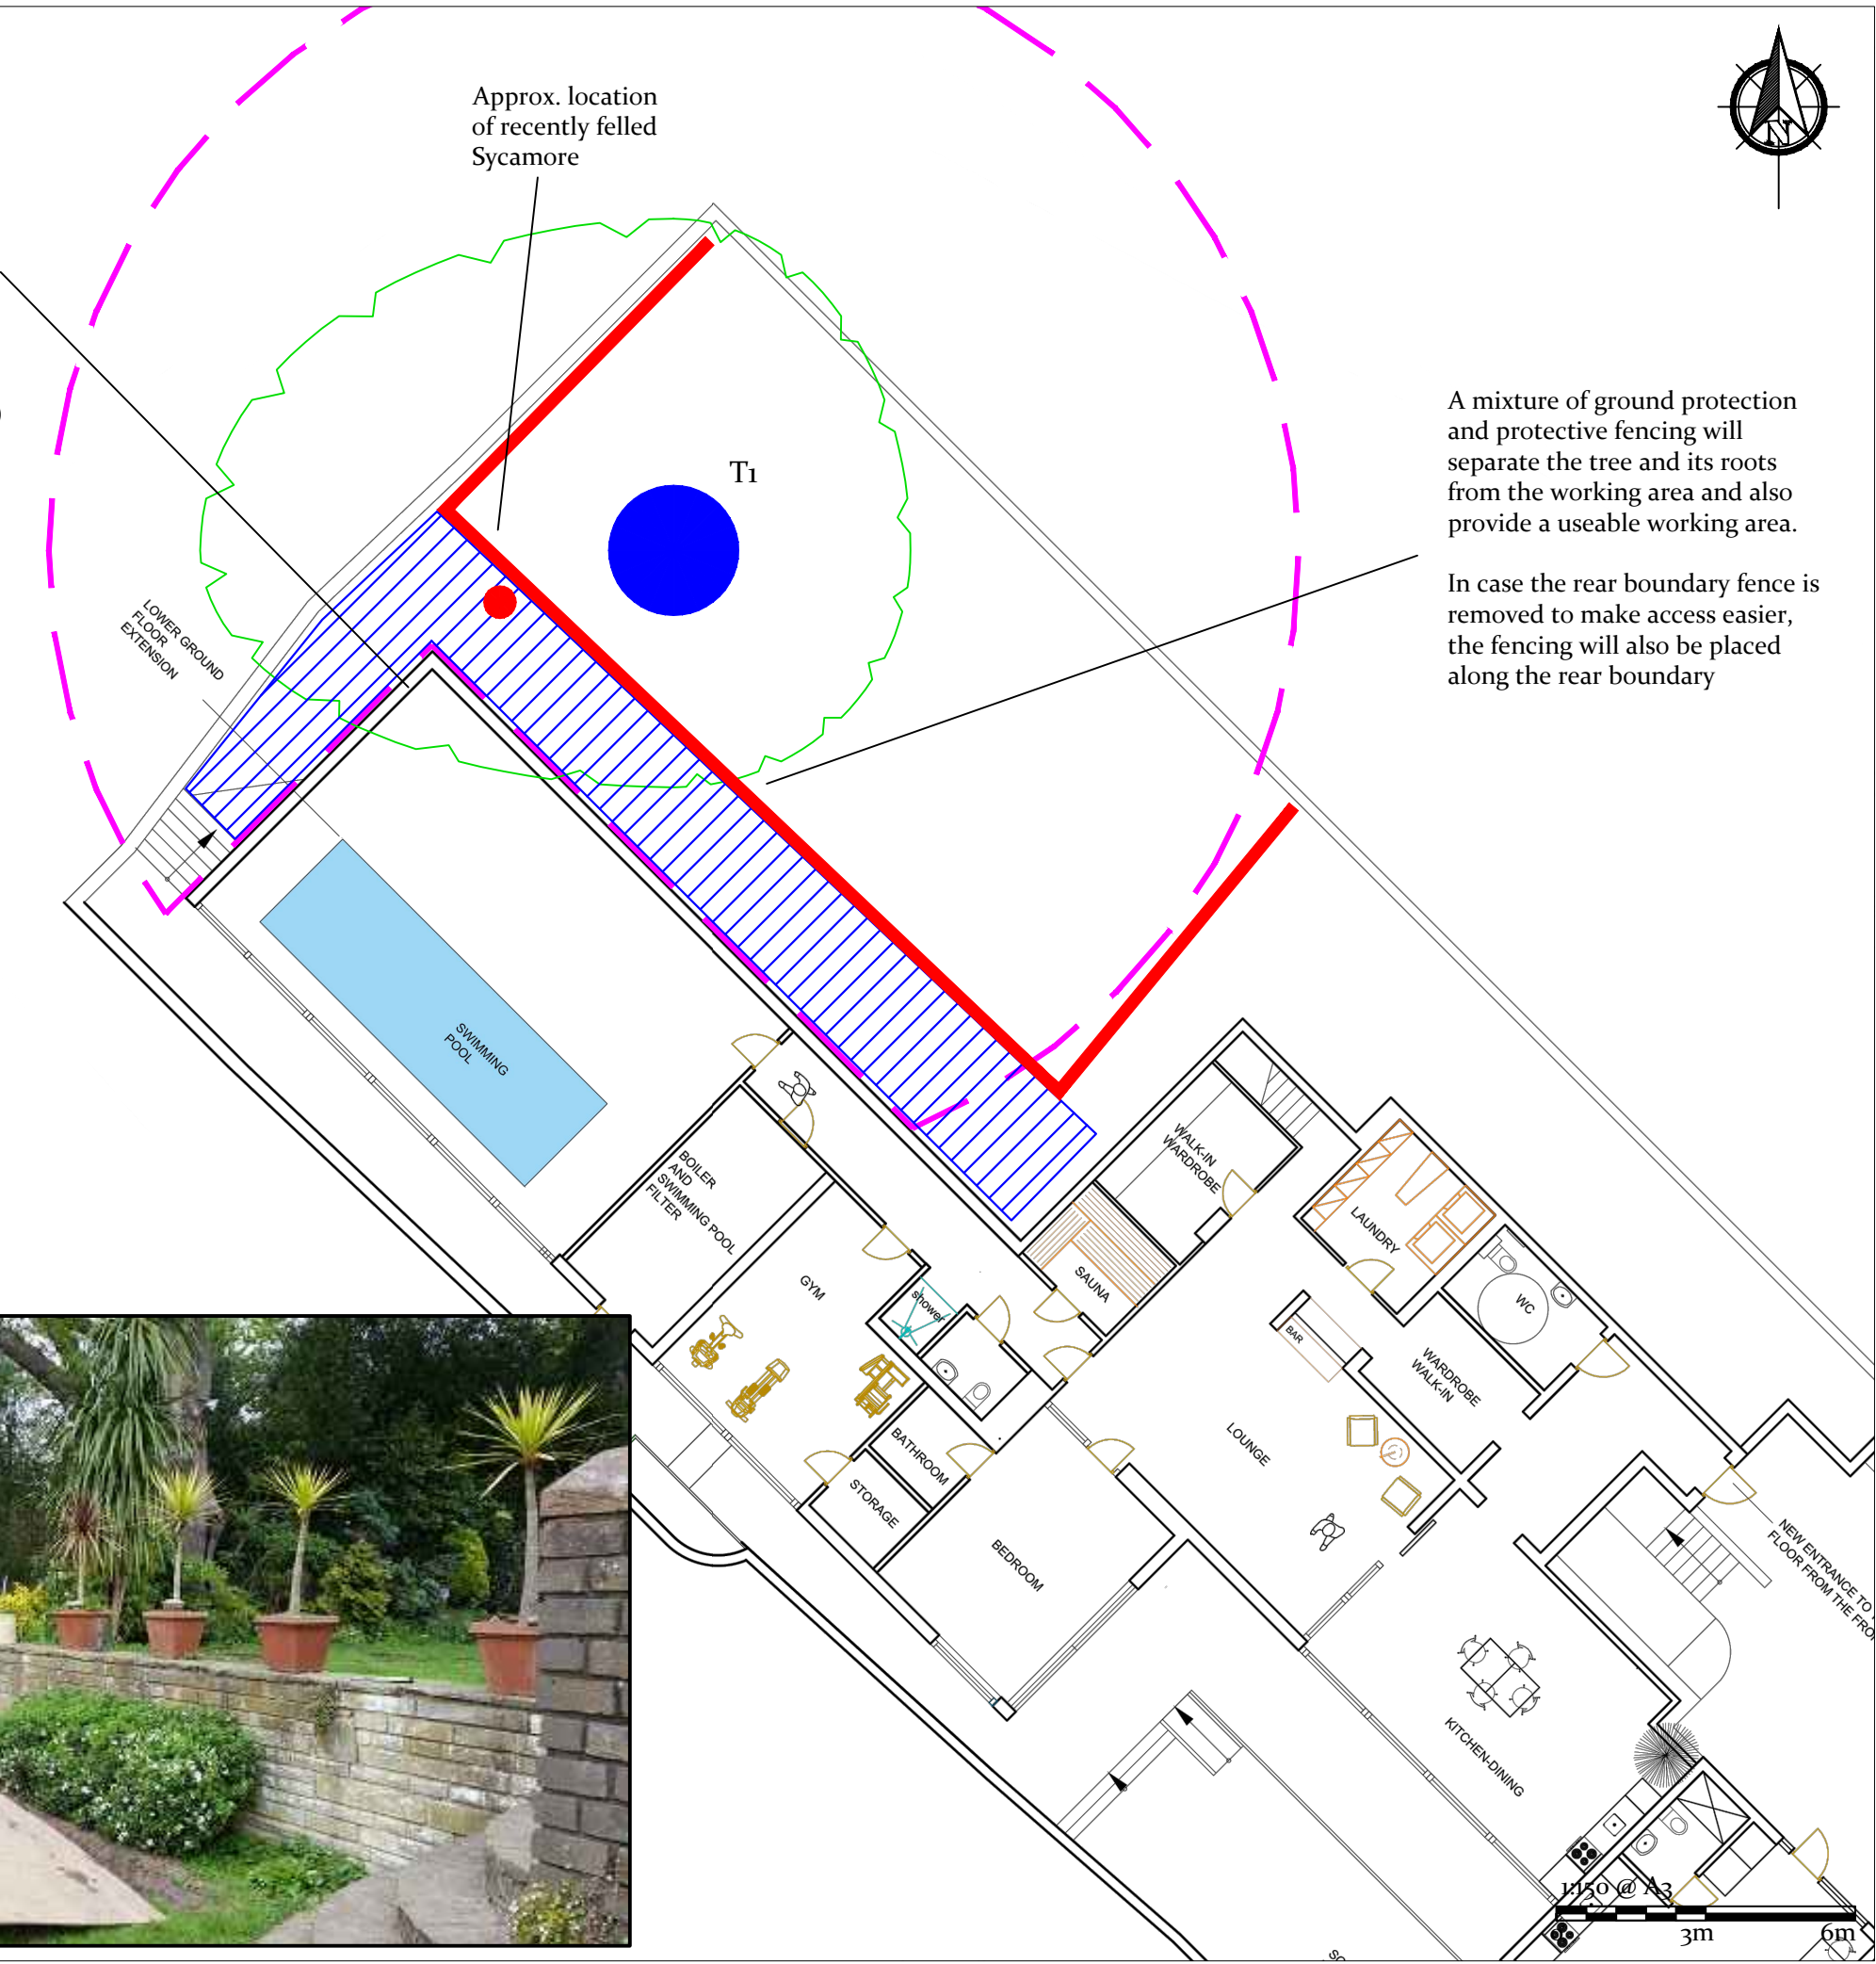
The Oak's RPA has been adjusted to take into account the 1.2m high brick retaining wall that separates the higher north-eastern side of the rear garden from the lower south-western side (see photo below). An air spade investigation was carried to determine whether or not Oak roots were present (see report for findings)

For comparison, had the retaining wall not been present, the RPA incursion would have been 16% (87m<sup>2</sup> of 547m<sup>2</sup>).

A mixture of ground protection and protective fencing will separate the tree and its roots from the working area and also provide a useable working area.

In case the rear boundary fence is removed to make access easier, the fencing will also be placed along the rear boundary
