Second floor
118a London Wall
London EC2Y 5JA
rp@prewettbizley.com
020 7359 2692

prewett
bizley
architects

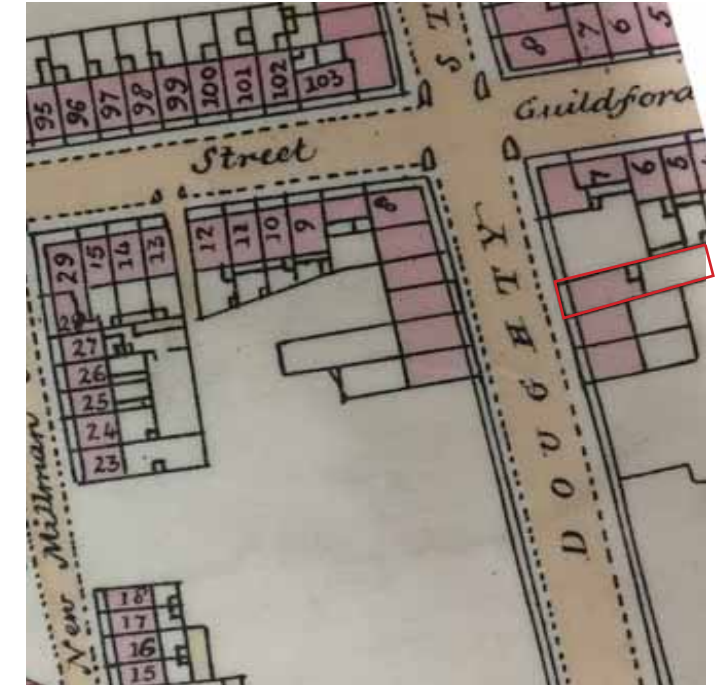
The London Survey indicates that no 42 was originally numbered 38. The subsequent infill of the vacant site north presumably forced re-numbering.

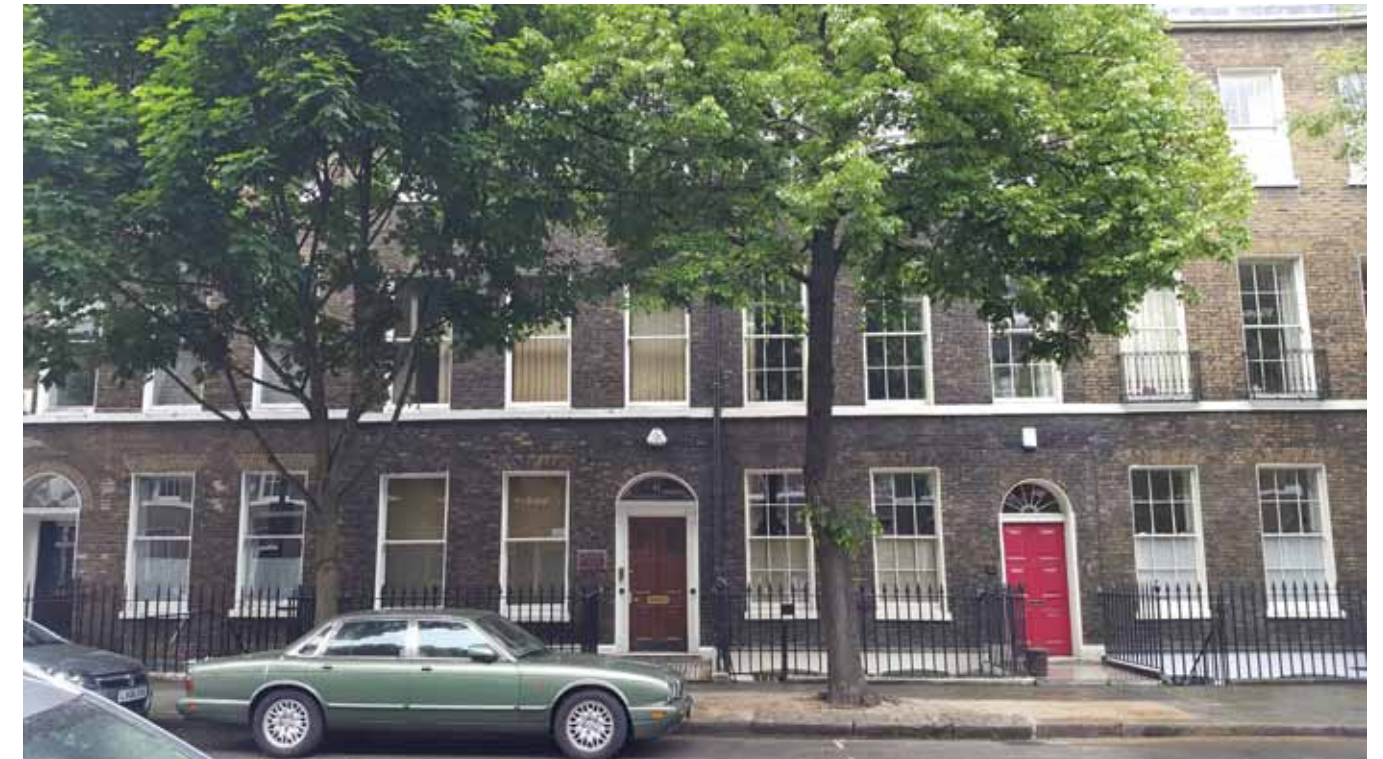
Street view of front facade. The upper floors are partly obscured by virtue of the trees, which were planted after 1970. The neighbouring properties (no. 43 and no.44) have 6/6 sashes, as would have been originally present.

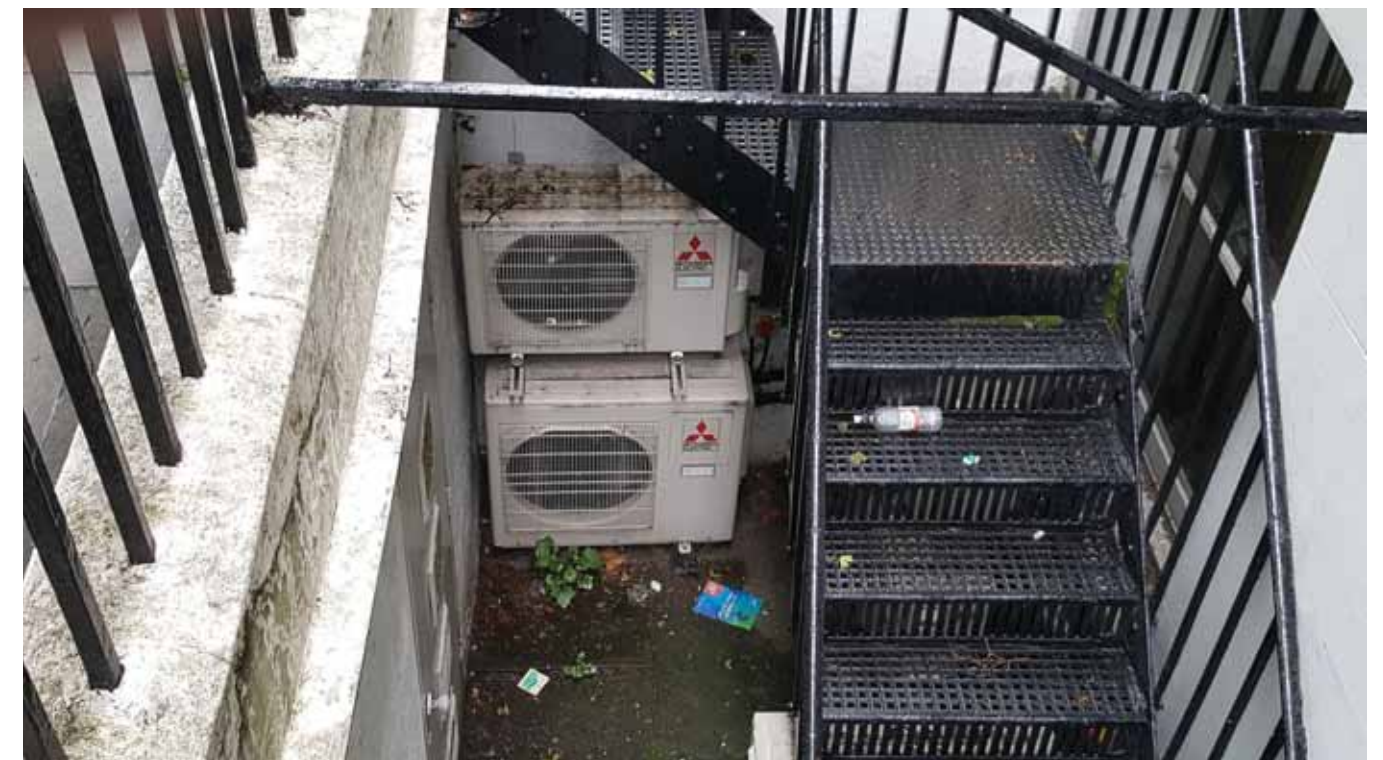
The front light-well. A cast iron stair in place of what would have been a stone stair. 3 fan coil units serving the air conditioning units within the offices.

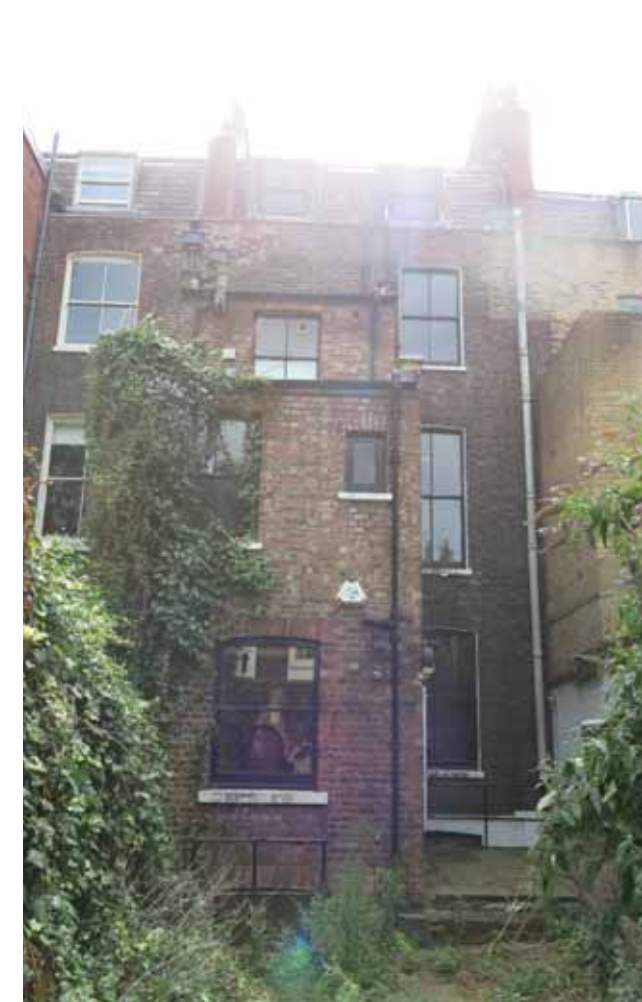
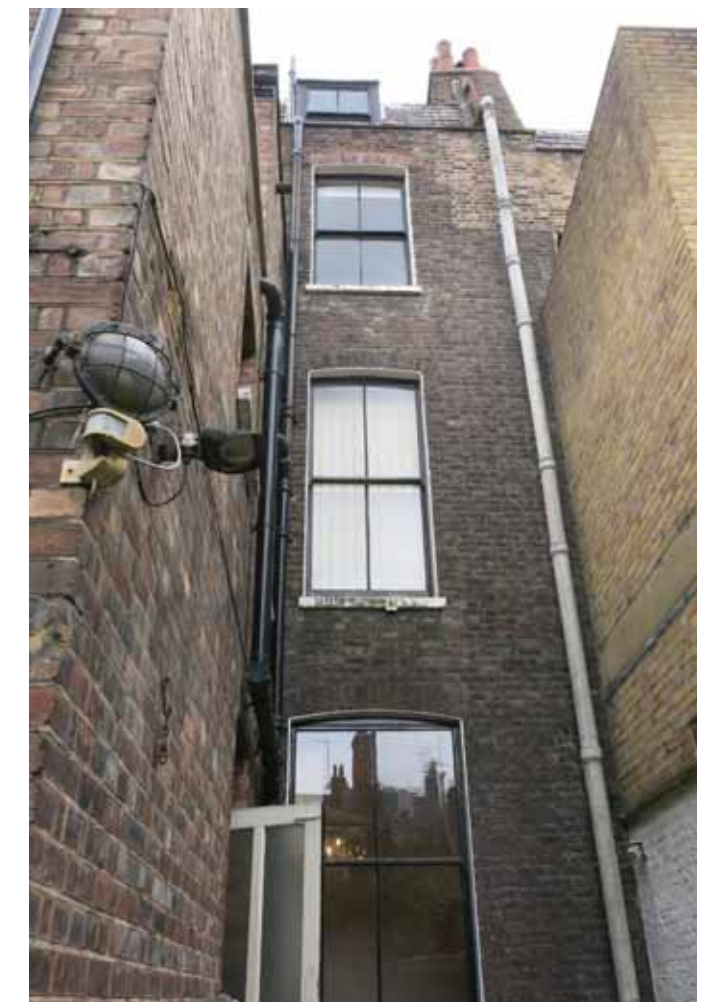
Top left: View of closet wing. The different colour of fletton bricks on the ground floor vs the first and second floor is clearly visible.

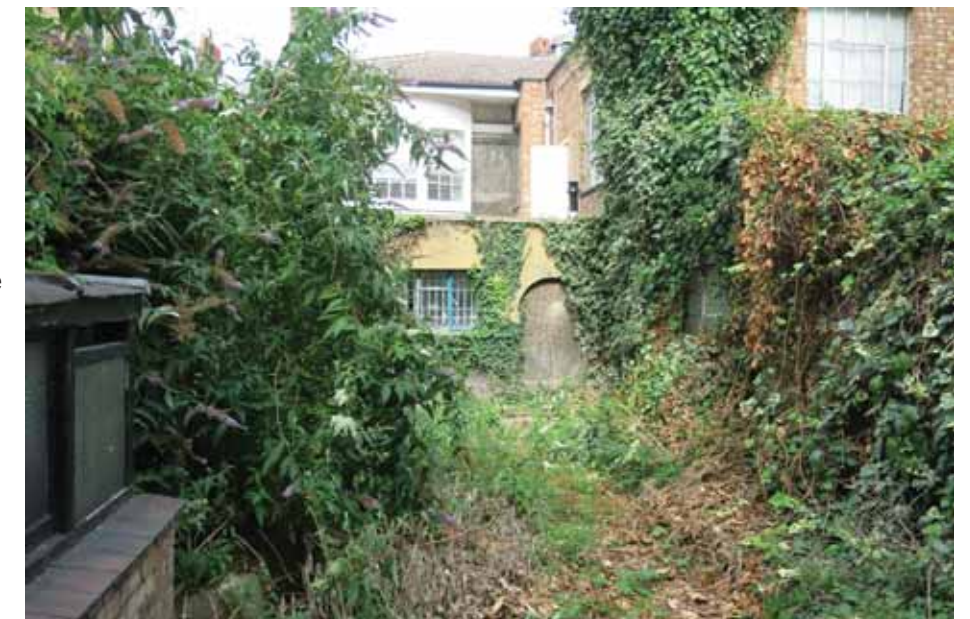
4.01 Building Analysis – Exterior

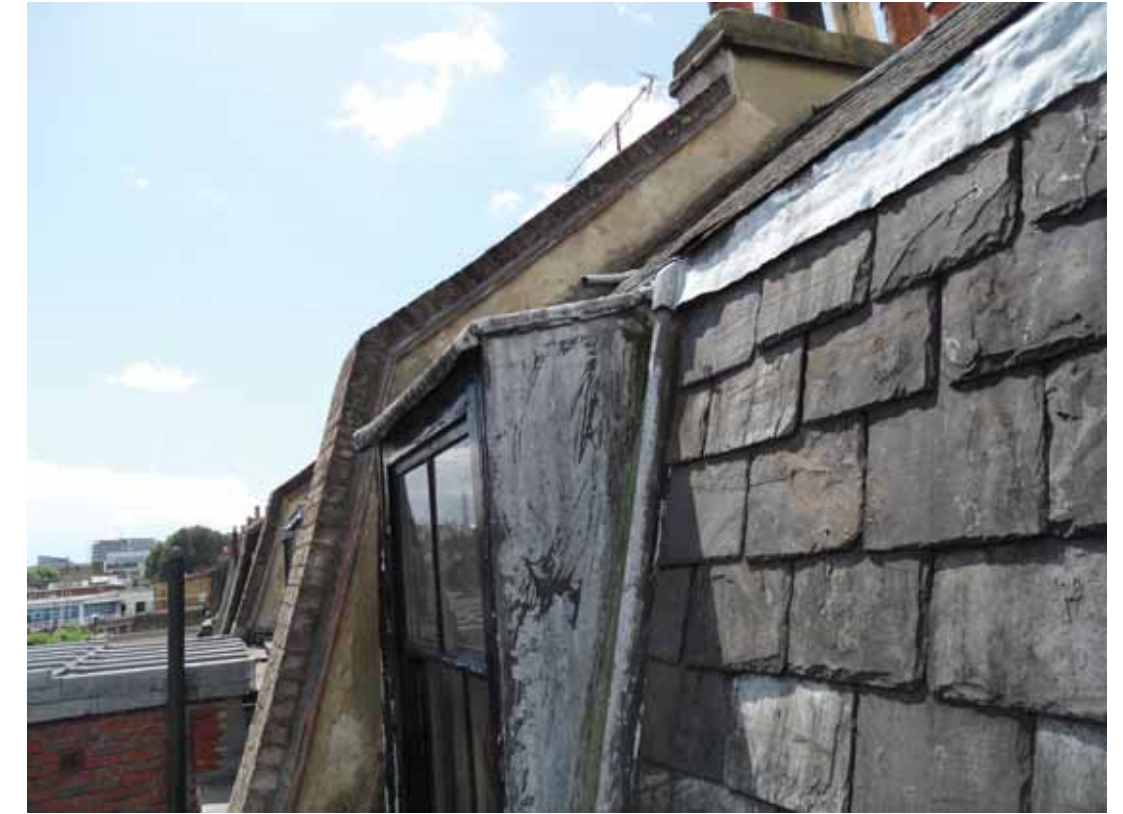
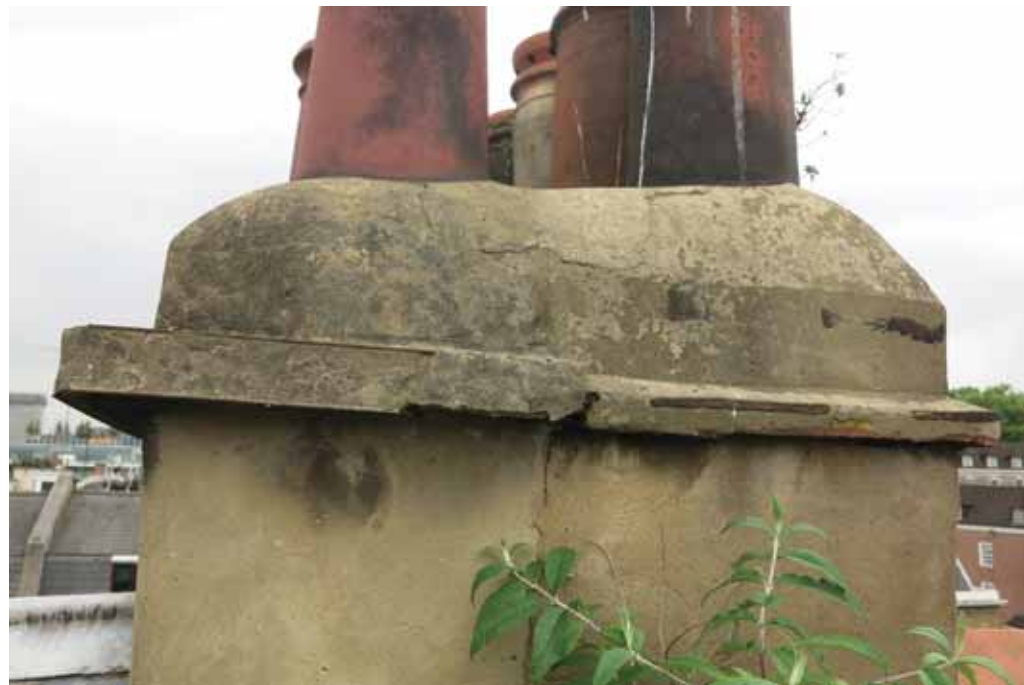
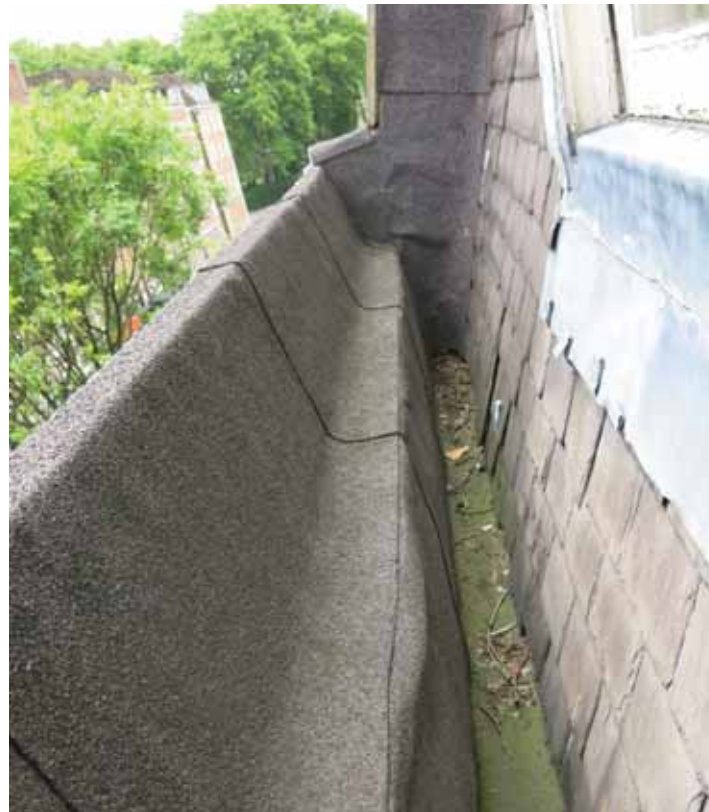
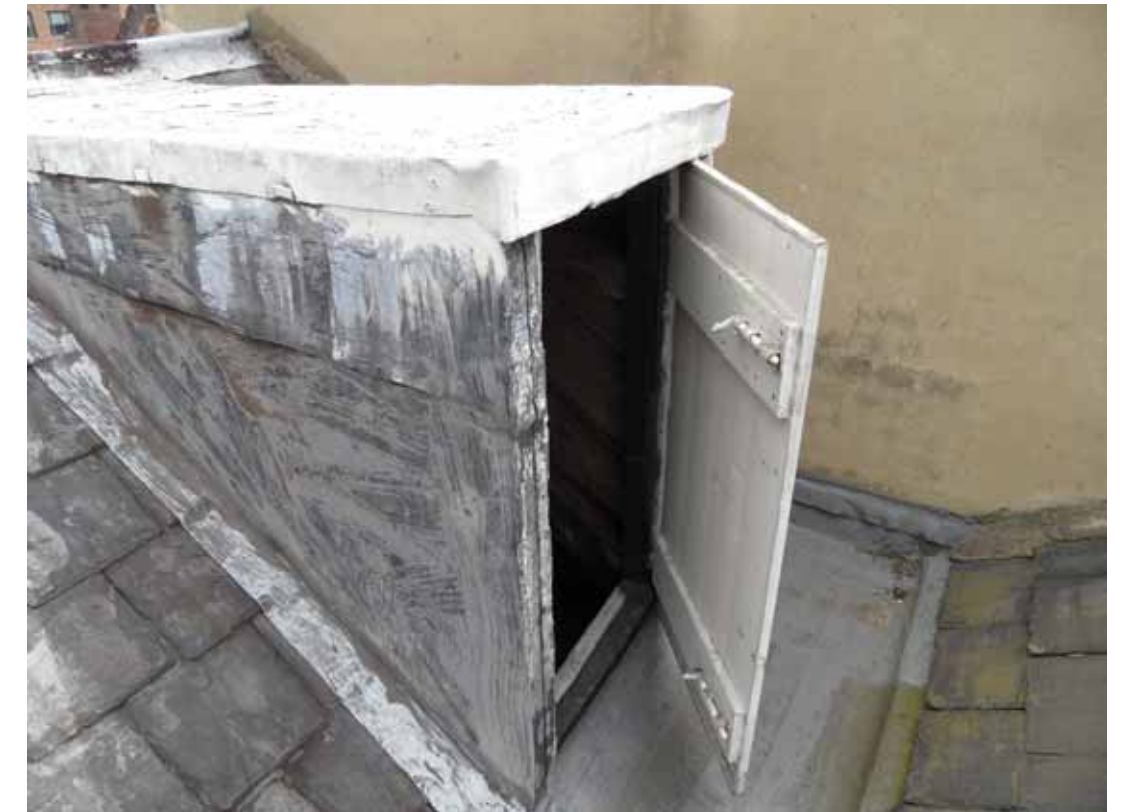
4.02 Building Analysis – Interior

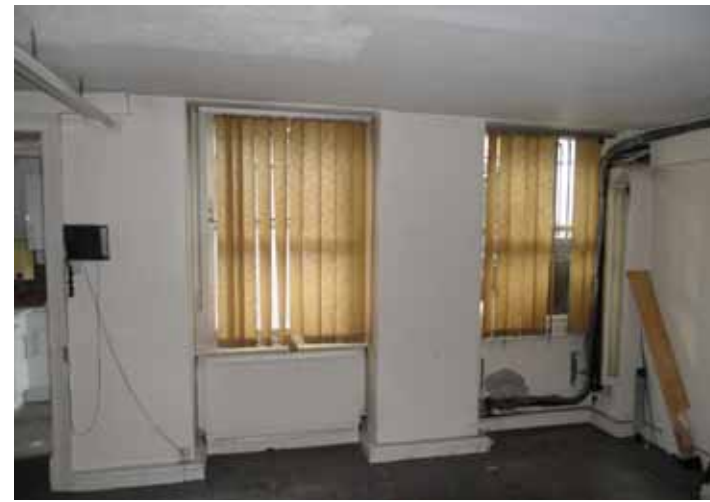
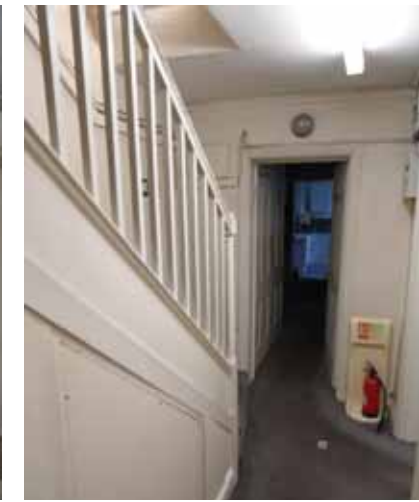
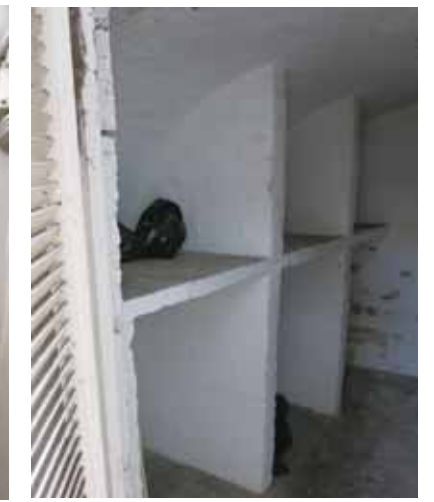
Left: Basement front room (RB-2), with air conditioning pipes coming through the front wall. The original door lining to the tradesperson's entrance is visible to the left.

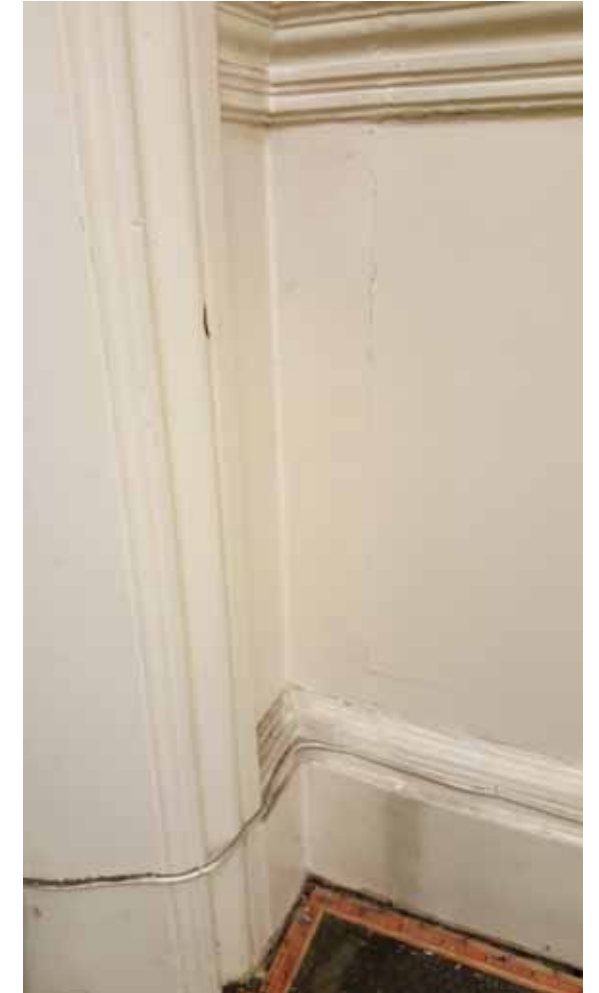
Where the front wall meets the party wall, a crack can be observed about 4 inches in from the corner on the party wall side. This extends through the dado and the skirting elements indicating that these details were extended following the removal of the 'false' wall that was associated with the shutter boxes.

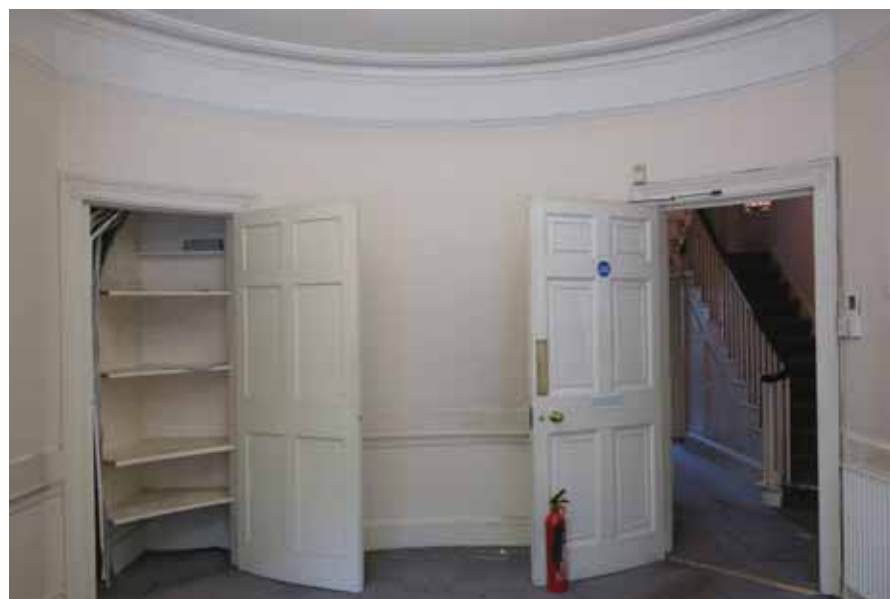
Symmetrical curved doors. The original cornicing has been replaced with a heavy Edwardian moulding.

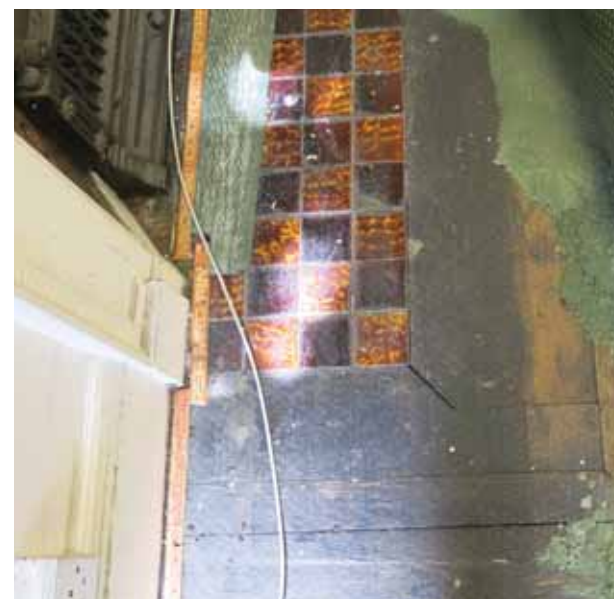
The original stone hearth has been reduced in size and replaced with glazed tiles.

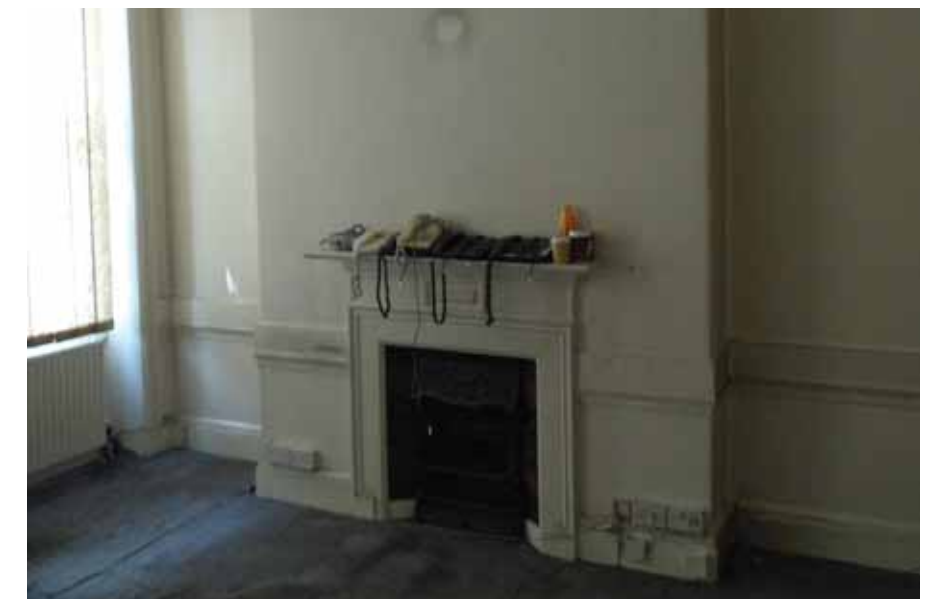
The original chimney piece has been replaced by a smaller Edwardian feature. Dado and skirting have been extended to meet this.

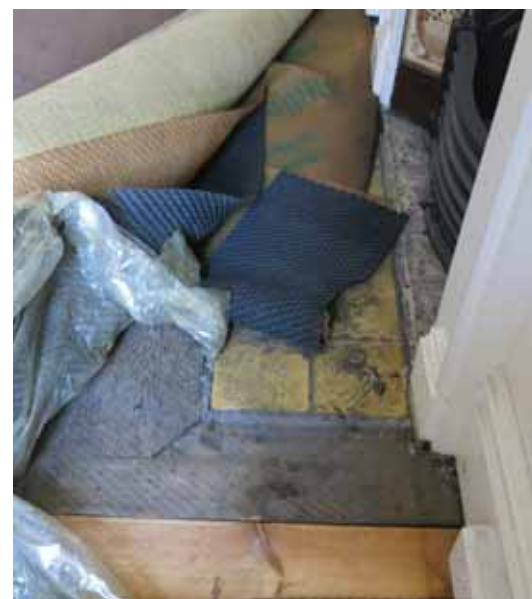
Hearth size reduced and stone replaced with glazed tiles.

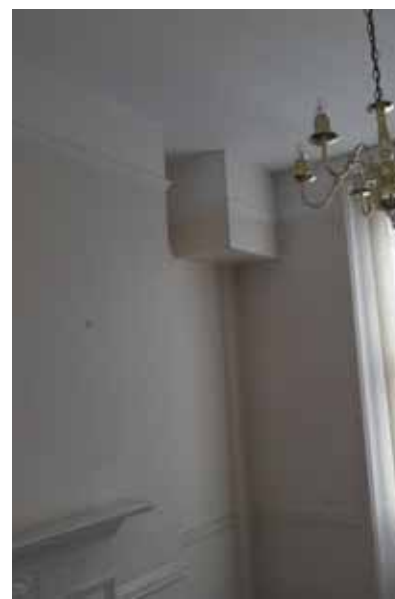
Boxing out on NE corner.

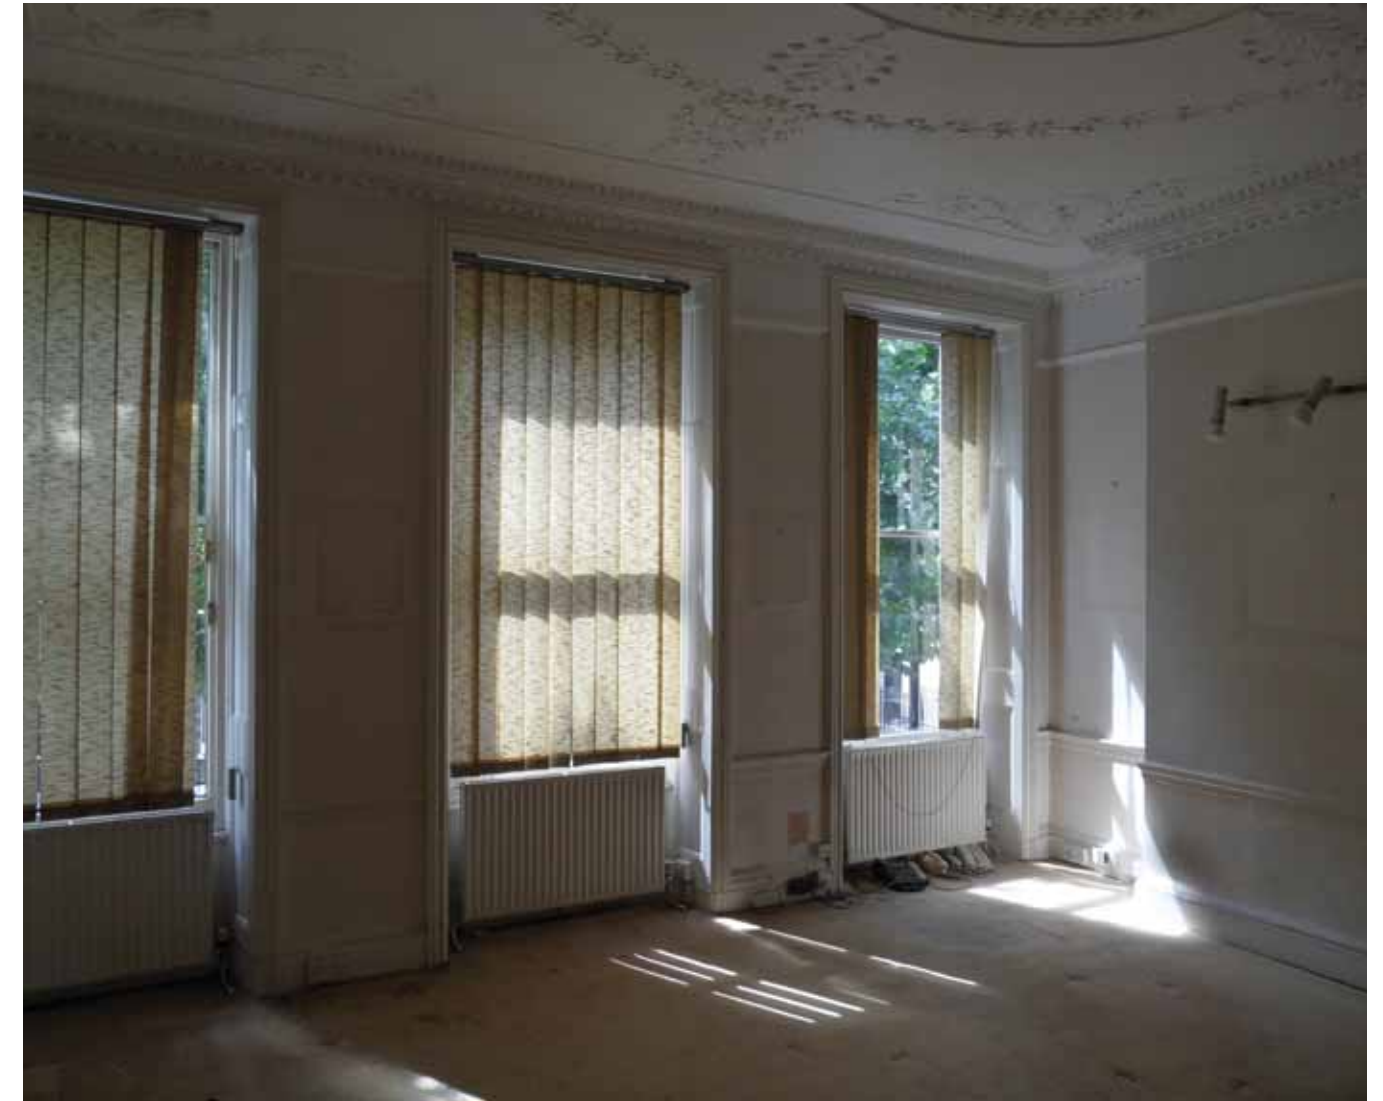
View of front wall, showing three windows with sash reveals and lining wall still intact despite of loss of shutters.

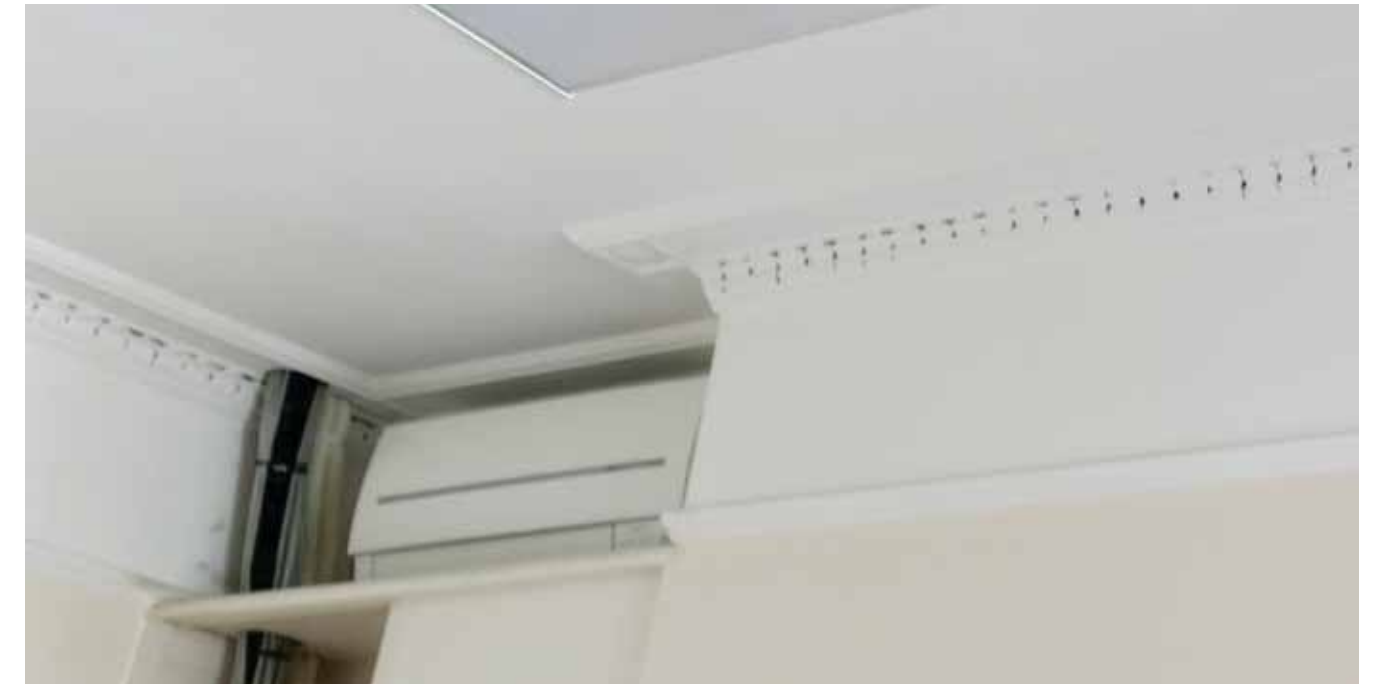
Original cornice feature though with some recent thoughtless damage.

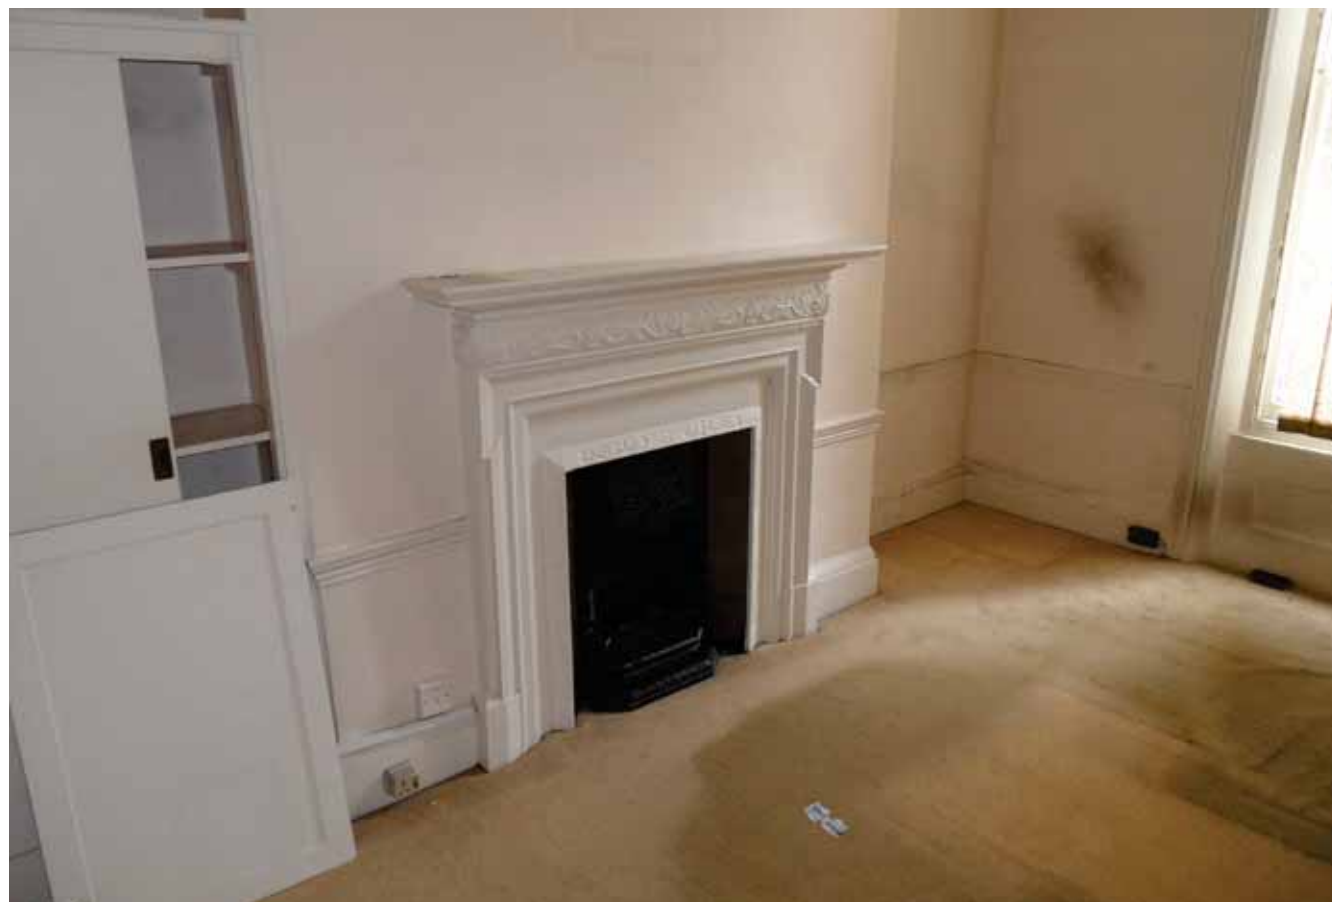
Edwardian chimney piece.

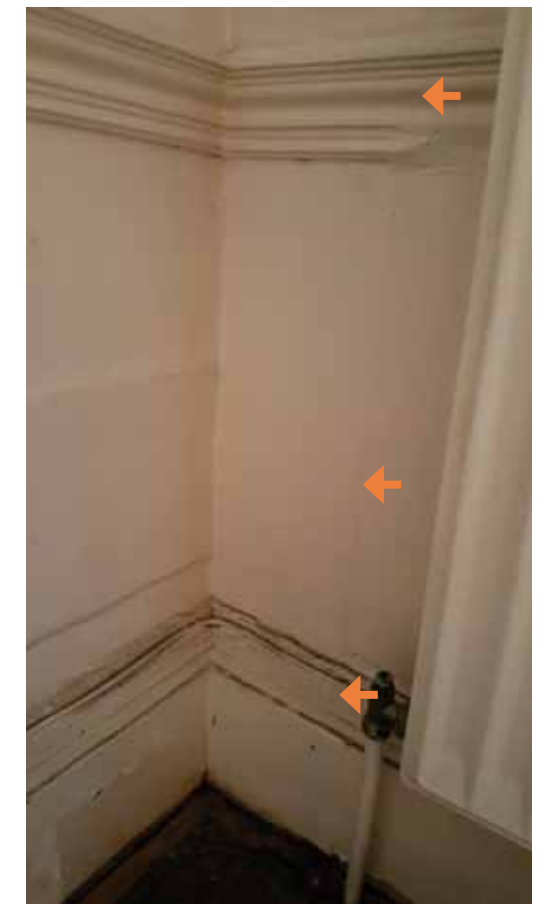
Where the rear wall (LHS) meets the hallway wall (RHS), a crack can be observed about 4 inches in from the corner on the hallway wall side. This extends through the dado and the skirting elements indicating that these details were extended following the removal of the 'false' wall that was associated with the shutter boxes.

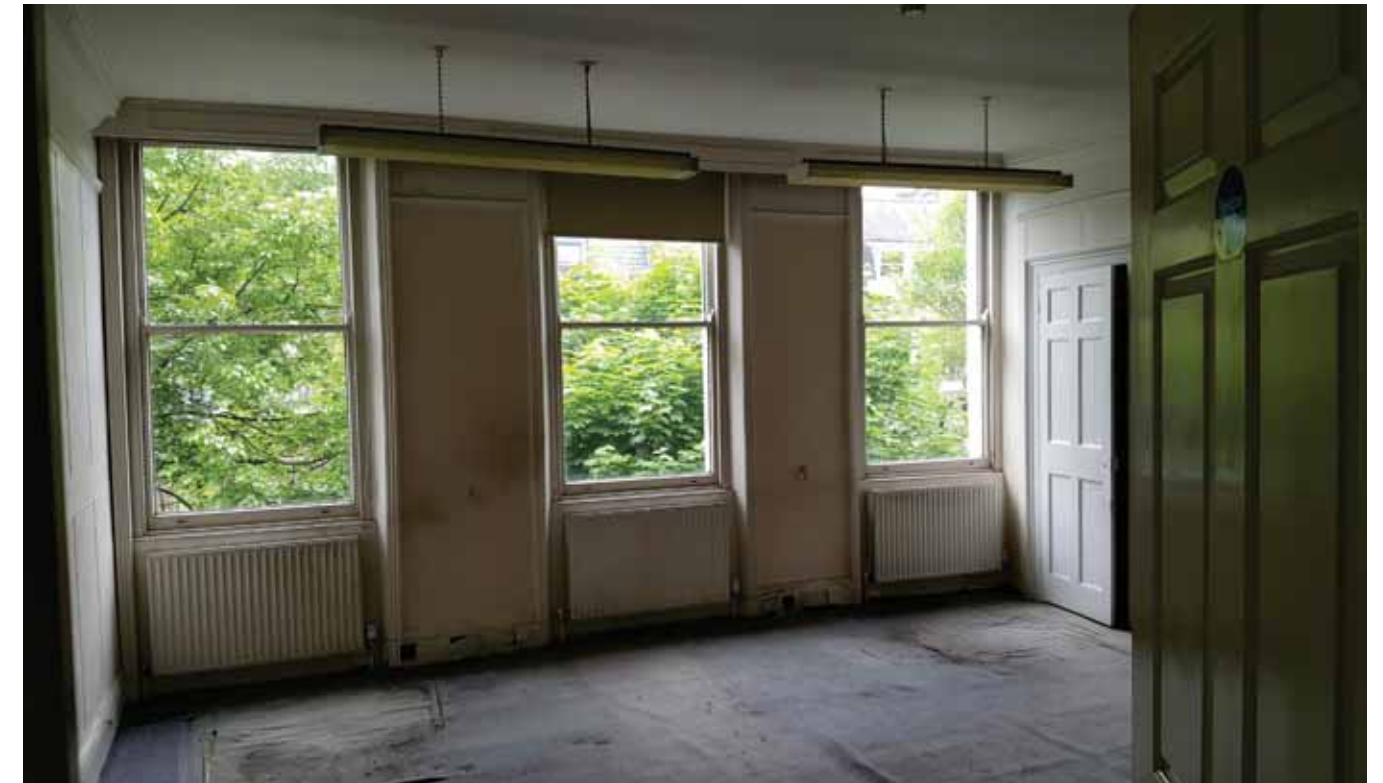
Three windows across front wall. Shutter boxes and false wall lost.

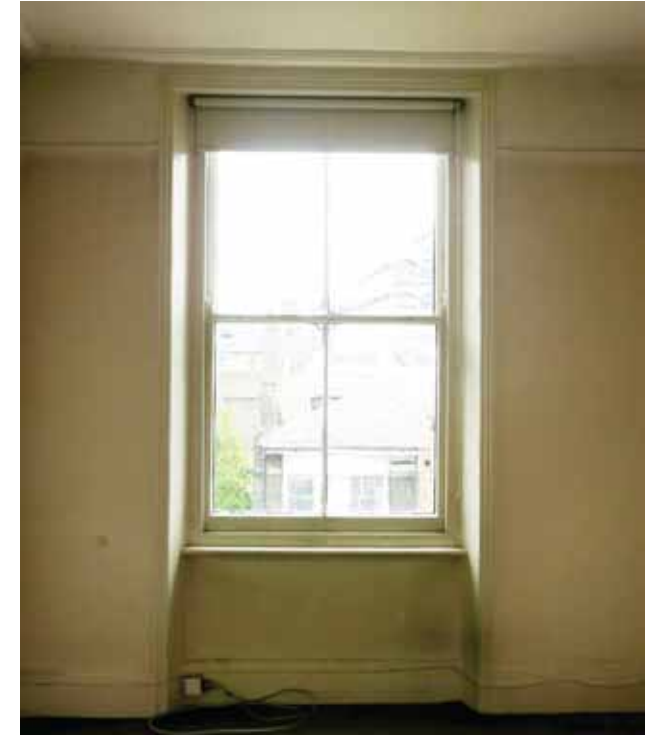
2 over 2 Edwardian window with missing window apron shutters and false wall.

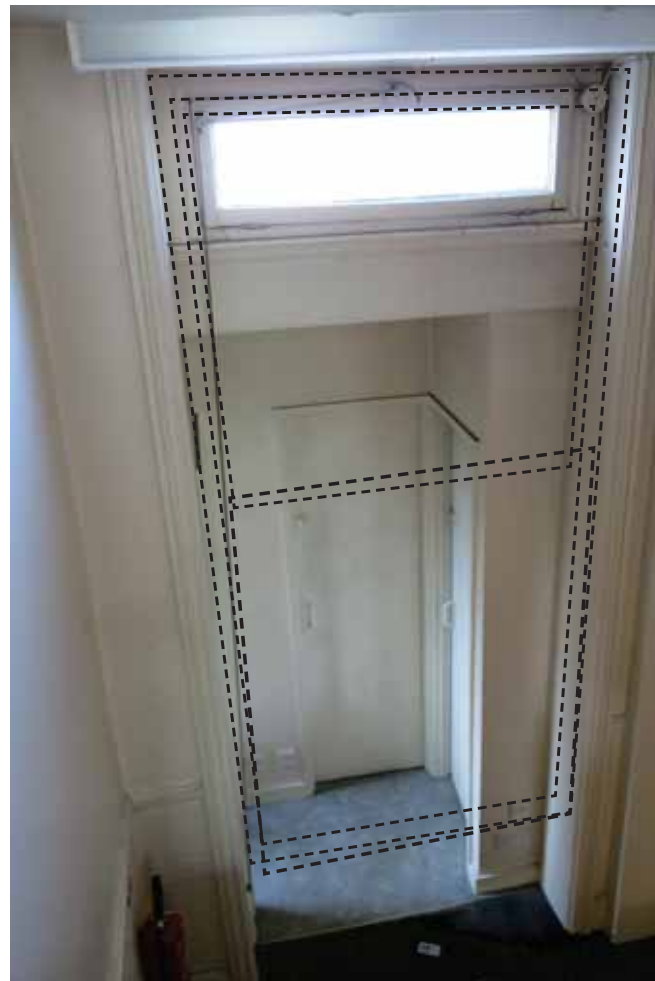
Hallway landing access to closet wing with original window position dotted on.

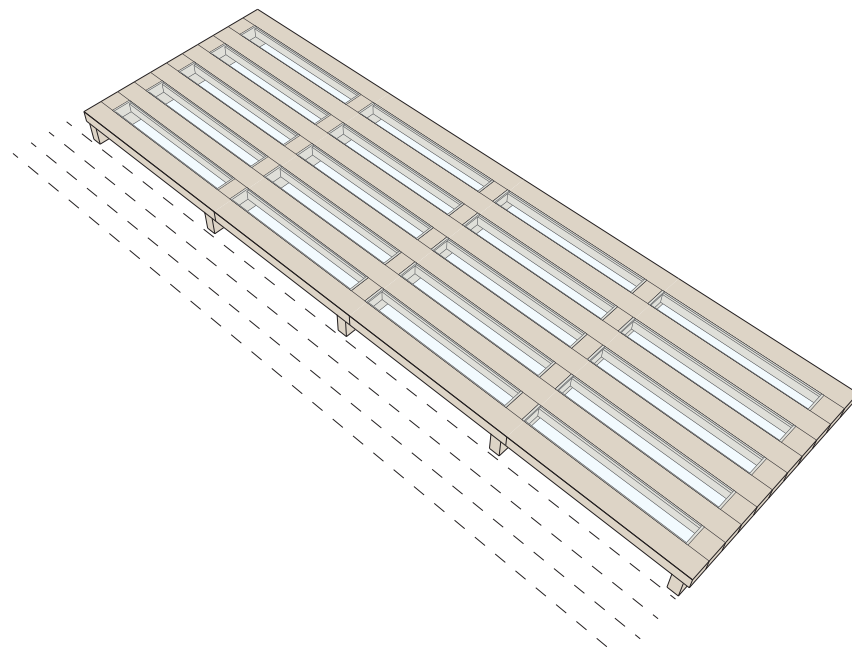
Assembly drawing of timber and glass floor element.

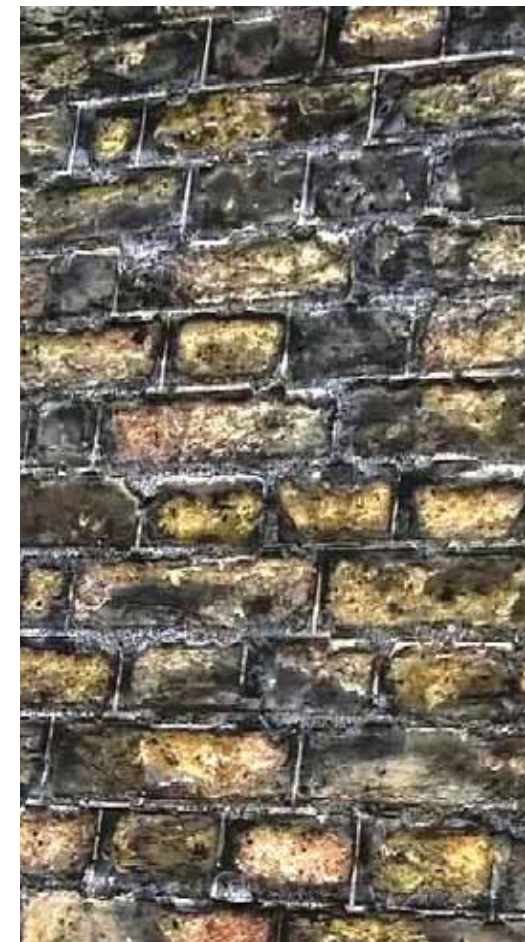
Extract from Report on Decay and Remediation by Terrence Lee (Appendix E). In places it can be seen that the spalling to the brick faces is quite severe at no 42.

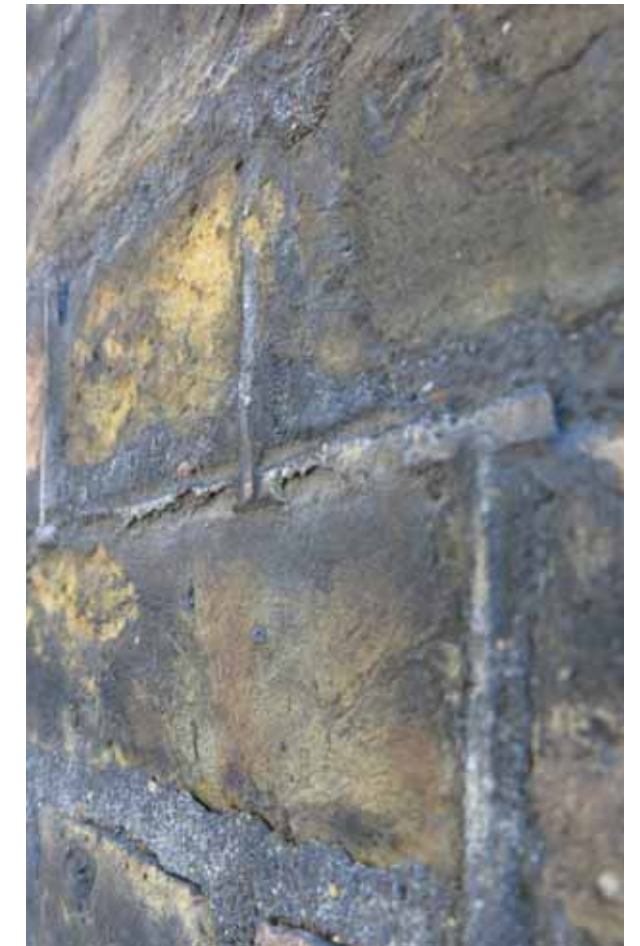
Close up of brickwork at ground floor at no 42. The dark stopping mortar has gaps between it and the bricks in places which is likely to be encouraging excessive wetting during rainy periods. This in turn may be accelerating the spalling.

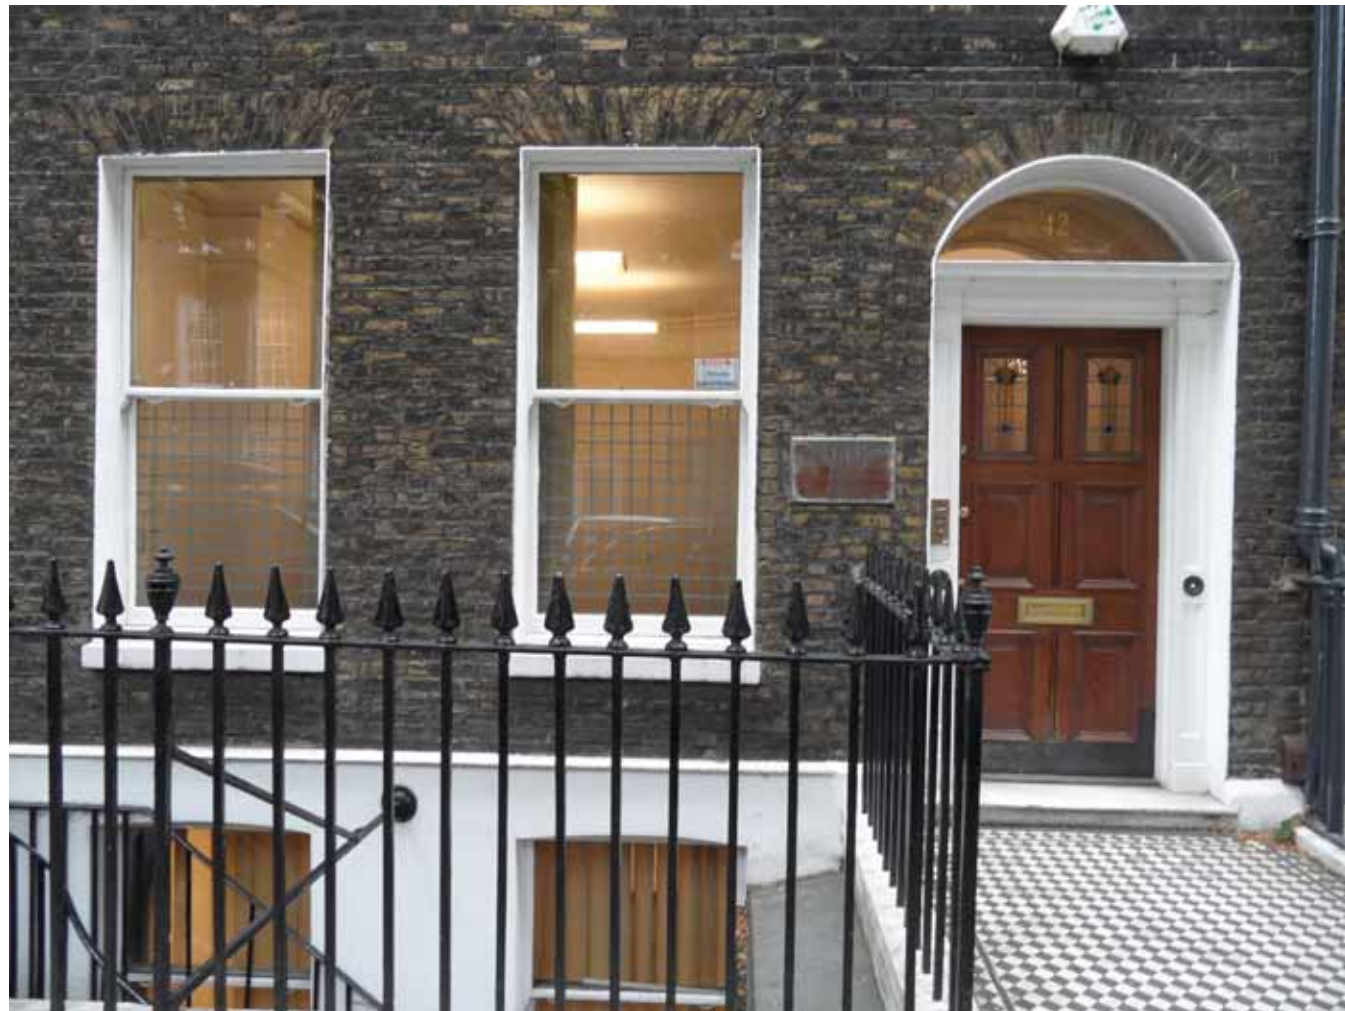
The windows at no 42 are currently all 1 over 1 pattern.

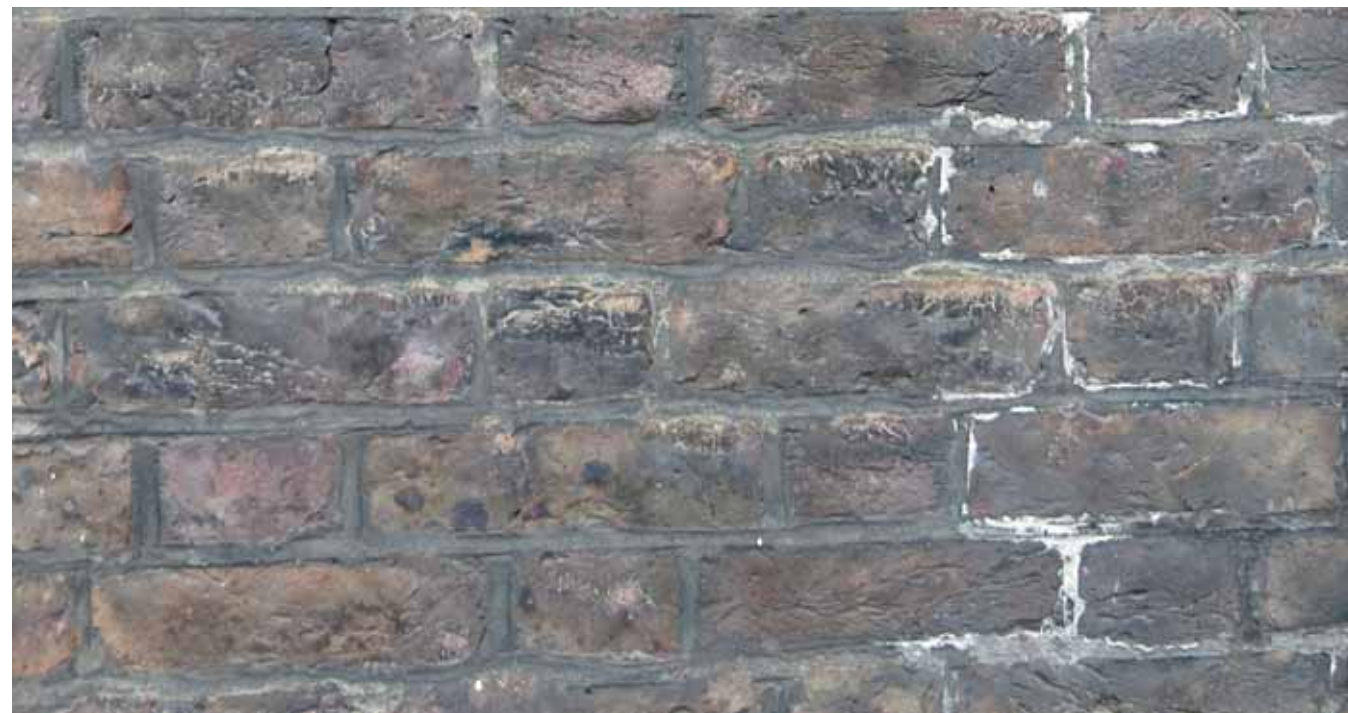
Dark multi stock brickwork with cement pointing.

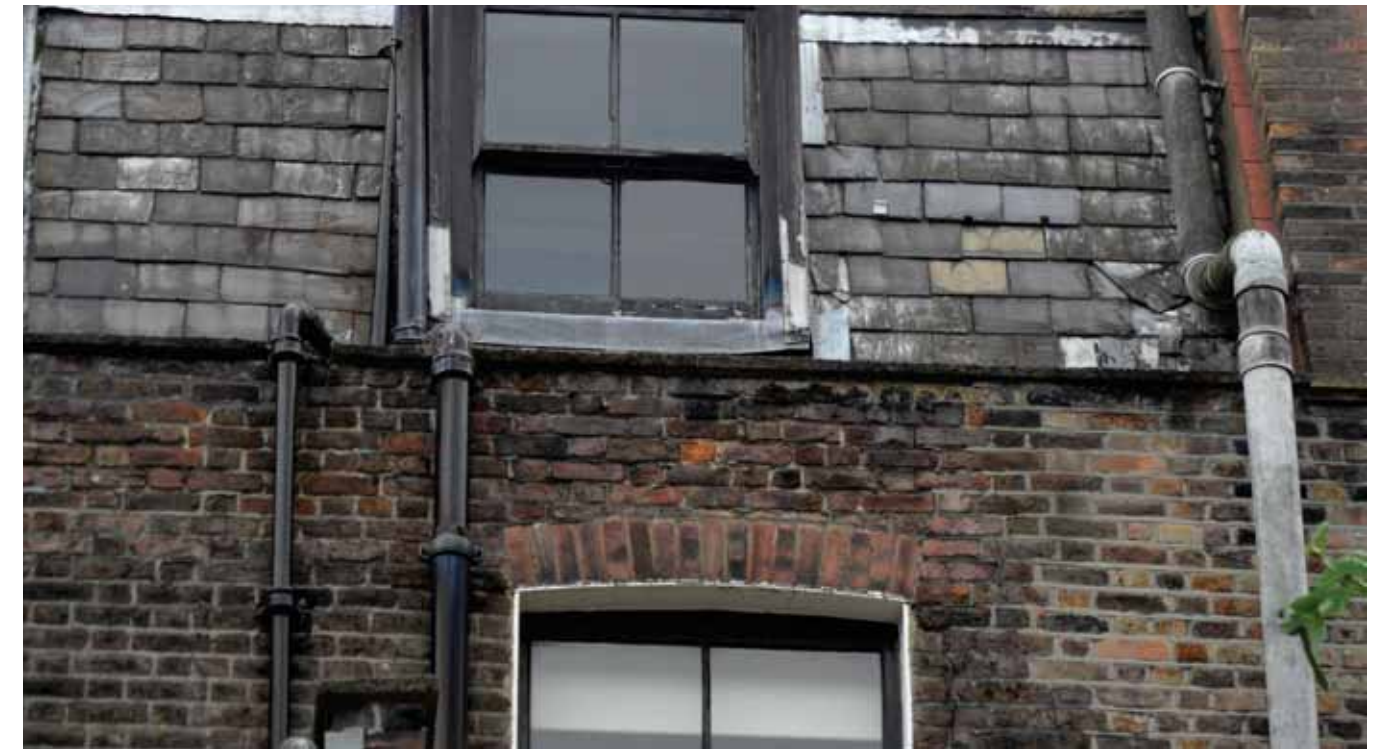
The upper parts of the brickwork to the rear facade which show signs of loss of pointing and brick damage as a result of failed coping stones. The repairs to the right hand side of the picture appear to have been executed in inappropriate cement.
