Second floor
118a London Wall
London EC2Y 5JA
rp@prewettbizley.com
020 7359 2692

prewett
bizley
architects

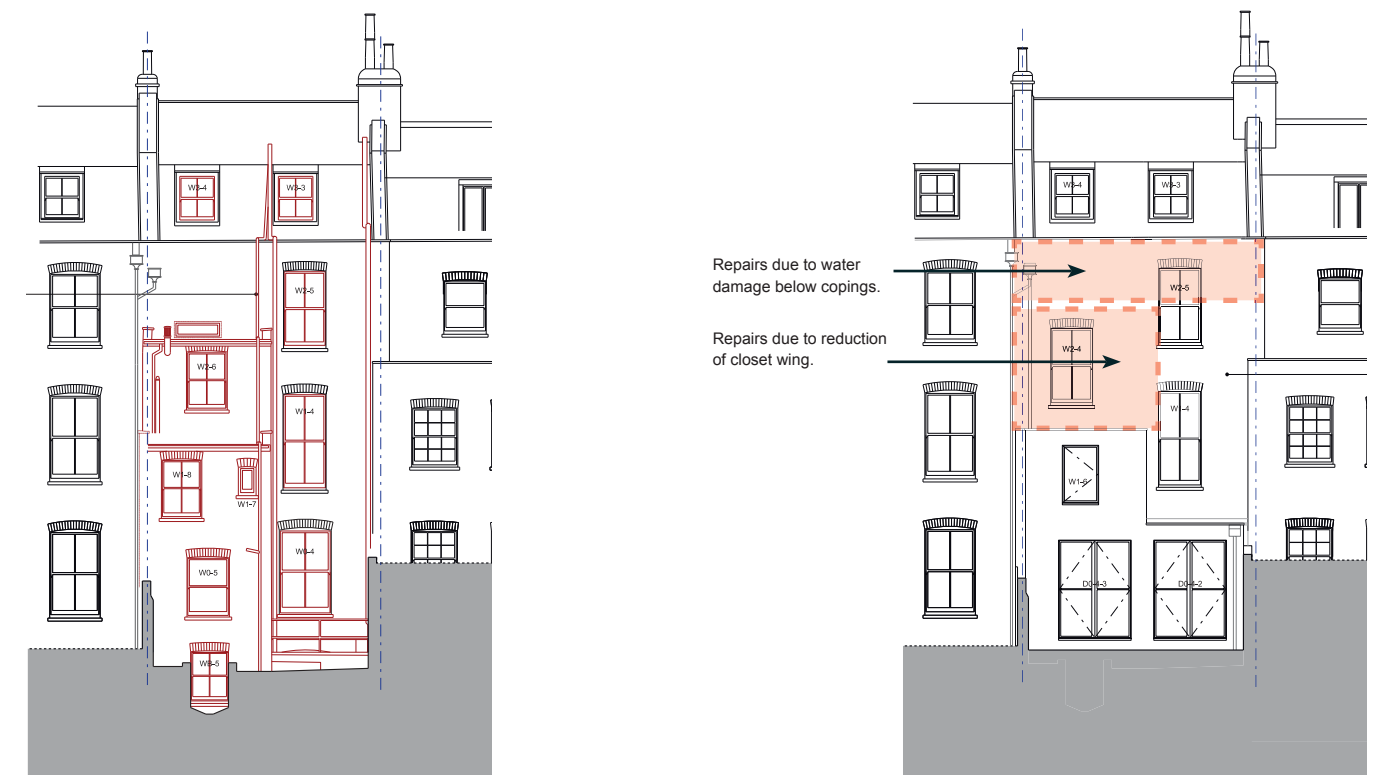
The existing and proposed drawings of the rear elevation above. Note the areas of repair to brickwork required.

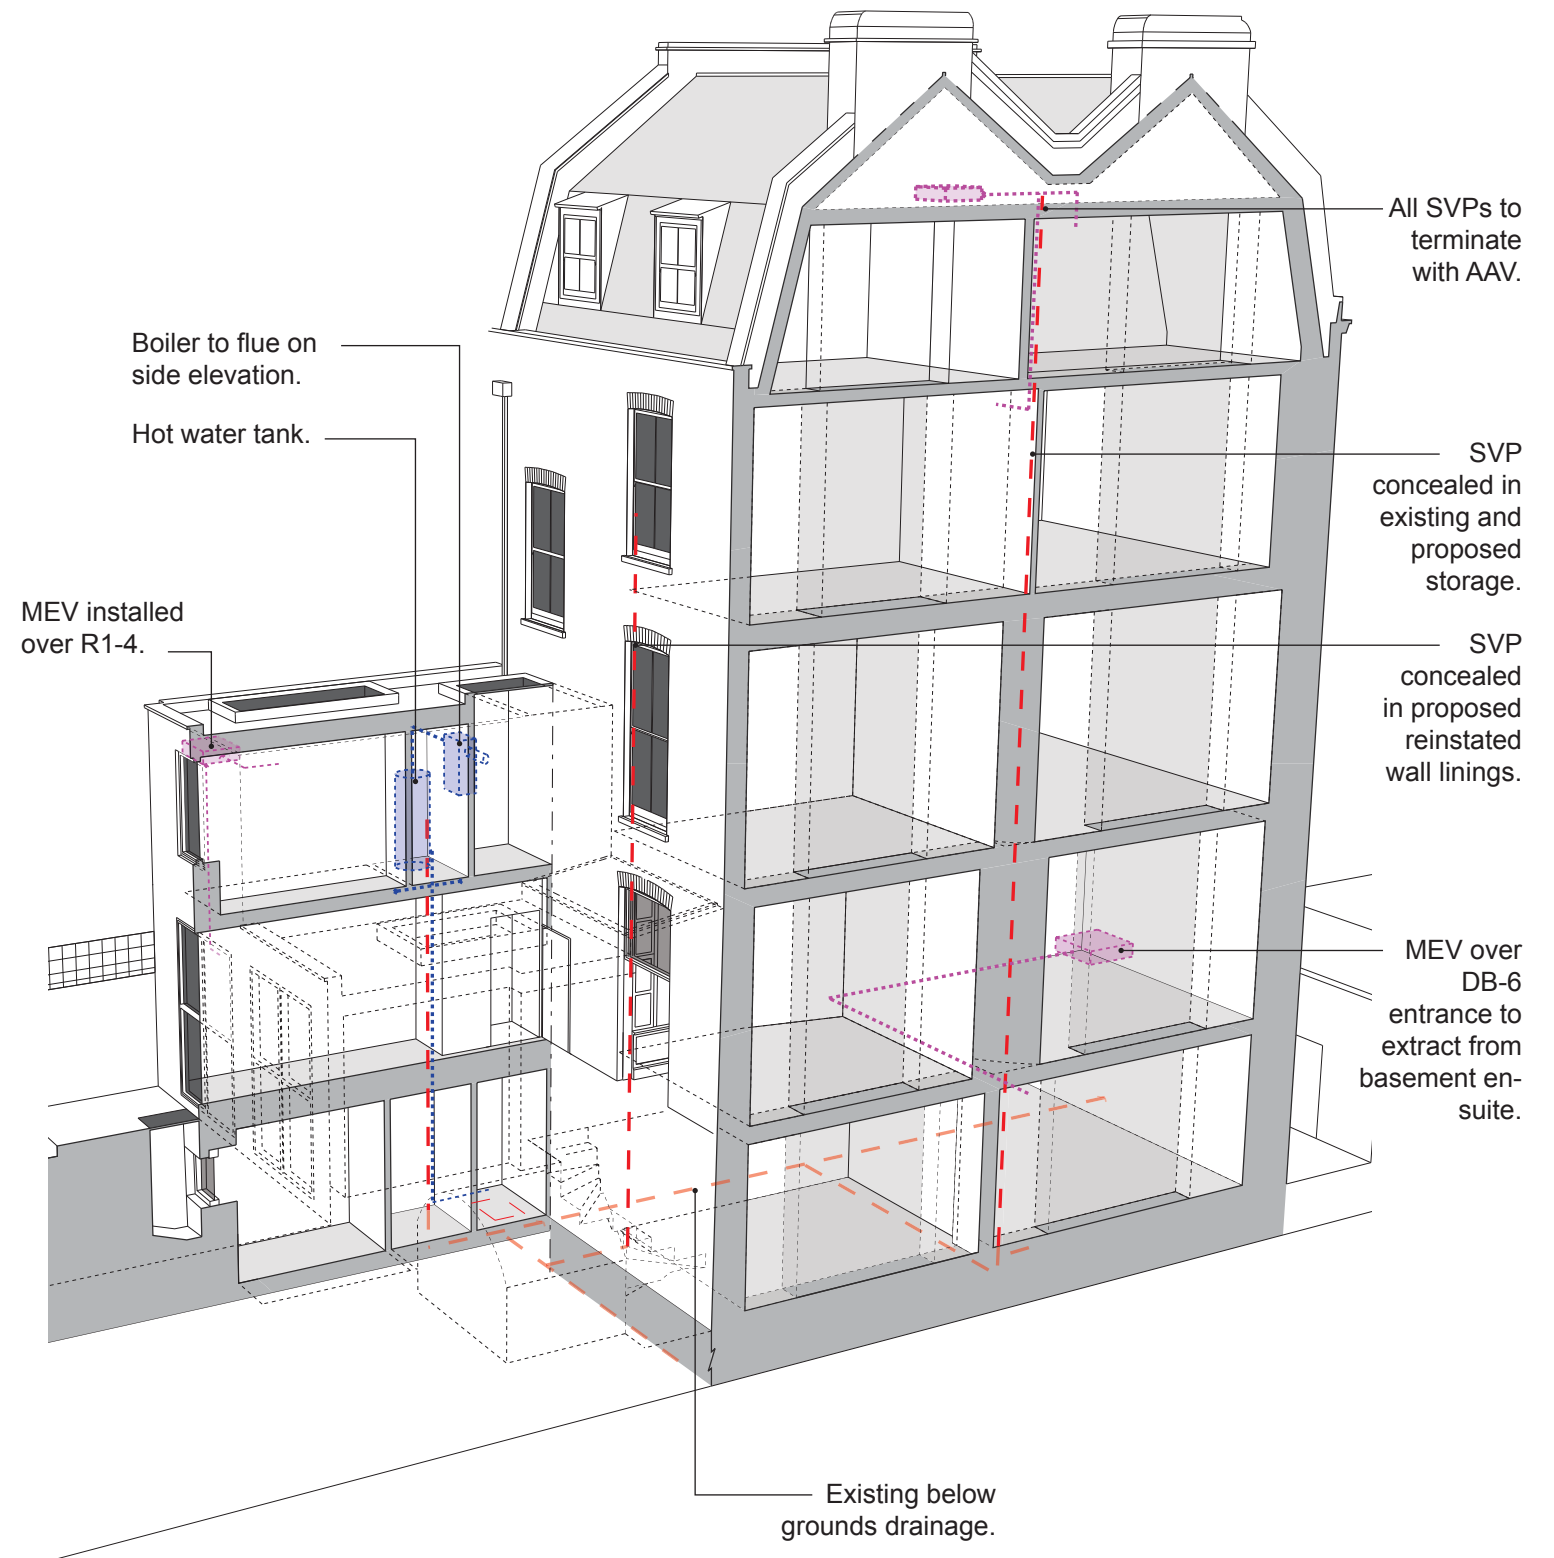
By designing the new closet wing/extension to be energy efficient, installing insulation within the mansard roof and by fitting the house with discrete secondary glazing, it is possible to omit the air conditioning and reduce the radiator size to about half, thereby freeing the internal architecture from the weight of this clutter.
