TREE PROJECTS

REPORT ON TREES AT

13a Pond Street
London
NW3 2PN

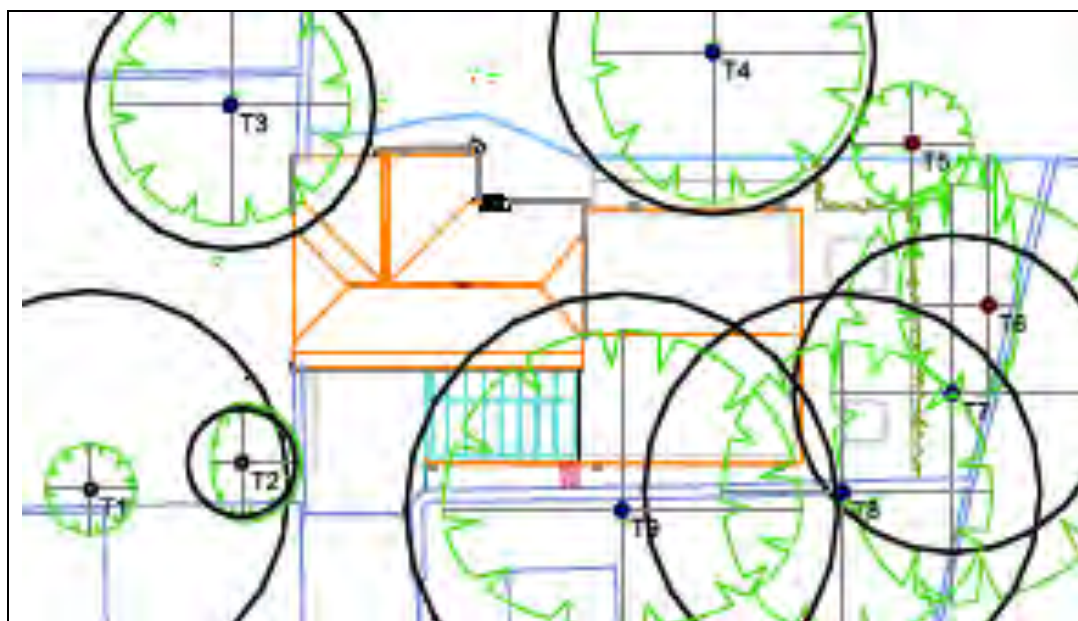
Figure 1: Tree RPA Constraints Data showing unadjusted tree Root Protection Area (RPA) as black circles centred on each tree. Trees with red centres are not considered worthy of retention and RPA is not presented. Base plan used here is that of the roof plan as existing

In respect of this project, RPA has been presented as a circle centred on each tree's trunk. It can be seen (Appendix 2 and Figure 1) that this extends into the site and overlaps parts of the existing buildings footprint. This will be discussed further in this report with more specific reference however suffice to say now that physical impediments to root distribution, such as foundations below ground level, are likely to cause roots to be directed and contained such they do not necessarily occur where the theoretical model suggests.

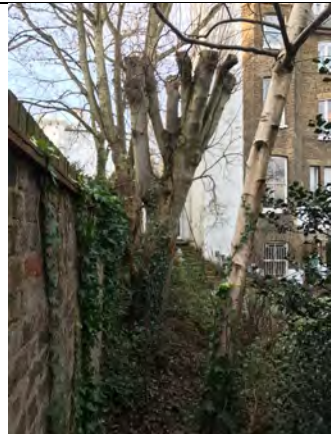
2.2.1 Tree T1: Sycamore, in poor condition with 10+ years safe useful life.

<p>Located within the rear garden of 33 Hampstead Hill Garden and probably self-seeded in origin, this tree has relatively recently been lopped to a stout pollard framework. What amenity value it possessed has been lost, and although in time it may re-grow, what regrowth is evident appears to lack vigour. See Photo 1. The proposed scheme will not impact this tree.</p>
<p>Photo 1 T1 Sycamore</p>

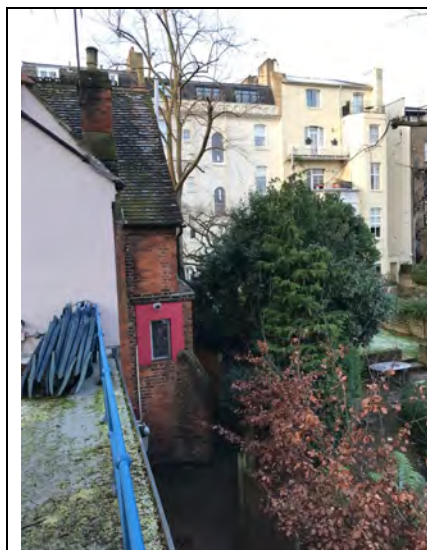
Photo 4, T3 Robinia in background: evergreen shrub in mid ground not considered materially significant to the application.

2.2.3 Tree T3: Robinia/ False Acacia. In good condition with 20+ years estimated safe useful life. Tree in background of photo's 2 and 3 and also in photo 4. Appears to be within the rear garden of 33 Hampstead Hill Gardens.

This Robinia was out of leaf during the inspection and so it was not possible to determine if it is the yellow leaved cultivar 'Frisia'. Typically vigorous, this tree has been reduced in the past at approximately 15m and has 3m regrowth. The garden in which it is rooted is some 700mm higher than that of 13a Pond Street. Care will need to be taken during demolition and reconstruction of the boundary wall. In all likelihood the roots of this tree do not extend into site due to the boundary wall and its footings.

3.2.3 **Robinia Tree T3:** The RPA of this tree is shown (as are others) as a circle centred on the tree. As has been suggested this is in fact a theoretical plot derived from the application of BS 5837 as would be applicable to a field or 'open grown' situation. The RPA as plotted overlaps the north west corner of the site however in reality it is

expected that its roots are fully contained within the garden in which it is rooted, this for two reasons: firstly the 700mm level difference between the site and 33 Hampstead Hill Gardens allied to the second principle: the barrier effect of footings of the wall which it is fairly safe to assume extend further below 700mm. It is a fairly commonplace occurrence in London and other developed and urban areas that the curtailment of roots is can arise. A key element of such a consideration is that roots tend to proliferate in the upper 600mm of soil i.e. a tree root system should be considered more akin to the bottom of a wine glass than a mirror reflection at ground level of what is seen above ground. Each site and its soil conditions will of course vary, for example trees will root below 600mm on open sandy soils and may not reach that depth on heavy clay soils. Principal drivers influencing depth of root growth are availability of air (beneficial/ increases depth of rooting) and compaction/ saturation/ waterlogging of soils (not conducive). In simple terms this report contends that where demolition of the existing brickwork and foundations is undertaken with care, and where a piling rig is positioned such that piles can be formed directly down through the path of existing footings without disturbance beyond the line of build, that no harm will arise to roots of T3. The upper crown is unlikely to be impacted as a piling rig capable of accessing the site, including being able to safely traverse a basement beneath the access, is very likely to be small and light in weight.

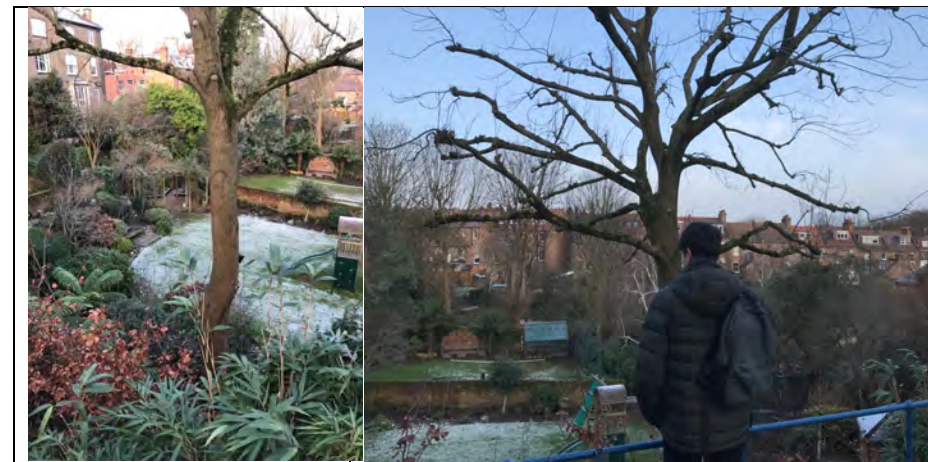
Photo 5 & 5a, T4 Ash

2.2.4 Tree T4, Ash. In good condition with 20+ years safe useful life.

Located in a private garden to the north of the site, this early mature tree has recently been crown reduced. The proposal is unlikely to have any impact on this tree.

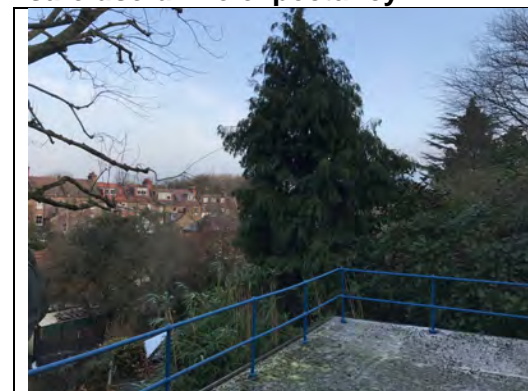
Photo 6, T5 Lawsons Cypress

2.2.5 Tree T5, Lawsons Cypress. In poor condition with <10 years safe useful life expectancy.

Located in a private garden to the west of the site this early mature tree divides into two main stems at around 1 m above ground level. The union between both stems appears to be a tight 'compression fork' an accepted weakness at risk of failure. No adverse impacts anticipated.

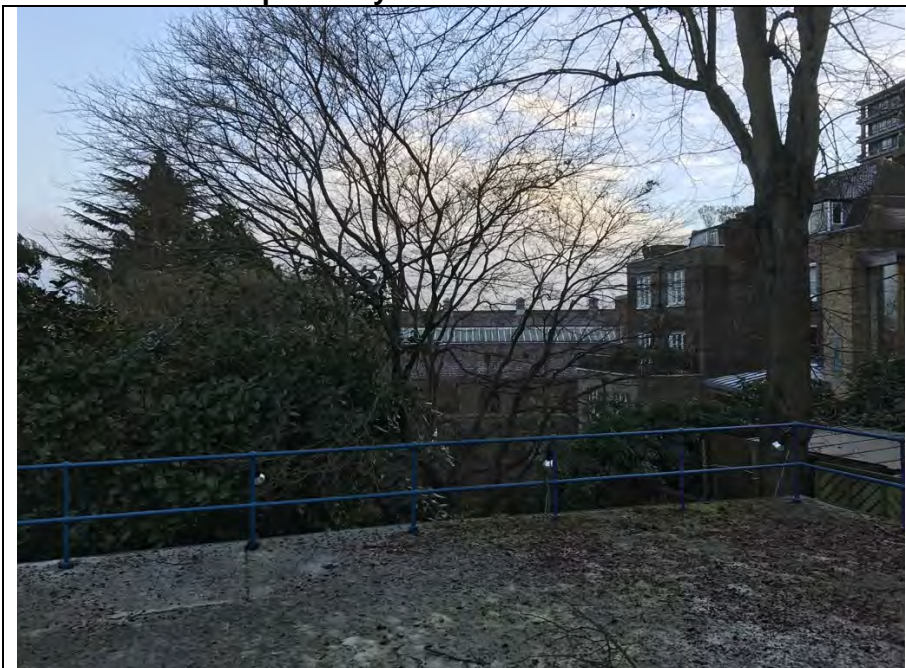
Photo 7, T6 Evergreen Magnolia (dark foliage left of shot) & T7 Japanese Maple (no leaves-centre of shot)

Seen from the first floor roof of the Foster Extension the Evergreen Magnolia can be seen to the left hand side of photo 7. behind railings. This tree is heavily suppressed having developed beneath the influence of adjacent Japanese Maple T7. Although presented as for retention within the scheme, it is considered that the amenity value of this tree is very limited given its position. Furthermore, thinking about use and enjoyment of the garden post construction, and in terms of competition with the more desirable Japanese maple and, the ability to sustain growth of smaller herbs and shrubs in ground it currently over shadows, removal is recommended in the short to medium term.

Visible to the right of the Evergreen Magnolia and central with the frame of photo 7, this is a useful tree that is in scale and proportion to its setting albeit nominally suppressed beneath T8. With a three stem break at around 500mm above ground level this tree is located to the east of the Foster Extension and away from the focus of construction activity. No adverse impacts are expected however existing paving should be retained for the duration of works up until replacement (commencement of landscaping) and a scheme of protection is warranted.

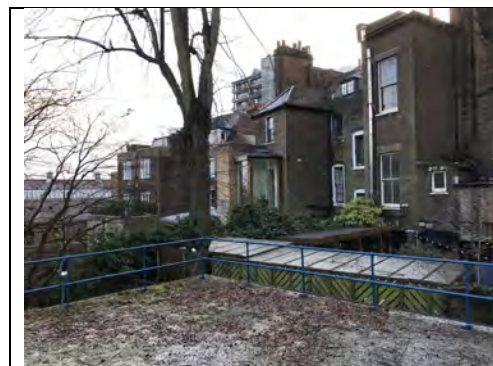
Photo 8, Lime T8

Both Limes T8 and T9 are judged to be in fair condition with 20+ years safe useful life. They are off-site trees located within the rear garden of The Roebuck public house No. 15 Pond Street: The condition of the trees is assessed as 'fair', with marking down due

primarily to the volume of dead wood within the crown which is at risk of falling and, due to the limitations of access which hindered careful inspection of the stem and lower parts of the trees.

Tree T8 is of sufficient distance from the area of proposed works that no adverse impacts are expected to occur. Tree T9 is closer to the proposed basement formation: the interposing boundary wall that divides the two properties is thought likely to have curtailed root development across the boundary.

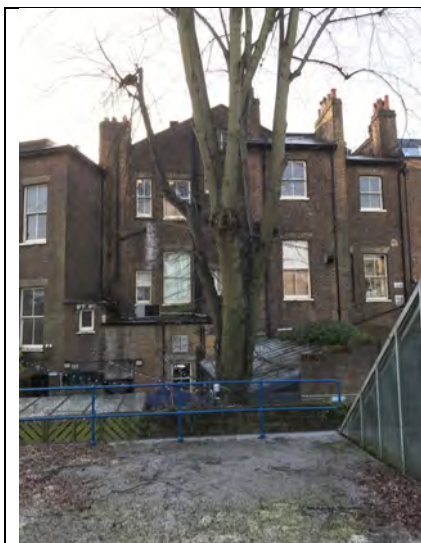
Photo 10, Tree T9 Pollard Points

Both trees are mature and appear to have been repeatedly pruned at the following approximate heights above ground level: Pollard at 6m, crown reduced at 4m and 9m above pollard points. Currently 5m + of re-growth has arisen since the most recent reduction. Within my schedule I recommend both trees are crown cleaned and reduced to previous reduction points (whilst retaining selected growth to avoid skeletal effect) and, subject to a detailed basal and climbing inspection.

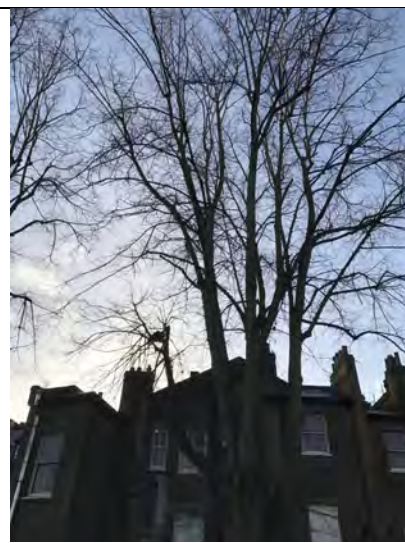
Photo 11, Tree T9 Upper crown Reduction Points

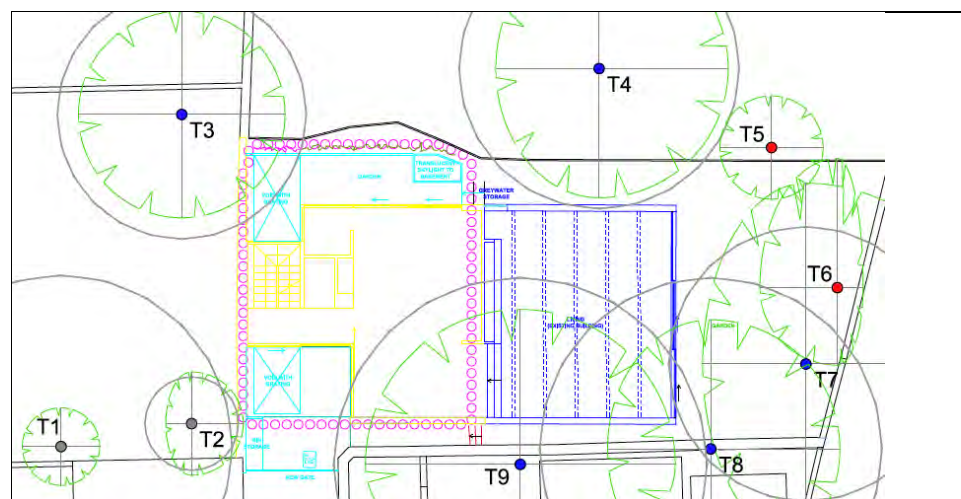
Figure 2: Tree RPA Constraints Data showing unadjusted tree Root Protection Area (RPA) as black circles centred on each tree. Trees with red centres are not considered worthy of retention and RPA is not presented. Base plan used here is an amalgamation of the site and basement as proposed plans where: Foster extension to be retained is in blue, basement as proposed (line of piles) in magenta, external garden areas in cyan (light blue) and proposed ground floor in yellow.

3.2.2 **Birch tree T2:** As can be seen in Figure 2 and the full plan at Appendix 3, The RPA of T1 abuts the existing line of the boundary wall. The wall is to be replaced following formation of contiguous piles that will form the new basement structural box. Due to the level difference between site and the ground in which this tree is rooted, it is proposed, following careful demolition of the existing wall and its footings, to form piles by positioning a piling rig on a raised mat formed of crushed demolition waste. In this way any guarding associated with the auger can be located at the higher ground level to avoid unnecessary over digging. In addition to this and due to the lean of the tree, there could be some conflict between equipment and the lower branches and crown: this is proposed to be addressed by short term tying of branches into the main stem and then carefully pulling back the stem using protection and ratchet straps anchored off the stem of T1. This operation and process will be sought for agreement under party wall negotiations and should be undertaken only by a suitably experienced arboriculturist. It is estimated that tying back would be required for little more than 5 days and be necessary during the formation of just three or four piles.
