St Giles - Zone 3 : 7 Denmark Street
Listed Building Application

Introduction

The existing building is located on Denmark Street, London WC2H 8LS. The building is undergoing a full refurbishment in accordance with Listed Building Consent - 2012/6867/L. Ian Chalk Architects have been appointed as the architects to deliver the building on site and Cord Contracting as the Contractor.

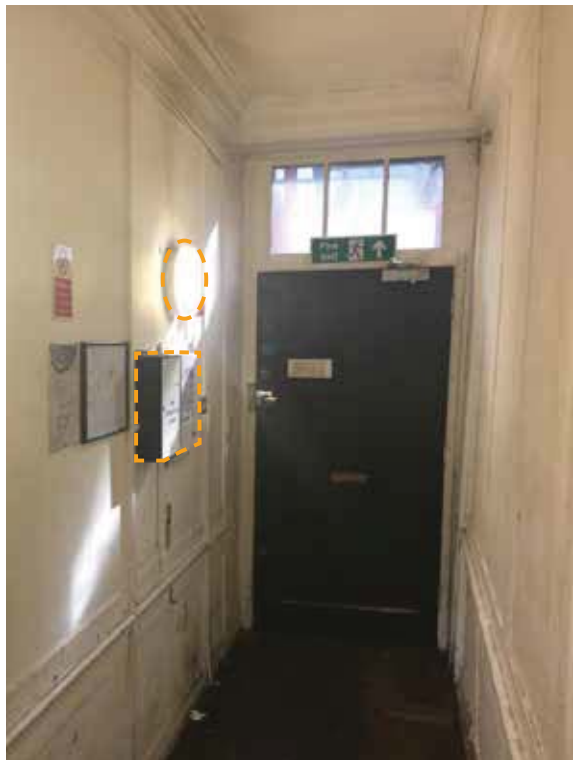
Entrance Hall of No.7, September 2017, following possession showing surface mounted containment and wall-mounted lighting

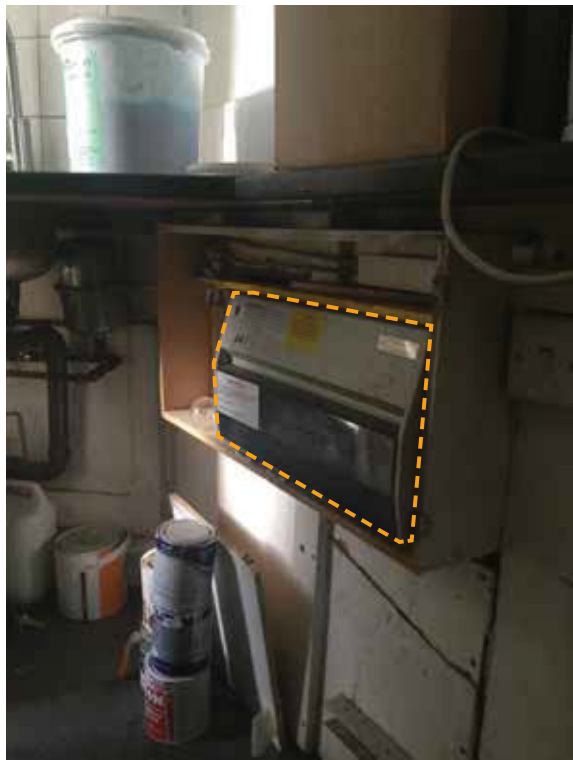
First Floor kitchenette, September 2017, with surface mounted containment

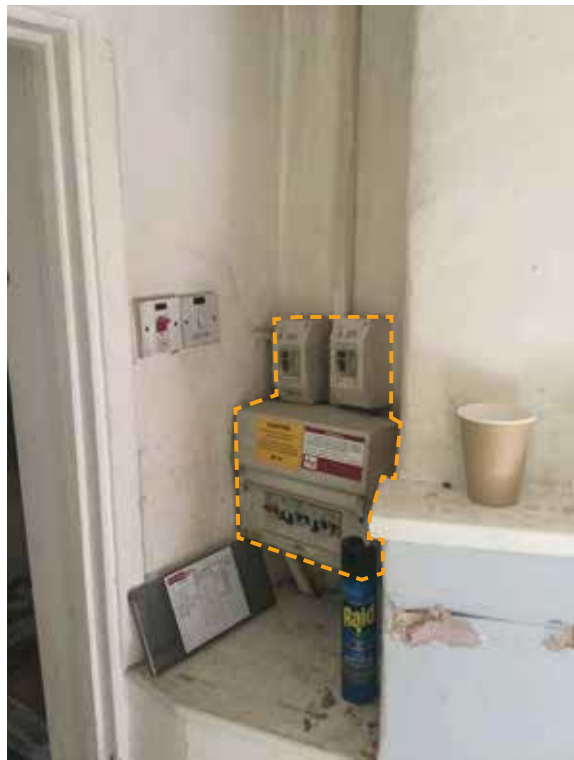
Third Floor back room, September 2017, services run through boxing and are wall-mounted above

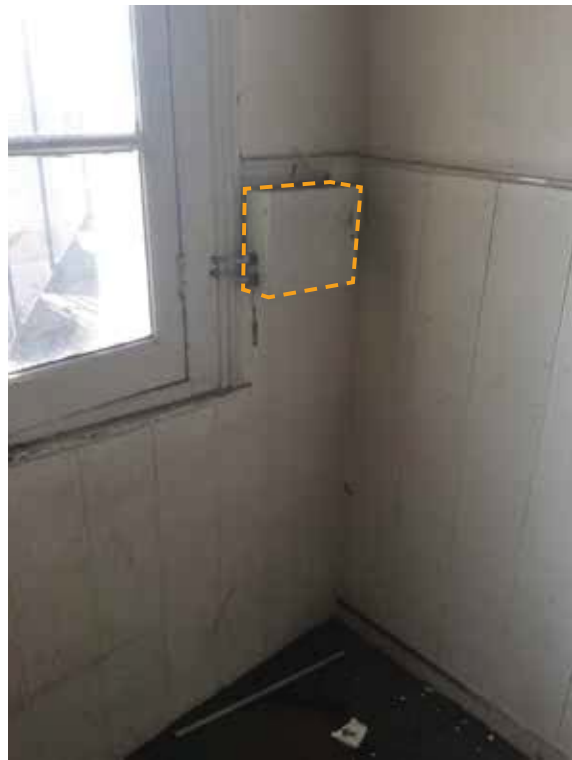
Second Floor half-landing, September 2017, wall-mounted containment with distribution penetrating window frame

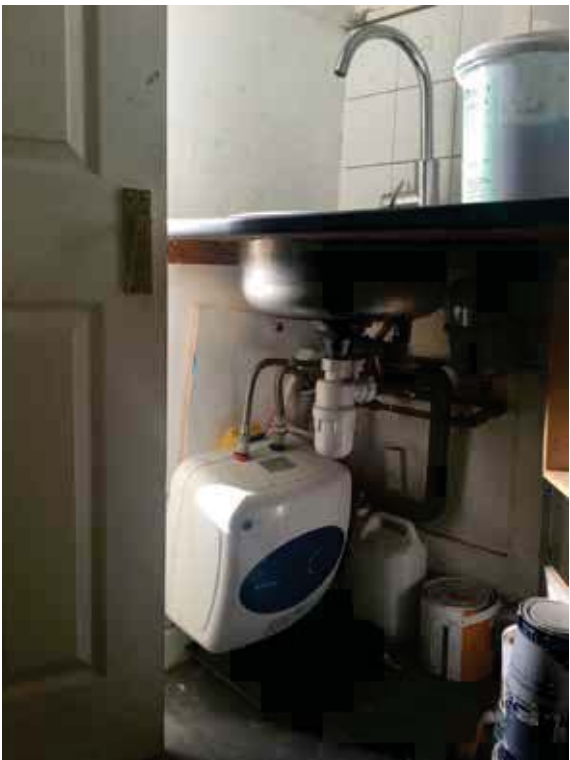
Pump found in kitchenettes

These units, whilst having some benefits, are noisy and can become blocked - this is a particular risk in this building as the pumps will be serving kitchen sinks and food waste and grease can easily block the pumping mechanism.

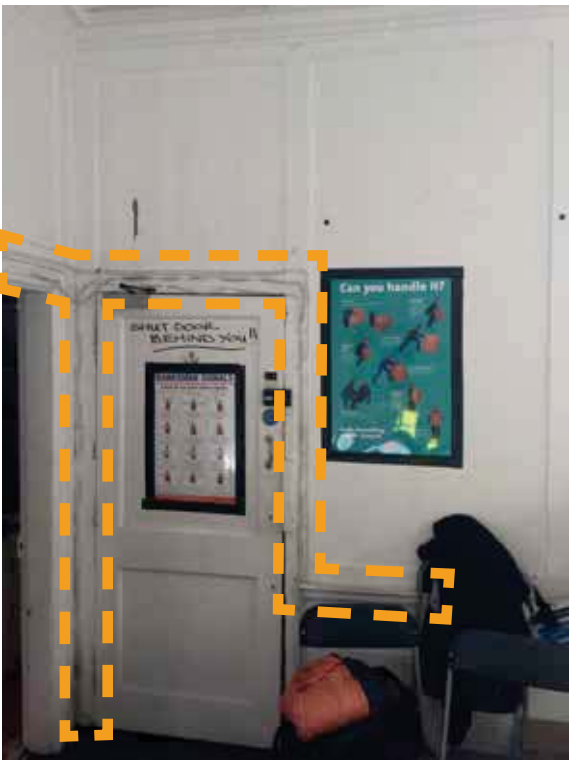
Wiring entering from the corridor space run across panelling and around doorways

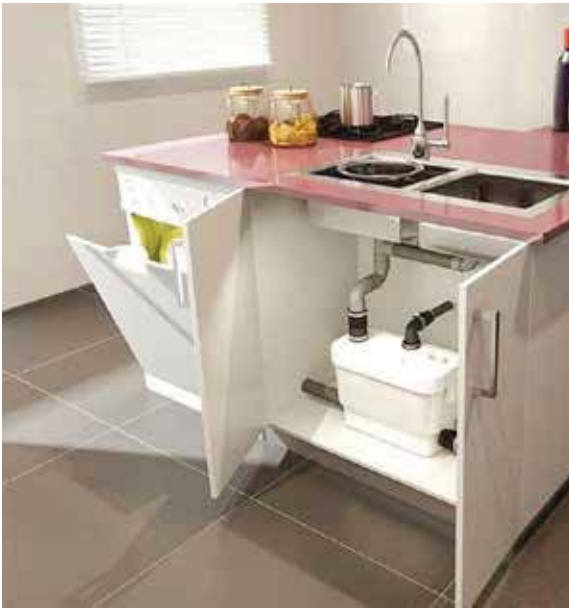
The risk of water blockages and leaks is a particular concern as the fabric of the building is fragile and includes lath and plaster ceilings and cornices. Any flooding that resulted from a kitchen blockage could severely damage the plaster details, as well as the timber linings.

Pumped drainage unit located beneath kitchen sink

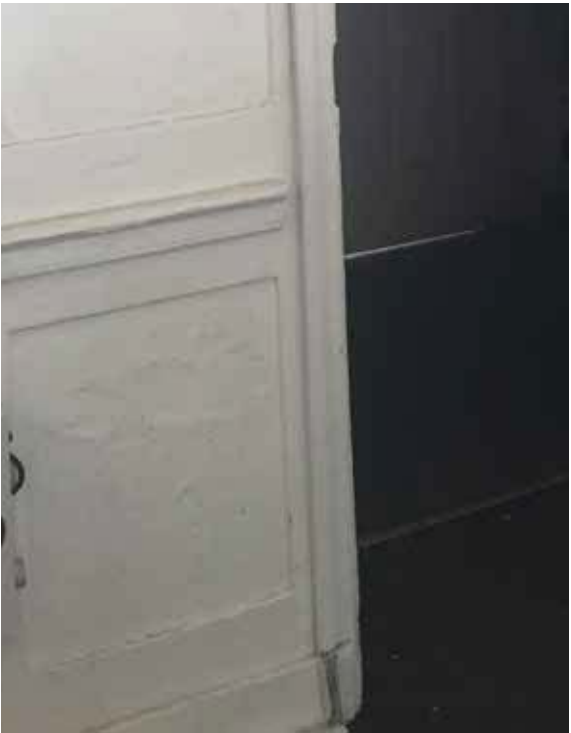
Example of damaged panelling in no. 7 Denmark Street. This panel will require replacement and offers the opportunity to incorporate flush-mounted switch plates

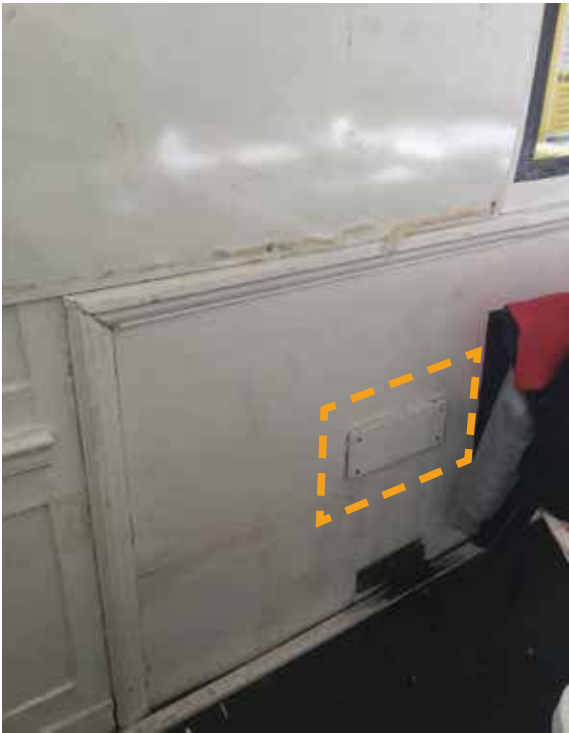
Example of previous services' cut-outs in existing panelling in no. 7 Denmark Street. This can be reused to allow flush-mounted switch plates

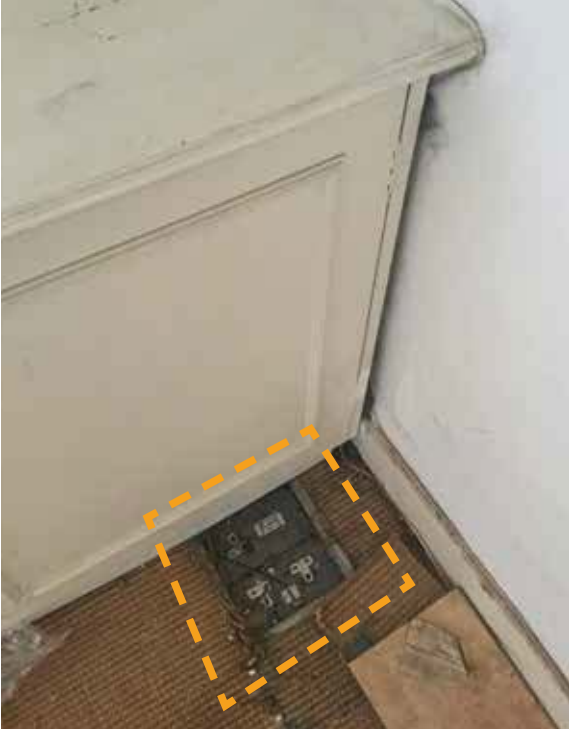
Example of electrical sockets integrated into the floor, to be removed and replaced with flush or surface-mounted switch plates as adjacent.

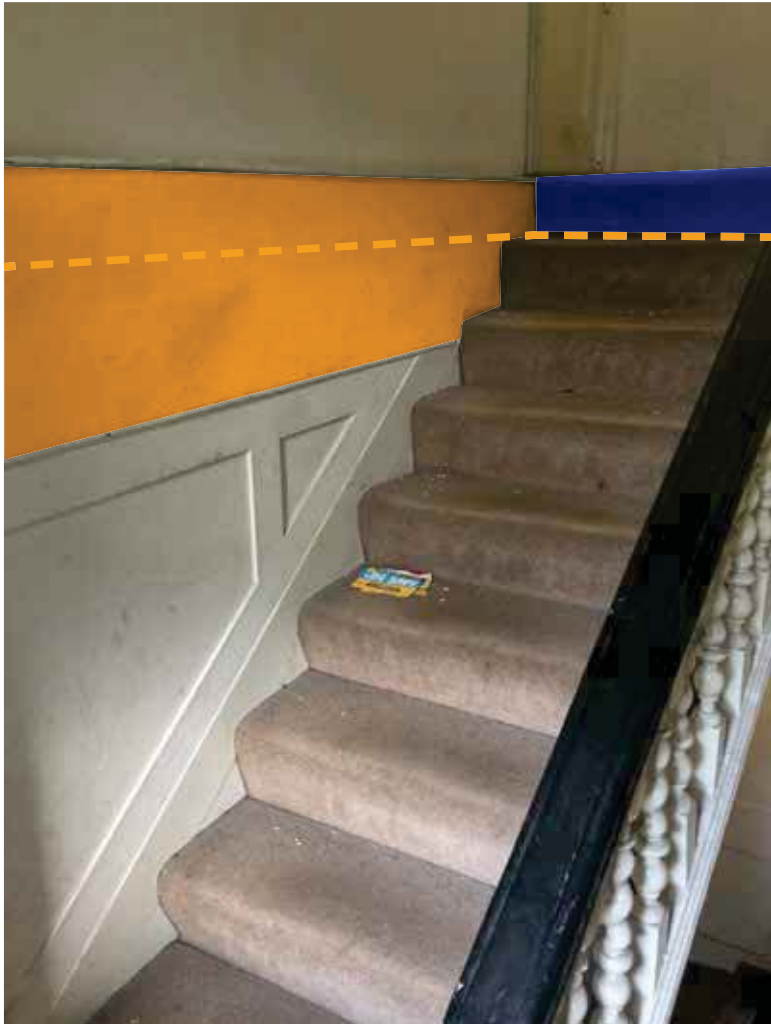
Modern floor built off of existing
Historic landing level

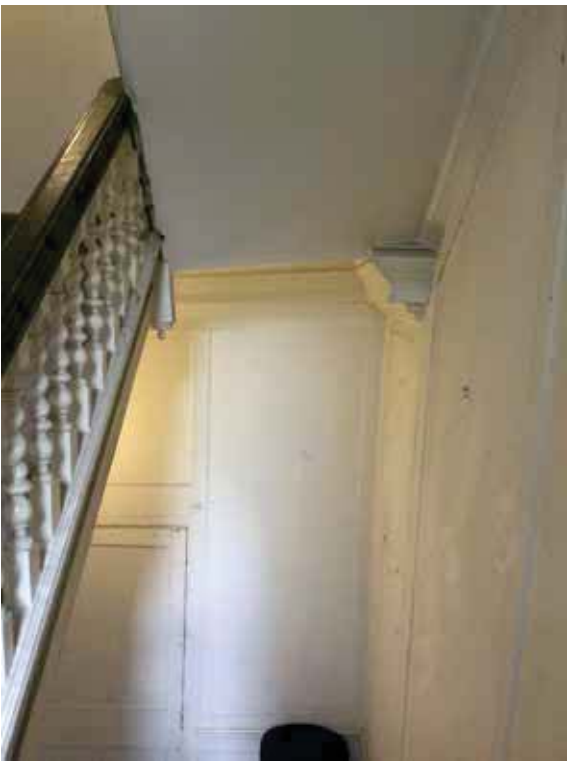
Currently, the structure is showing signs of failure, particularly in the stairwells. Initial inspection has uncovered historic attempts to address the continual subsidence and while improvements have been made, the problem remains.

2nd Floor Landing showing extent of floor deflection

In order to stop any further degradation a number of strengthening works will need to be undertaken. The timber spine beam, stair beam, and floor joists all require strengthening works to halt any further deflection. Each approach shall be analysed and dealt with case-by-case and outlined in Egenuiti's Structural Report, but generally, failing timber beams shall be strengthened by steel beams either side and existing timber joists shall be strengthened by a new timber joist bolted along it.

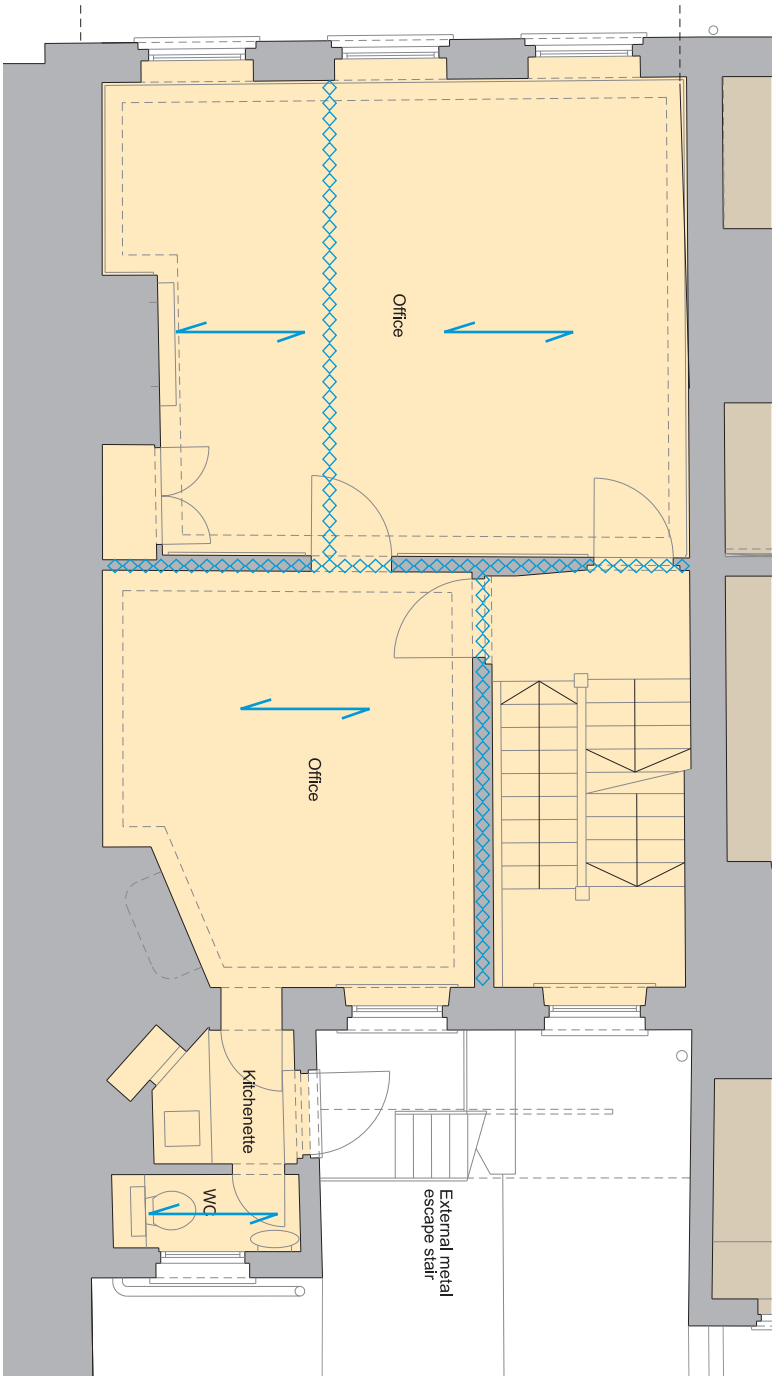
Original structural layout in need of strengthening

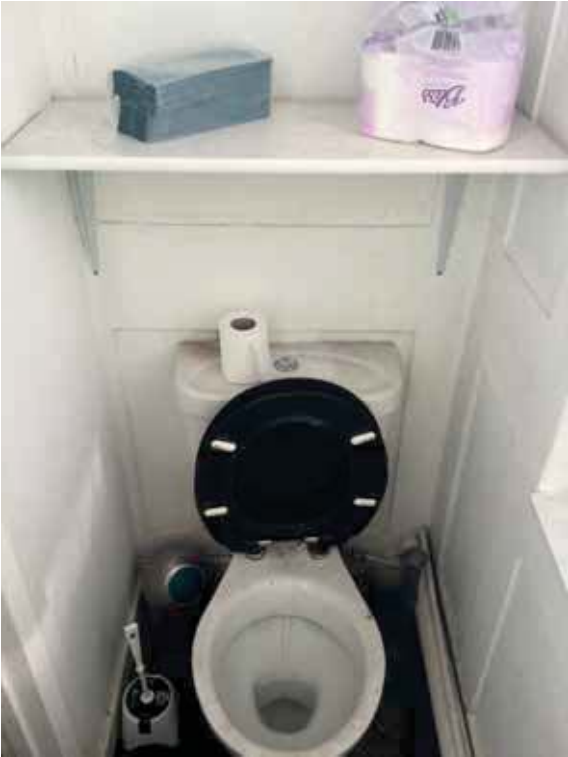
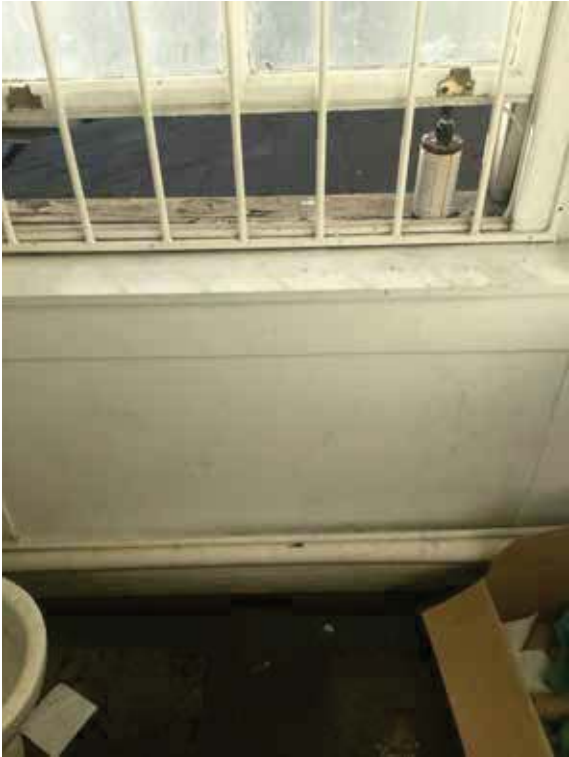
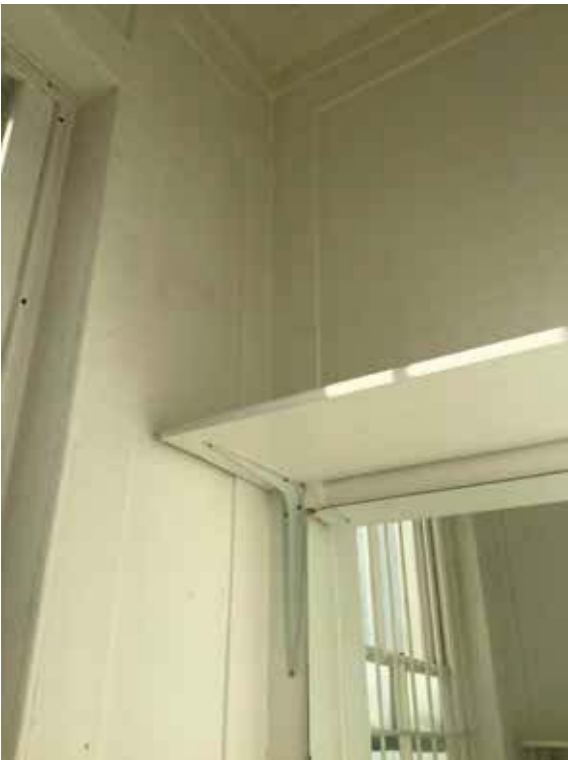
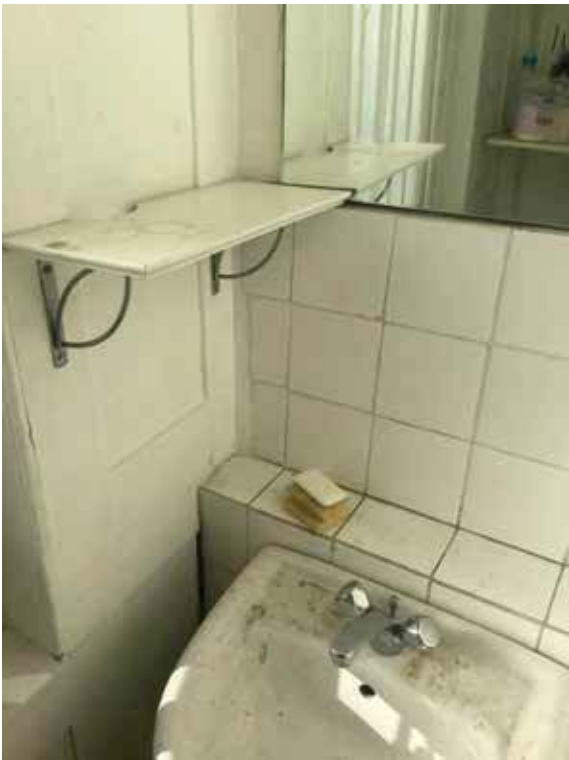
The closet wing has been subject to subdivision and modifications that impair ones ability to read the fabric and proportions of the original space.

Existing First Floor Closet Wing
Cornice and panelling remains much intact, however, shelves and partition detract from the wing

Consent has been granted for the removal of the partition. Once removed, panelling will be repaired and reinstated in order to respect the aesthetic of the original.

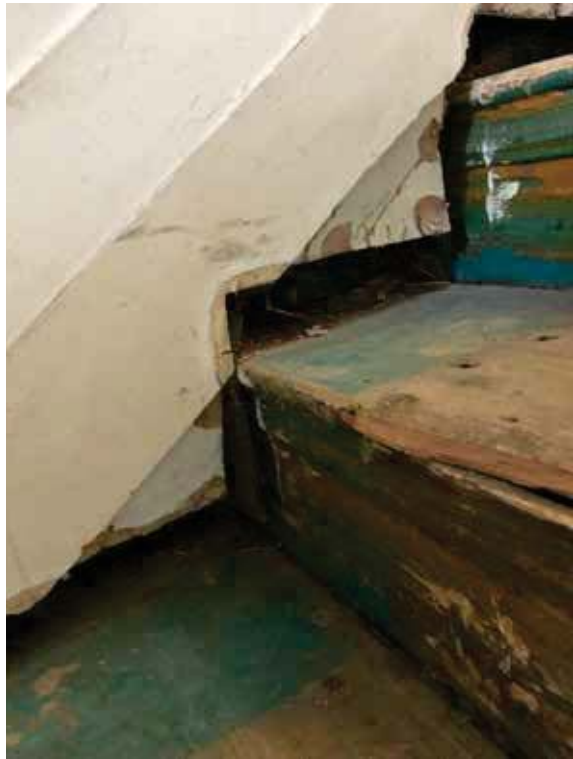
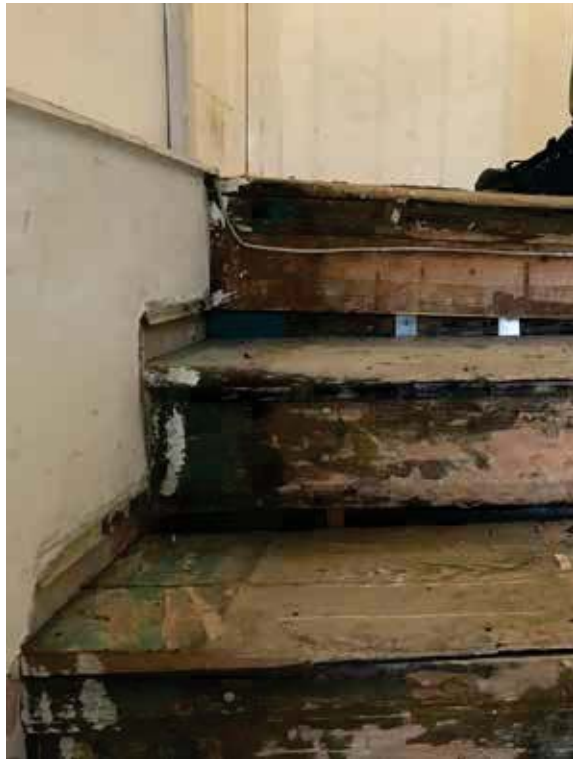
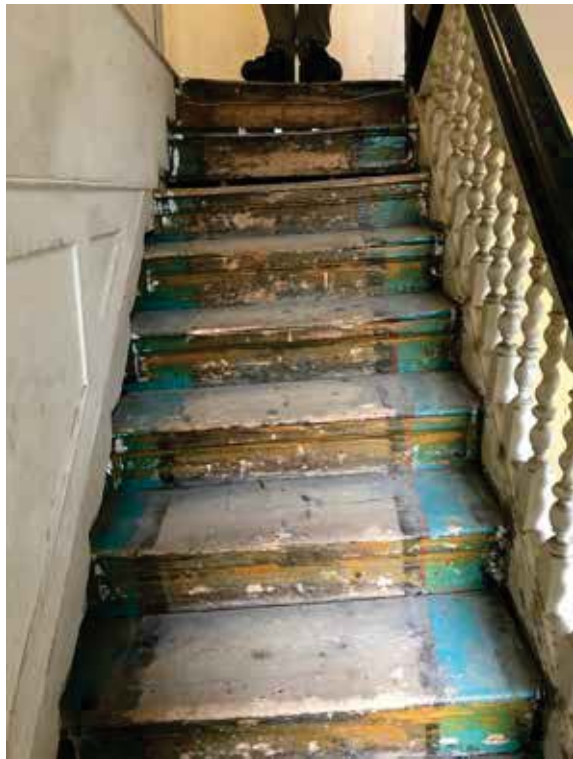
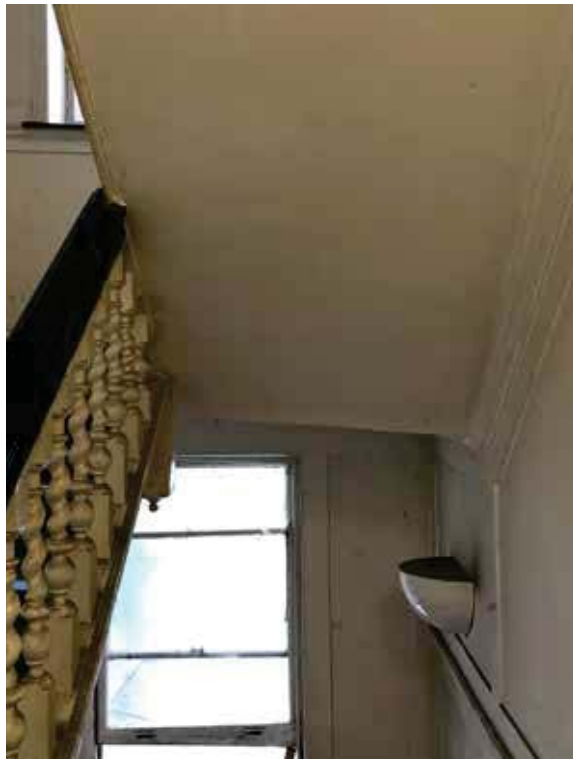
As these inspection photos show clearly, the stair in no.7 is in urgent need of repair. Deflection occurs at every level, with the second floor showing the most significant levels of movement.

Evidence of severe deflection within the stair wells

The flights that meet the second floor landing should be removed and rebuilt, rather than simply repaired. Moving the stair to its original would run the risk of causing further movement and affecting the original fabric.

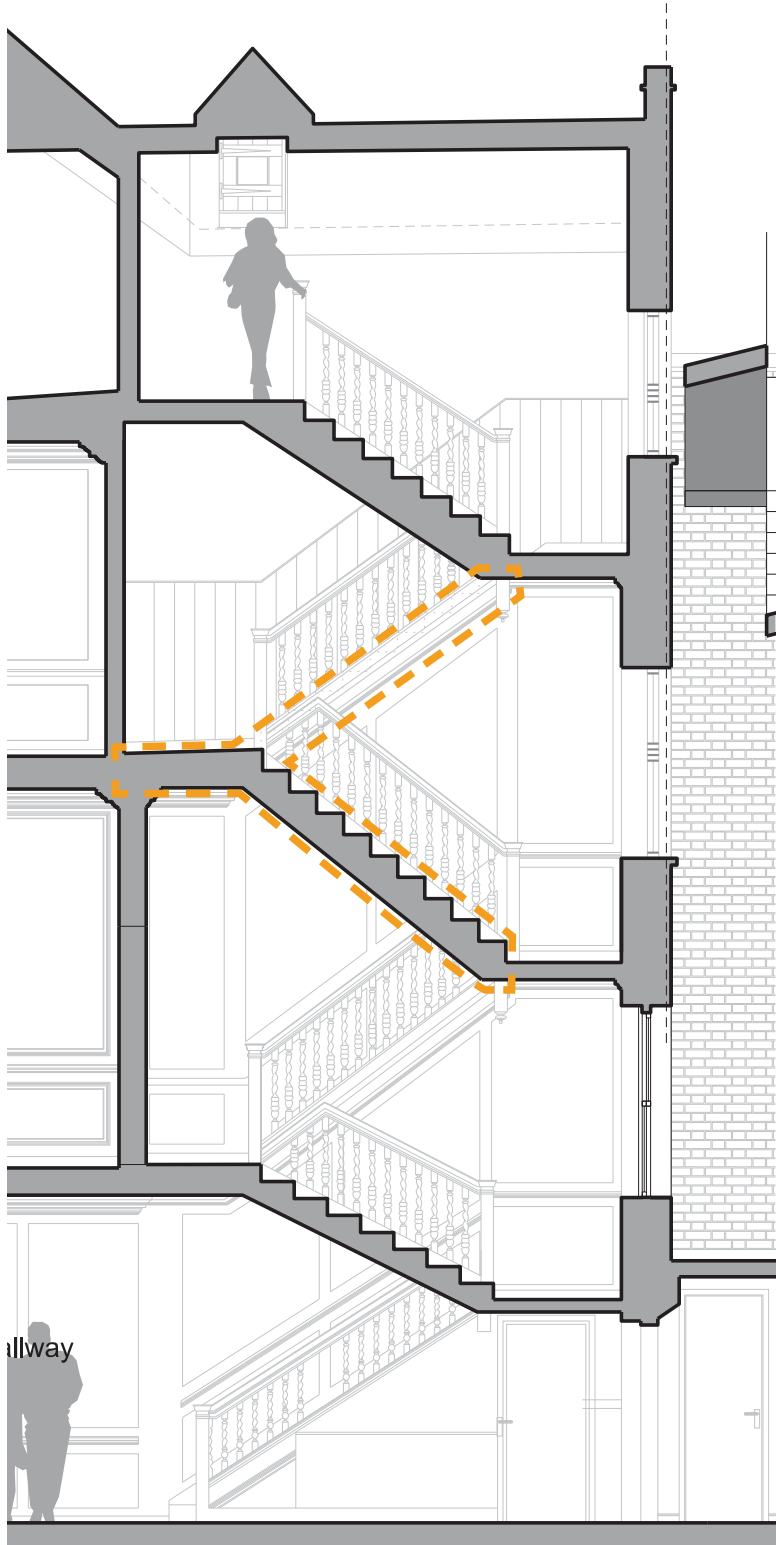
The flights of stairs that meet the second floor landing are the most affected. It is proposed that these are rebuilt for the safety of the tenants and longevity of the property

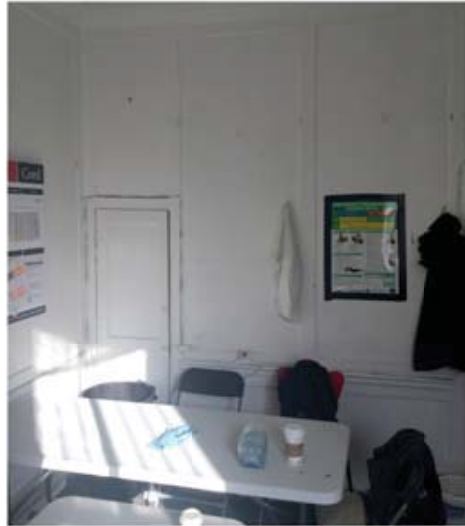
01
X_502 Existing Condition First Floor
Original Panelling and dado mostly intact - to be repaired

All instances of damaged or missing dado rails are to be repaired and reinstated in accordance to the details below

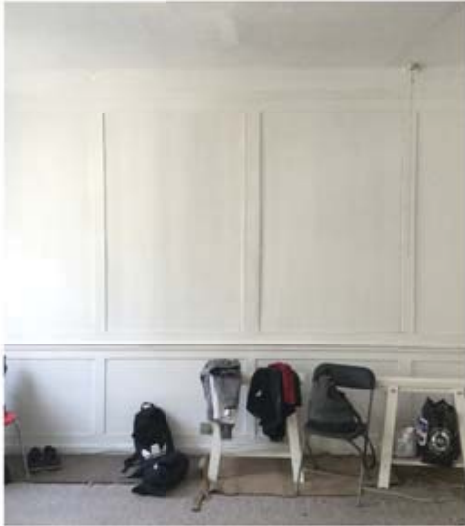
02
X_502 Existing Condition Second Floor
Original panelling and dado mostly intact - to be repaired
