Landmark Trees

ARBORICULTURAL IMPACT ASSESSMENT REPORT FOR:

94 Agamemnon Road
London
NW6 1EH

Ref: NJA/94AGM/AIA/01

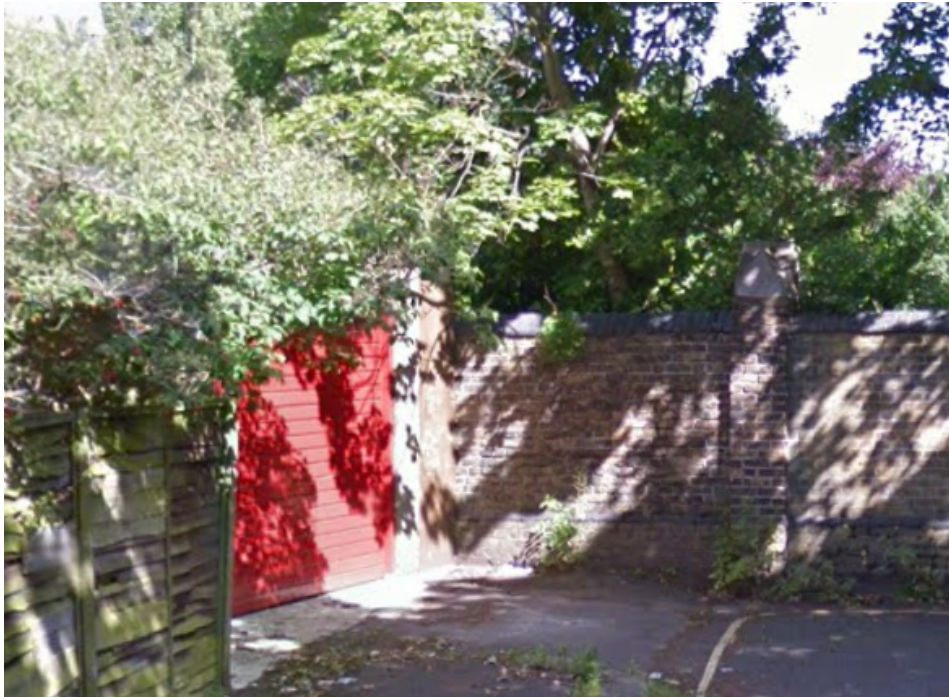
Photograph 2: Brick wall separating T1 from application site (Source: Google Maps)

4.2.4 Assuming that they will be retained, the orientation of the off-site tree will ensure that shading constraints are minimal, with leaf deposition and honey-dew likely to be as it is today. It will also be noted that the tree is growing in an unsuitable long-term position, abutting the boundary wall.

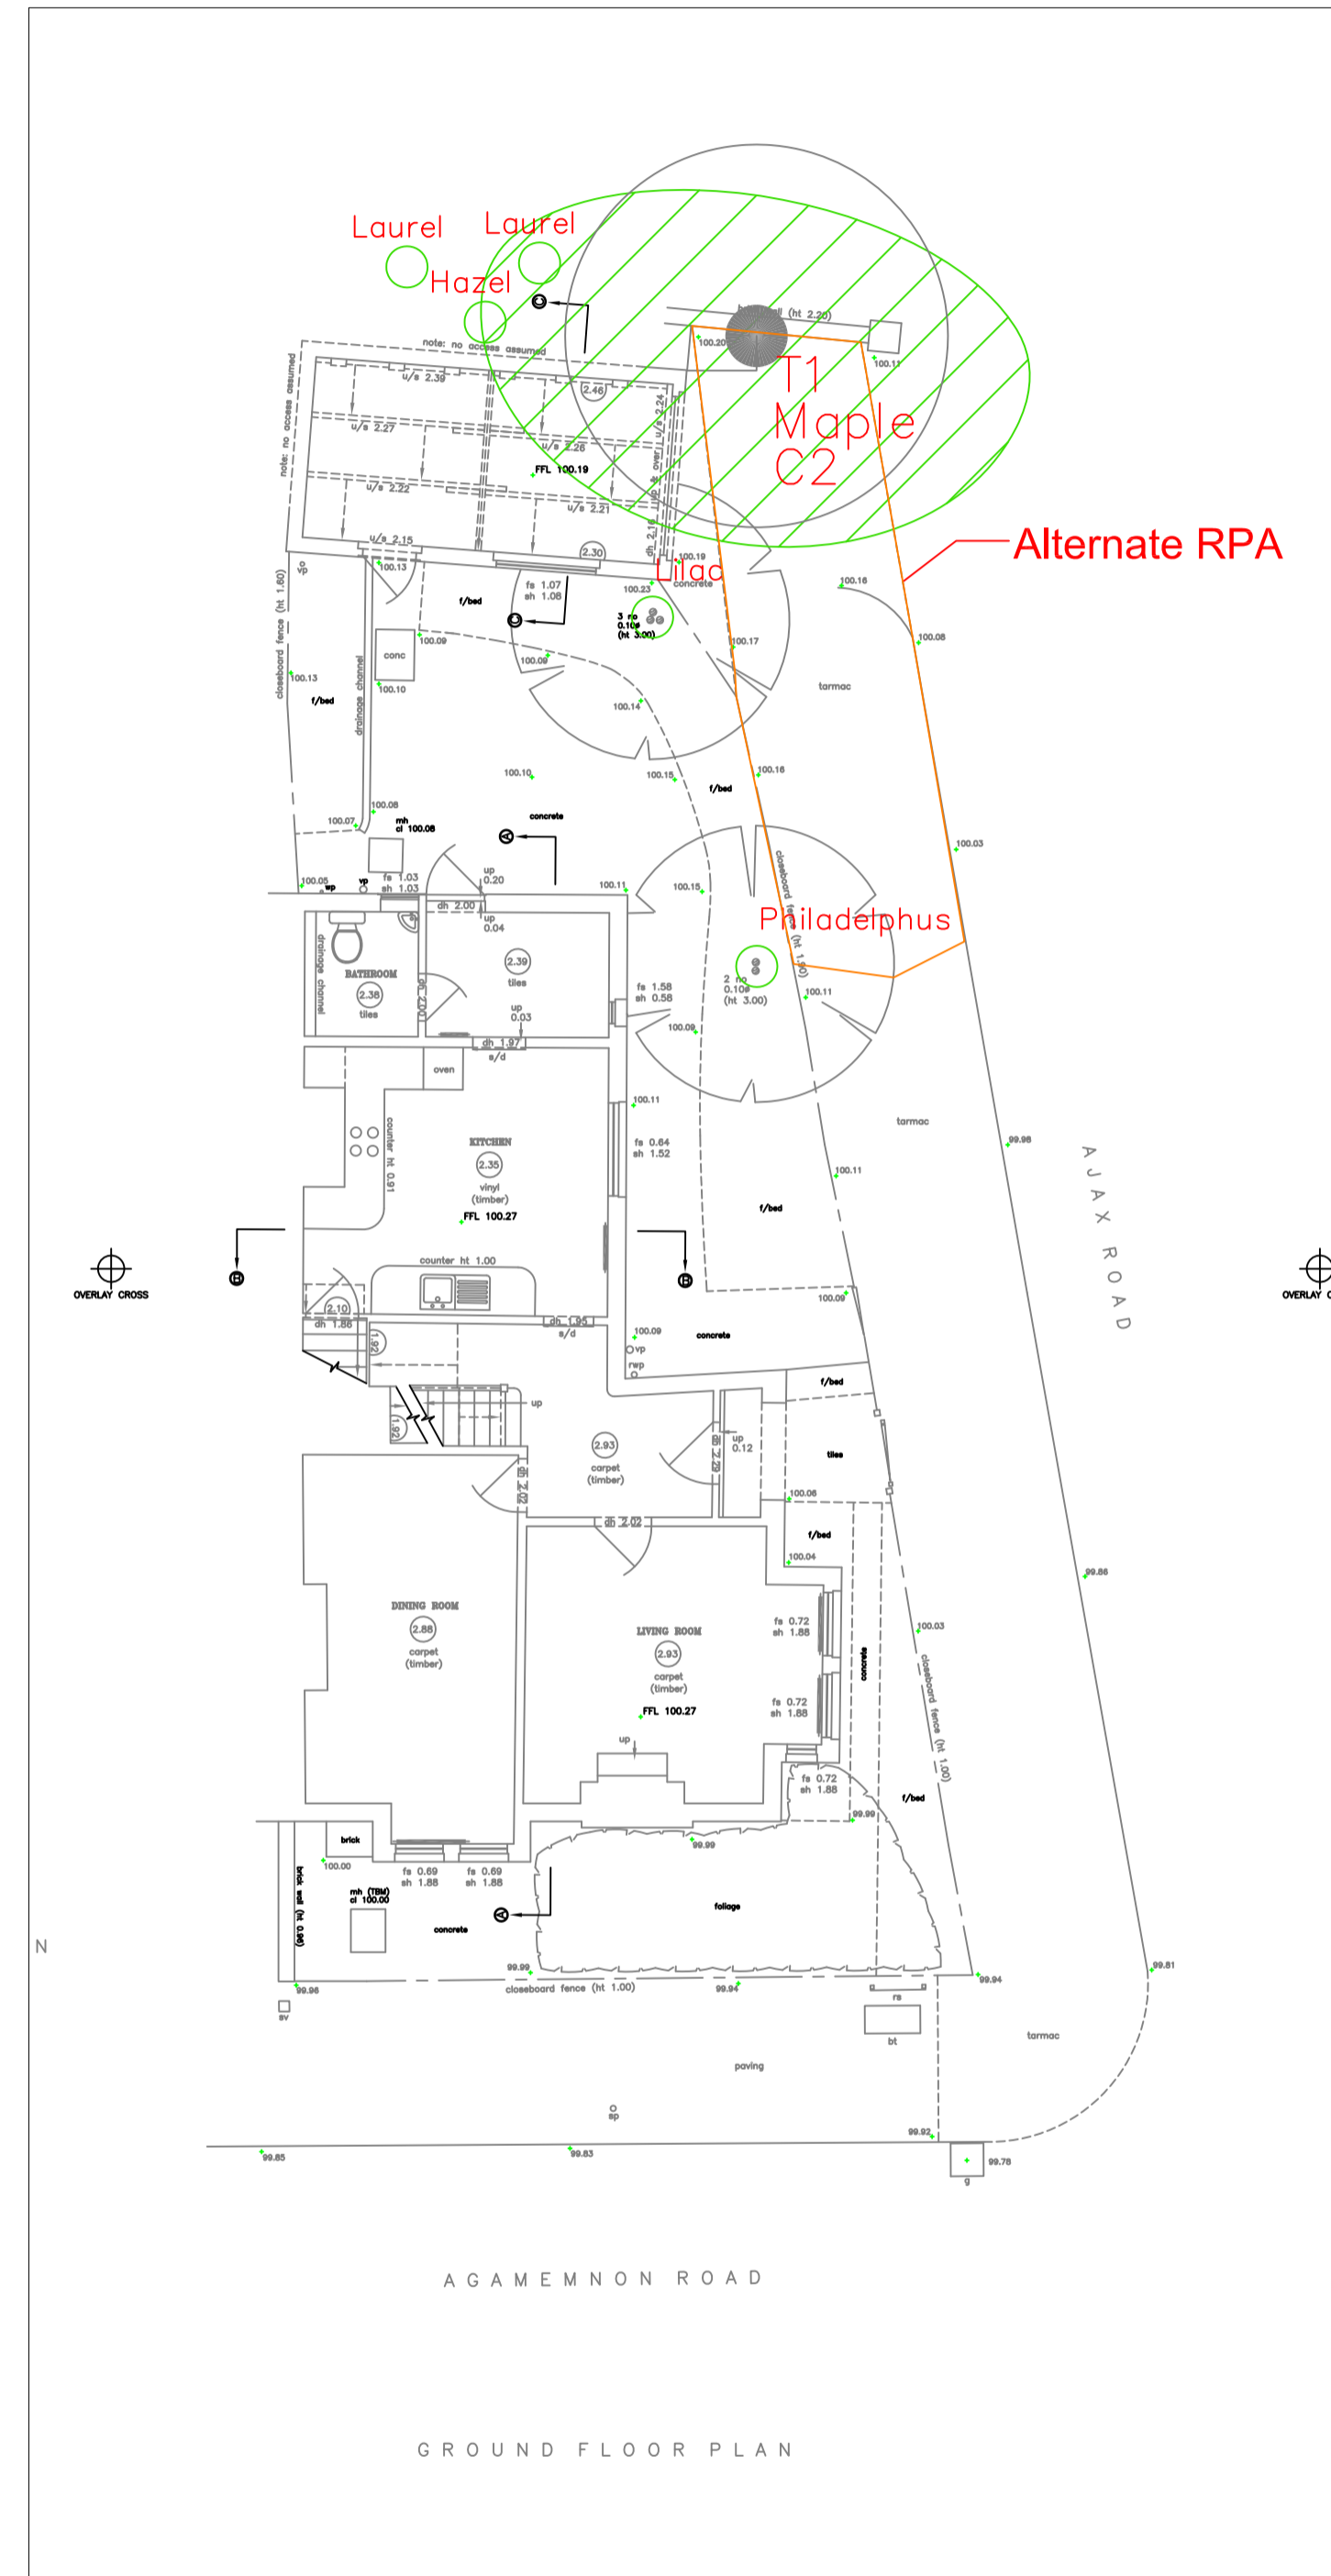
TREE CONSTRAINTS PLAN

3.2.1 Only 1 tree on or adjacent to the site comprises a planning constraint, the C category *(Low Quality), semi-mature Norway maple located beyond a Victorian brick wall.

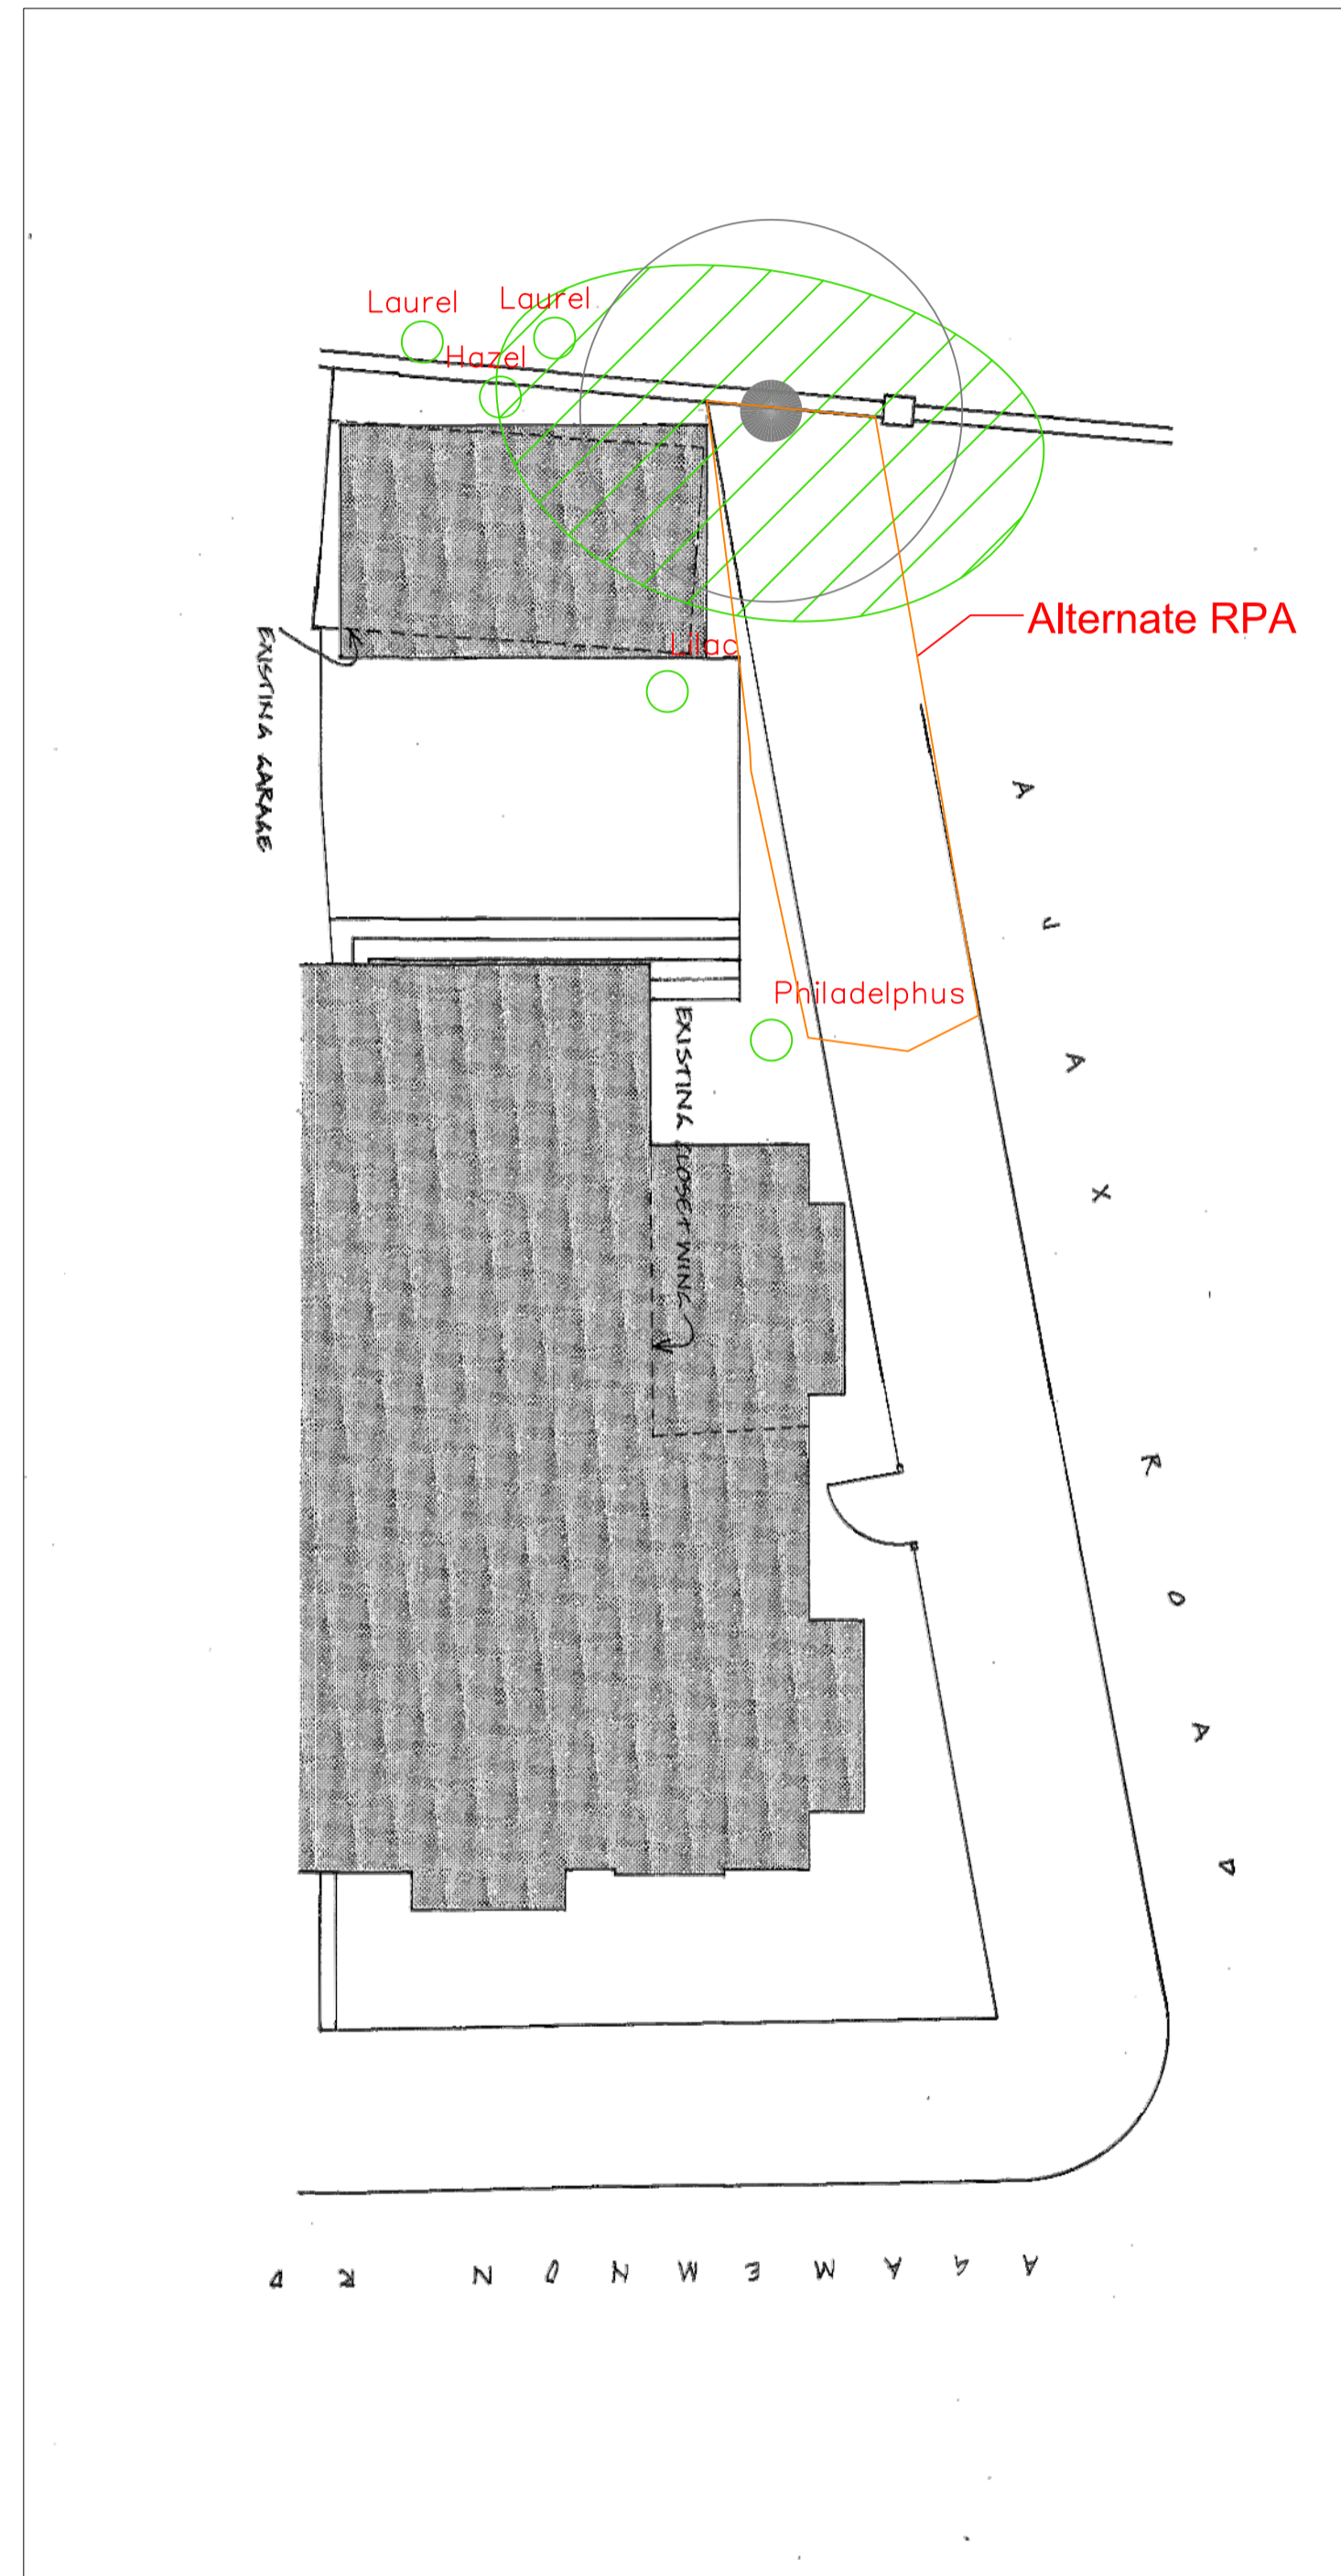
ARBORICULTURAL IMPACT ASSESSMENT PLAN (S)

- 6.1.1 Following the modification of the RPA of T1 as per paragraph 4.6.2 of the British Standard, there is no encroachment by the proposals and thus only theoretical impacts to the tree. Trial pits can of course be provided to confirm this hypothesis, but given the low quality of the tree and likely influence of the existing structures, we suggest instead manual excavation of the first 700mm of the nearest corner footing at the time of construction.
- 6.1.2 The lowering of the floor level of the new garage significantly lessens the need to crown raise / cut back the canopy of T1, any minor facilitation pruning will be of negligible impact provided it is carried out in accordance with good arboricultural practice.

- 7.1 The potential impacts of development are very low, there is no encroachment of the modified RPA of the only tree to form a planning constraint and no tree removal is necessary to facilitate the proposals.

6.3.2 The path of foundations through the conventional RPA will be manually excavated to 750mm depth under arboricultural supervision; any roots encountered within the trenches / pits will be cleanly pruned back to an appropriate junction with a sharp pruning saw or secateurs back to a junction. Roots larger than 25mm diameter may only be cut in consultation with an arboriculturalist.
