21<sup>st</sup> December 2017

### Tree Works Notification

#### Site: Land at 39 Priory Terrace, London NW6

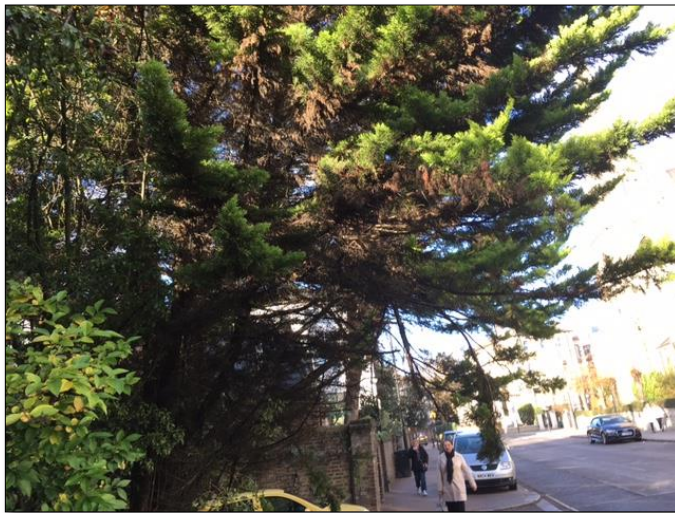
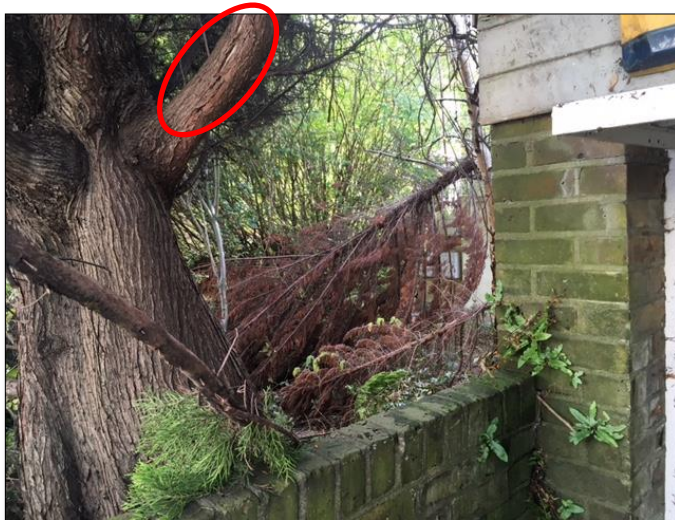
1. As is quite common with mature Monterey Cypress, the subject tree is suffering the effects of *Coryneum* canker (causal fungus *Seridium cardinale*). The fungus, possibly spread by insects and birds, kills the bark around the branch or shoot, causing the foliage to die off and which in turn leads to the death of the branch. The browned foliage hangs on, adding weight to the dead branch causing them to break in windy weather. This is not only ugly but hazardous when the branches are near to public highways or other property. There is no cure for the disorder, which spreads slowly throughout the tree continually reducing visual amenity and eventually killing the whole tree.

2. The weight of Monterey Cypress foliage is considerable and in windy conditions, the branches are susceptible to developing cracks (longitudinally) and splits as has occurred in several locations on the subject tree. The branches tend to twist and break, especially under added weight of snow or even rain.

3. The tree possesses a large, cankerous wound upon the main stem (south side), which is a structural weak point upon the tree. Although unlikely, in my view, to break off at this point, the reduces the tree's ability to take up and distribute moisture and elements efficiently from the soil, causing stress throughout the tree and which predisposes it to further infections and disorders as described. The stressed tree system is less capable of containing the spread of aggressive and pathogenic fungal colonisation. The prospects of the tree surviving in a safe and attractive condition are negligible.

4. The tree is growing extremely close (1m) to boundary walls and a set of single-storey garages, which display symptoms of damage and distortion. It is possible that the growth of this tree and the action of its roots, have caused damage to occur to the garages either by directly impacting upon the structures or by indirectly reducing soil volume supporting the foundations.

Fig. 1 and 2 – Dead and dying branches and cracks (circled) in main branches; leaning stem with decay, close to distorted structures

Sp6. Felling involves the careful removal of a tree to ground level (or other specified height), either in sections or in one unit (straight felling). The method of felling will be suited to the constraints of the site and judged by the competent operator undertaking the task. Removing the stump may be part of the requirements and this will be carried out using a mechanical stump grinder where accessible.

5. In summary, the tree is suffering a number of disorders, which are significantly affecting the tree's amenity contribution and physical structure. There is a negligible prospect of tree improvement. Pruning the tree will reduce tree vitality further and aggravate pre-existing conditions. The tree may be associated with local structural damage and its removal will eliminate the risk of damage or injury caused by falling branches and any effect it may be having upon local structures.
