EXISTING SECTION

CLIENT Venoru Ltd	
PROJECT 49 Marchmont Street, WC1N 2AN	
DRAWING EXISTING SECTION	
DRG. No 09	REVISION A
SCALE 1:50 @ A3 PAPER	DATE 16 Jan 2018

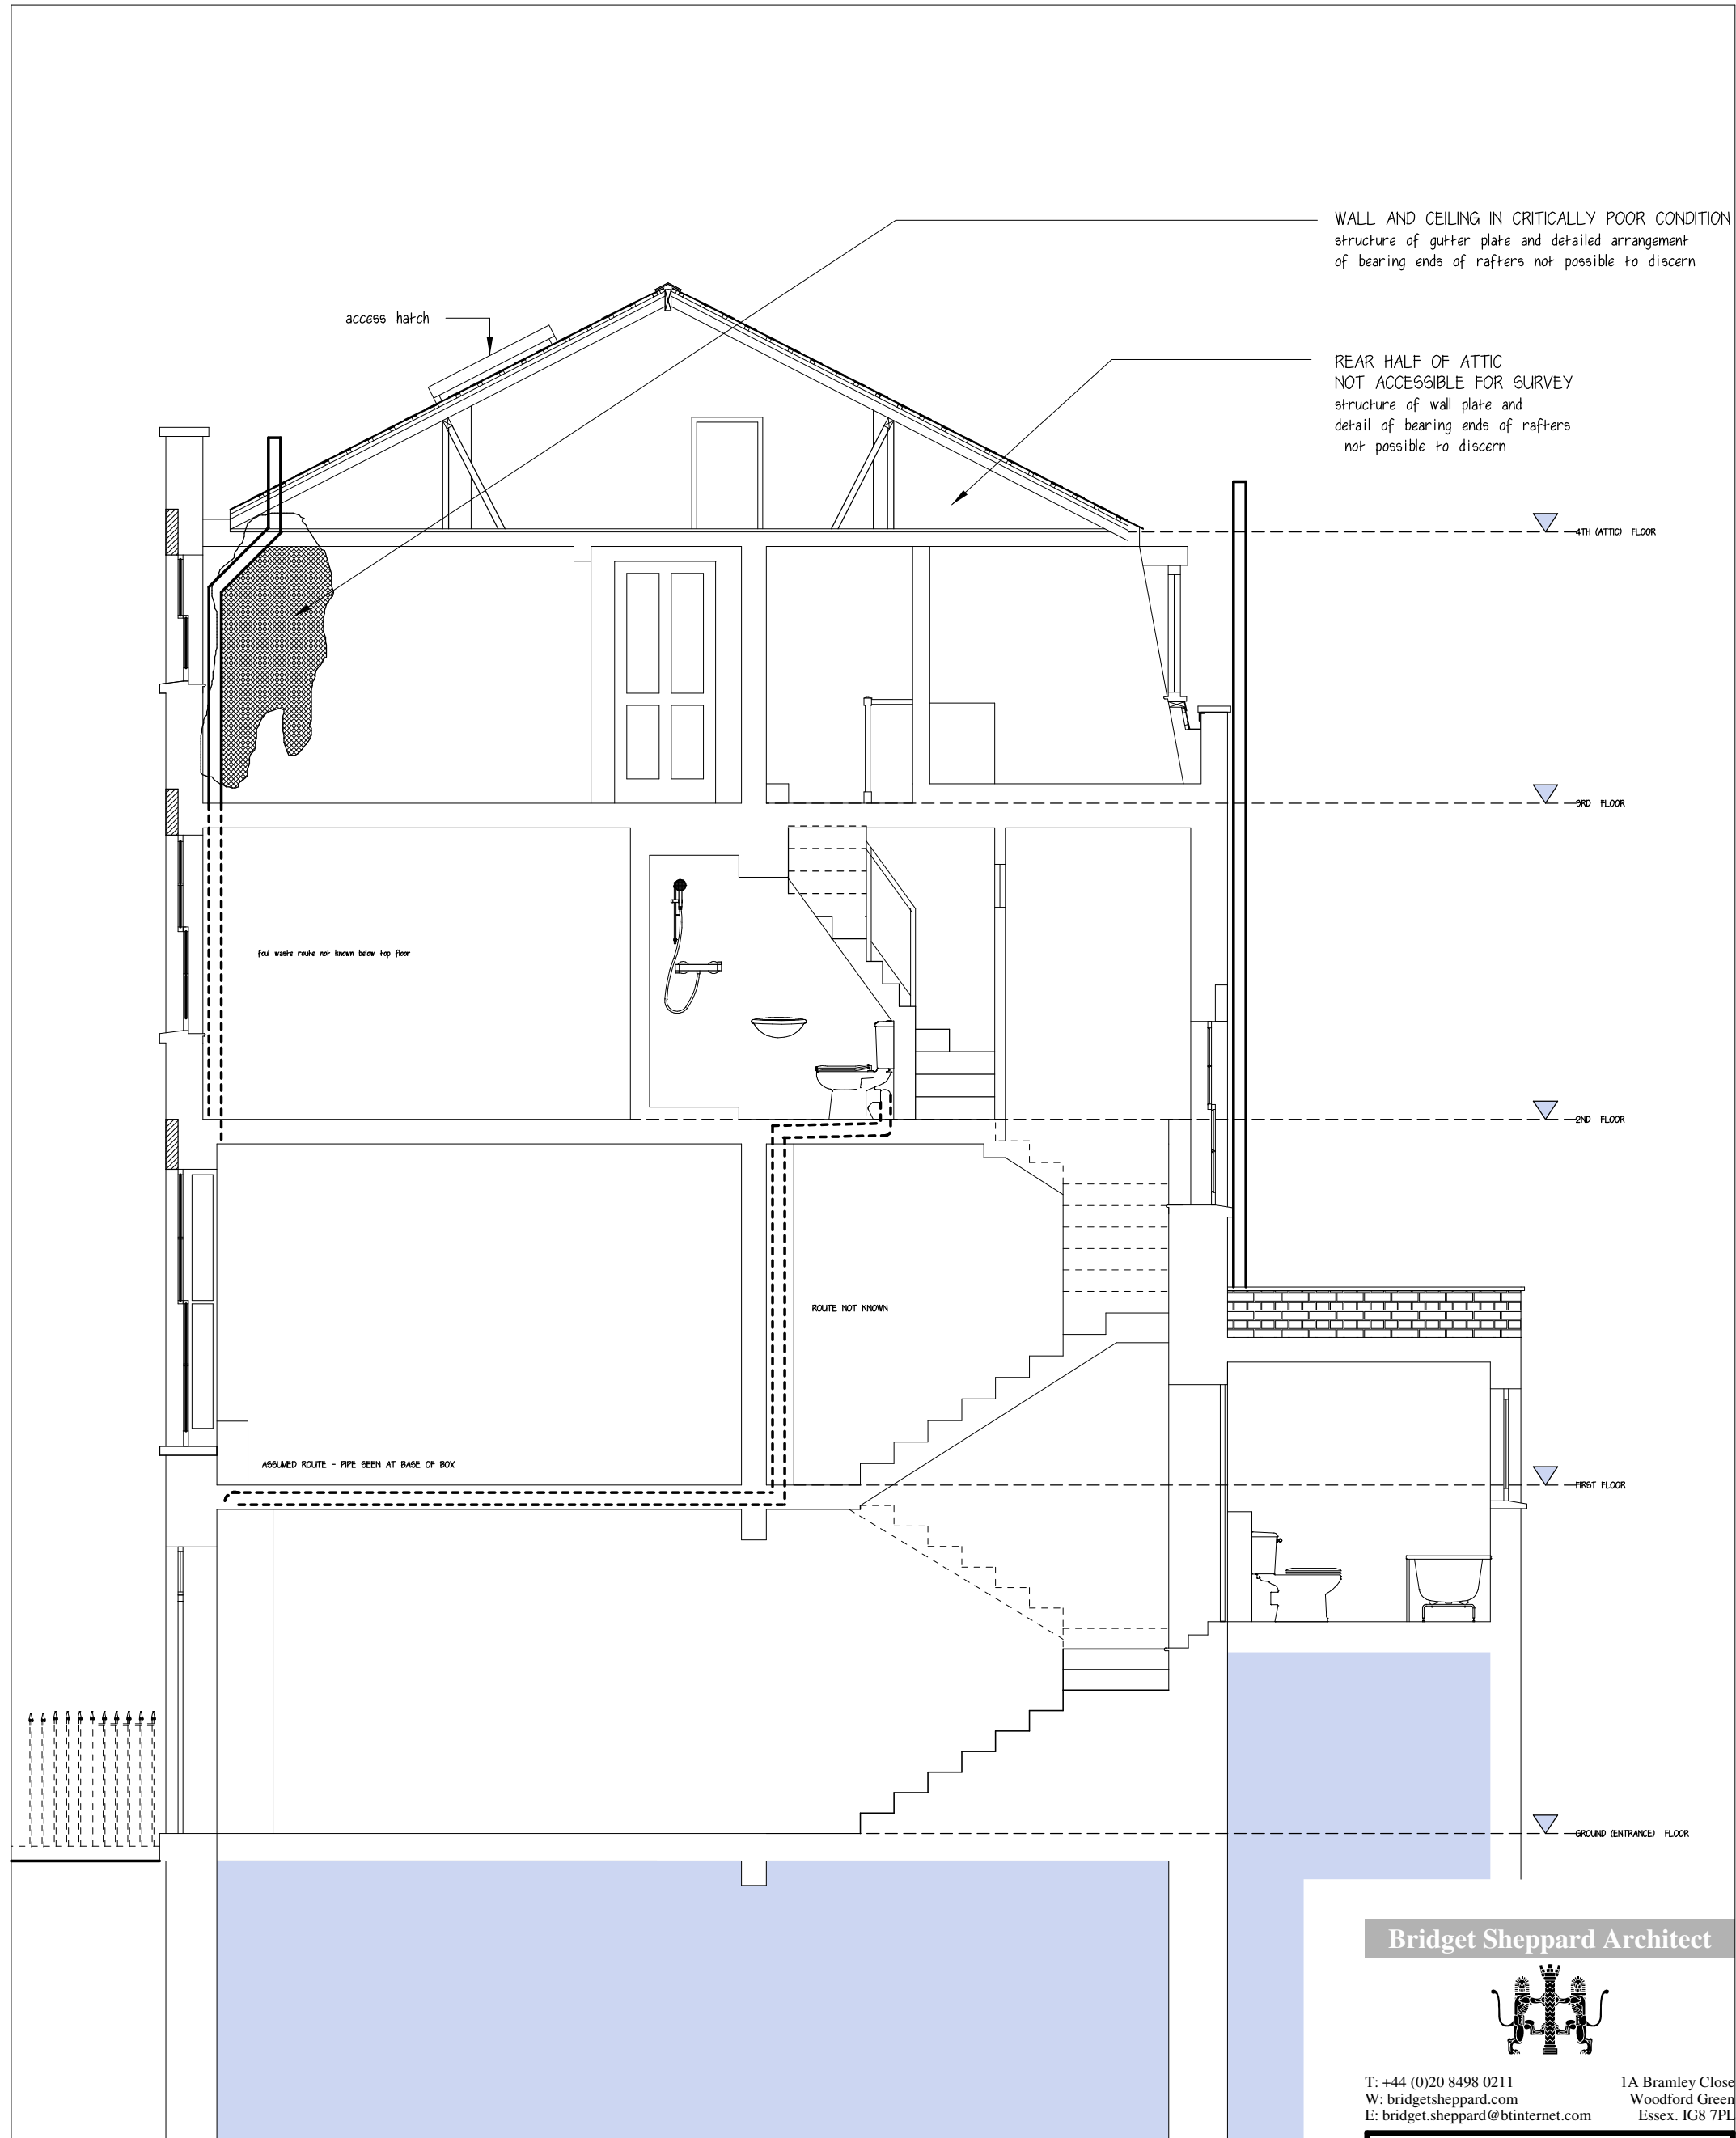
WALL AND CEILING IN CRITICALLY POOR CONDITION
 structure of gutter plate and detailed arrangement
 of bearing ends of rafters not possible to discern

REAR HALF OF ATTIC
 NOT ACCESSIBLE FOR SURVEY
 structure of wall plate and
 detail of bearing ends of rafters
 not possible to discern

FOUL WASTE ROUTE NOT KNOWN BELOW TOP FLOOR

ROUTE NOT KNOWN

ASSUMED ROUTE - PIPE SEEN AT BASE OF BOX
