## ARBORICULTURAL IMPACT ASSESSMENT REPORT & OUTLINE

8 Prince Albert Road  
Camden  
London  
NW1 7SR

Ref: NLP/8PAR/AIM/01a

Date: 3<sup>rd</sup> February 2017

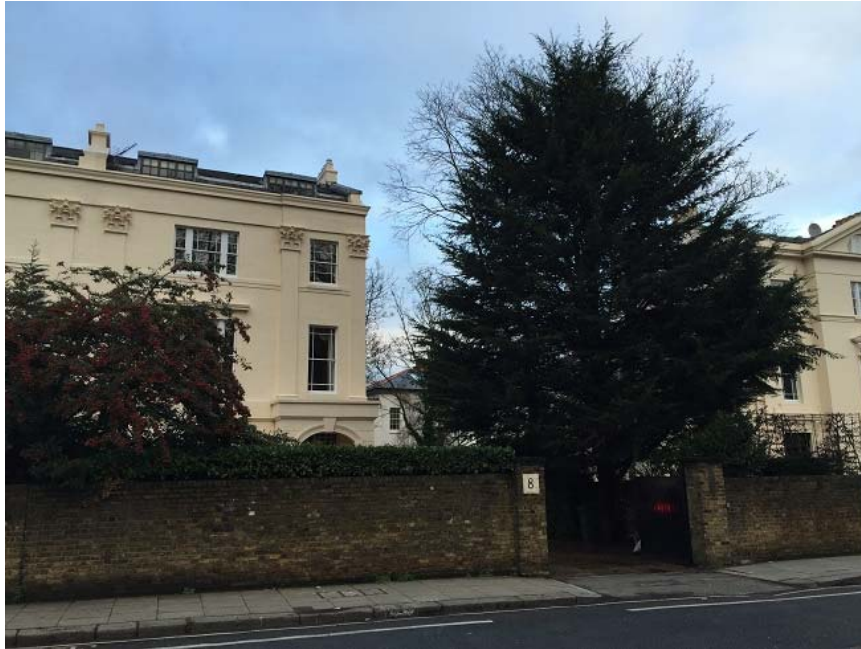
Photograph 1: 8 Prince Albert Road, Camden, London NW1 7SR

| 3.1.2 | The gardens slope downward from street level at the side of the existing building and there are a series of retaining walls and steps down this slope. |

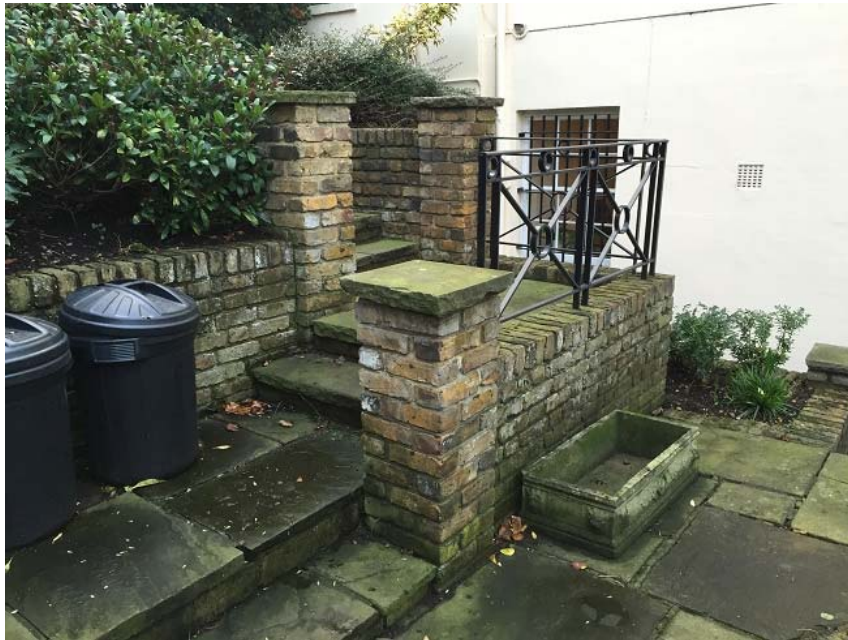
6.1.1 The principal impacts in the current proposals comprise the encroachments of the theoretical RPA of trees T5 (12%) and T6 (4.2%) by the lower ground floor extension. Whilst these impacts, particularly to T5, are potentially moderate in theory, the existing level changes and built infrastructure will have acted to significantly inhibit the development of roots by both trees into the likely proposed footprint (see Photograph 2 below).

6.1.2 Whilst it is feasible that some roots have undermined the boundary wall and retaining walls present and will be affected by the proposal, this likelihood is remote. Notwithstanding this, mitigation of the hand excavation of the top 750mm of the line of the foundations where they pass through the RPAs and pre-emptive pruning of any roots discovered is proposed.

Photograph 2: Level changes and hard landscaping between T5&6 and likely footprint

6.3.2 The path of foundations through RPAs will be manually excavated to 750mm depth under arboricultural supervision; any roots encountered within the trenches / pits will be cleanly pruned back to an appropriate junction with a sharp pruning saw or secateurs back to a junction. Roots larger than 25mm diameter may only be cut in consultation with an arboriculturalist.
