133 Arlington Road London NW1 7ET

Ref: 17110

Site Visit Date: 10th Jan 2018 Report Date: 24th Jan 2018 **CONSULTANTS**:

Duramen Consulting *Consulting Arboriculturists*Unit 2 Brenchley Mews
Charing, ASHFORD,
Kent TN27 OJW

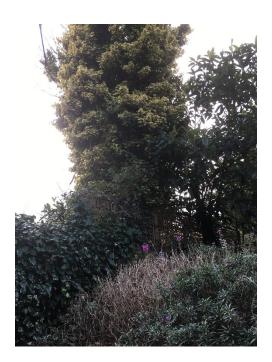
Photo 1: Showing T1 from the sunken patio of No 133.

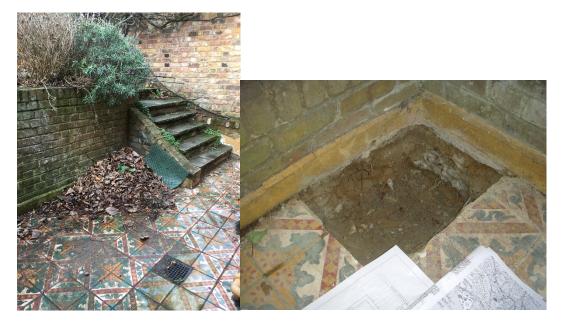
6.4 The absence of significant roots at the level of the existing patio was confirmed by the digging of Trial Hole 1 ² pictured below. Trial Hole 1 had no significant roots present, confirming that the proposed basement extension into this area will have a minimal impact on T1.

Photo 2 (left): Showing the steps leading up from the patio to the level T1 is growing on, and shows the patio retaining wall.

Photo 3 (right): Trial hole 1 which was dug in the corner of the patio closest to T1, showing no significant roots present.

- 6.5 The proposed building line is not anticipated to go beyond the patio's retaining wall (photo 2). However, significant roots of T1 (given the size of the RPA) could be present behind this wall and may hinder excavation during construction if excavation had to be extended behind it. There may also be future structural implications as well.

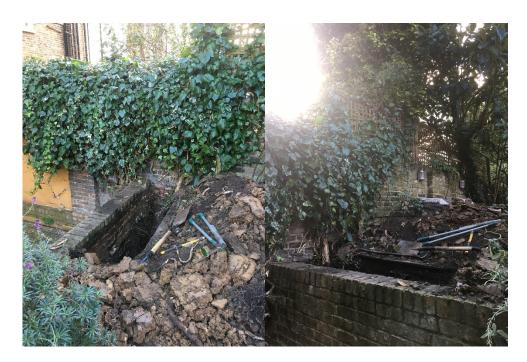
- 6.6 In order to clarify root distribution a second trial hole was dug behind the patio retaining wall stretching as far as the boundary wall. This established the level of the footings of the boundary wall remaining at the same level as seen at the side of the patio, despite the changing of levels of the garden. From the patio, the wall is visible from footings (at the same level as the patio) to top. As the garden rises in ground level it was possible that the wall foundation might have been shallower further along the garden, and that the soil level had simply been raised up against it.

Photo 4 (left) and Photo 5 (right): showing the size and positioning of Trial hole 2 (its position is shown on Figure 1 – Tree Constraints Plan - in section 9 of this report).

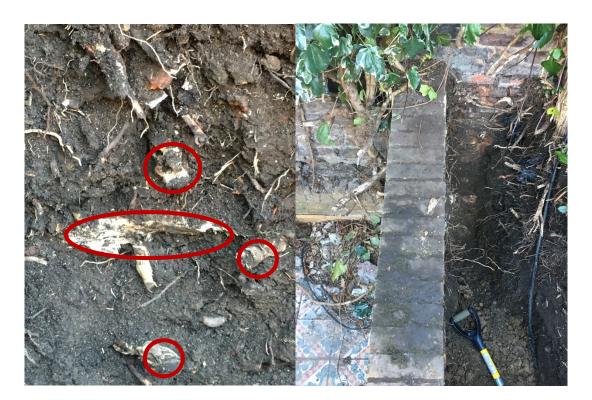
6.7 Trial Hole 2 determined that the boundary wall continued at the same level along the extent of the boundary in spite of the changing levels of the garden. However, it appeared that one root from T1 had grown through the mortar between bricks, though it only seemed to extend a short distance (approx. 10cm) into site. Five other significant roots from T1 were found within the trial pit, but they did not extend as far as the retaining patio wall. Thus T1's roots were present onsite, but not in significant number, and far fewer than might have been suggested by a simple circular RPA as defined in British Standard 5837. See photos 6-8 below for further information.

Photo 6 (above left): Some of the roots (in red circles) from T1 found during the excavation of Trial Pit 2. The root coming down from the top of the picture was from mature ivy.

Photo 7 (above right): Taken from above the patio retaining wall with the boundary wall at the top of the photo. T1 lies beyond the boundary wall and the top right-hand corner of the photo. Note the continuation of the boundary wall along the site, essentially forming an underground root barrier for T1. The roots seen in the middle right of the picture in higher quantity are from the mature ivy, the thick stem of which is just visible in the top right edge.

Photo 8 (left): One root from T1 was found growing through the weakened mortar in the wall (in red circle), highlighting that the wall is not providing a completely impermeable root barrier (as evidenced by Photo 6). As in Photo 7 as other roots are clearly able to extend into the site. The roots in the right hand side of the picture originate from the adjacent mature ivy.

- 6.8 The conclusion with regards to T1, is that despite the large theoretical Root Protection Area, the roots do not have a significant presence in the area of the proposed basement extension. However, should excavation be required beyond the patio retaining wall, it has been established that some roots are present and therefore care should be taken. The establishment of roots being onsite will also have to be considered during the proposed re-landscaping works. Further details of correct working methodology for working within the Root Protection Areas of retained trees can be provided within an arboricultural method statement.

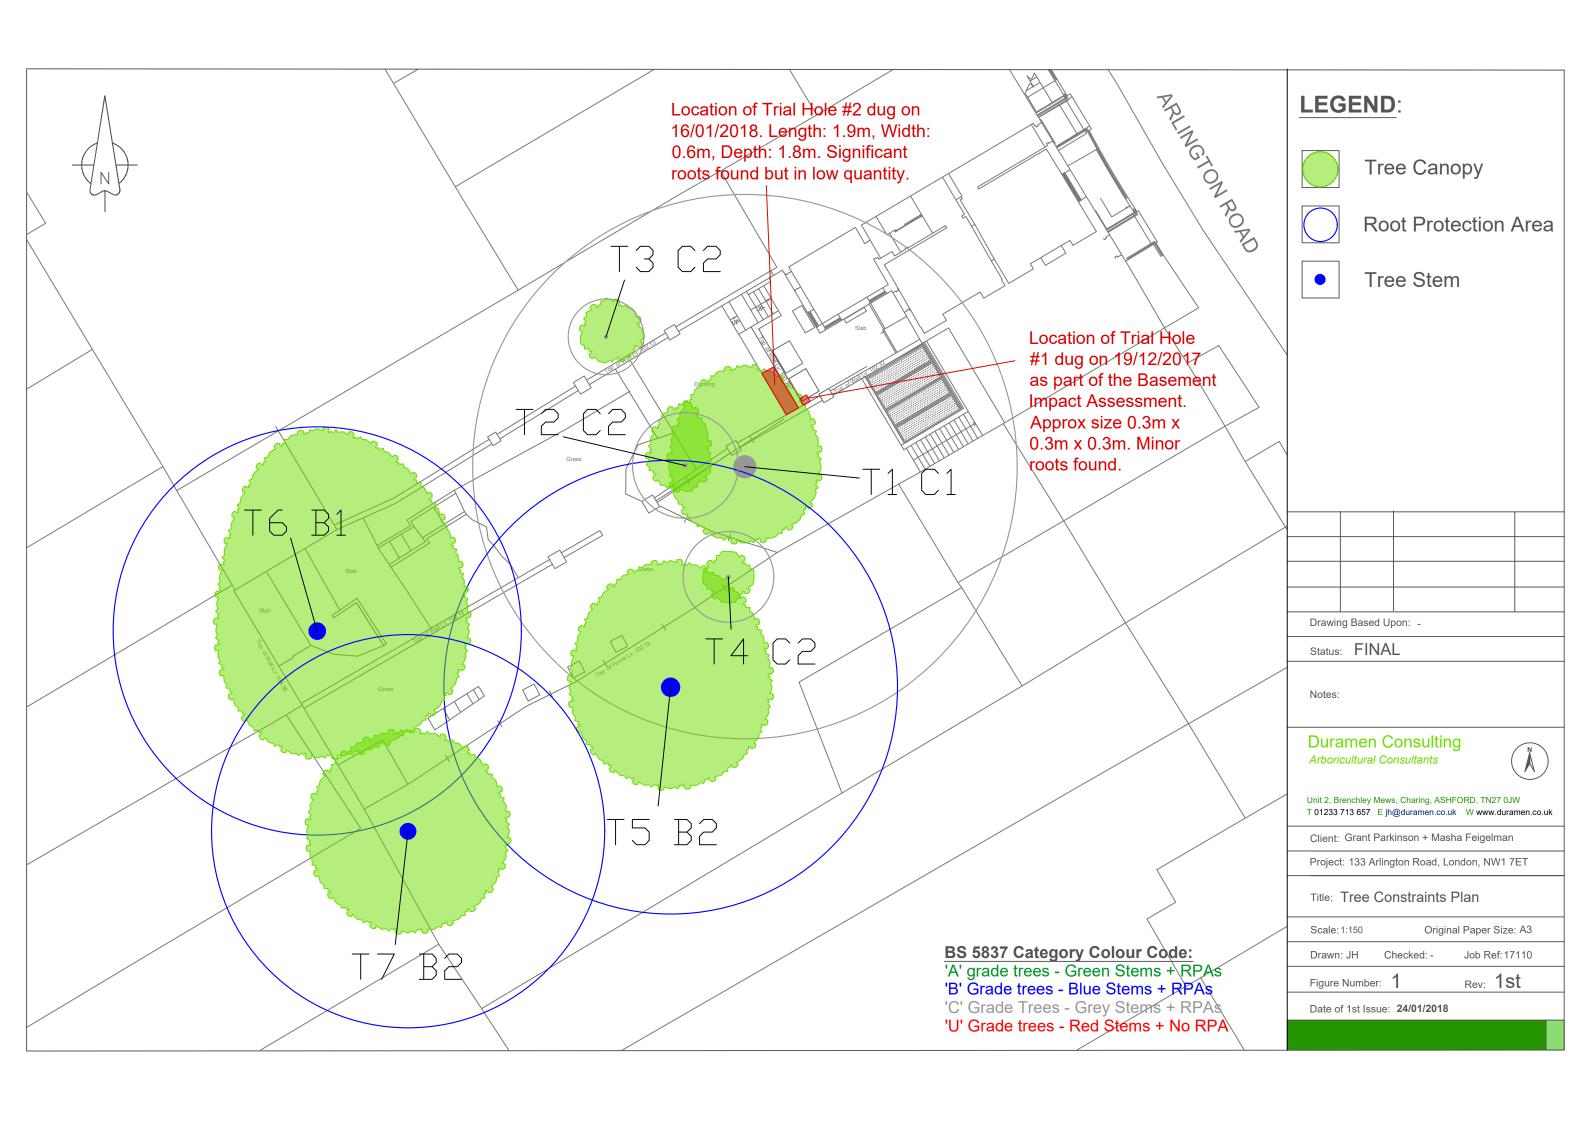
9 Tree Constraints Plan (Figure 1)

- 4.1 Seven individual trees were surveyed and are the subject of this report. Details of the trees are provided in Appendix 3 to this report. Their locations are shown on Figure 1 Tree Constraints Plan in section 9 of this report.

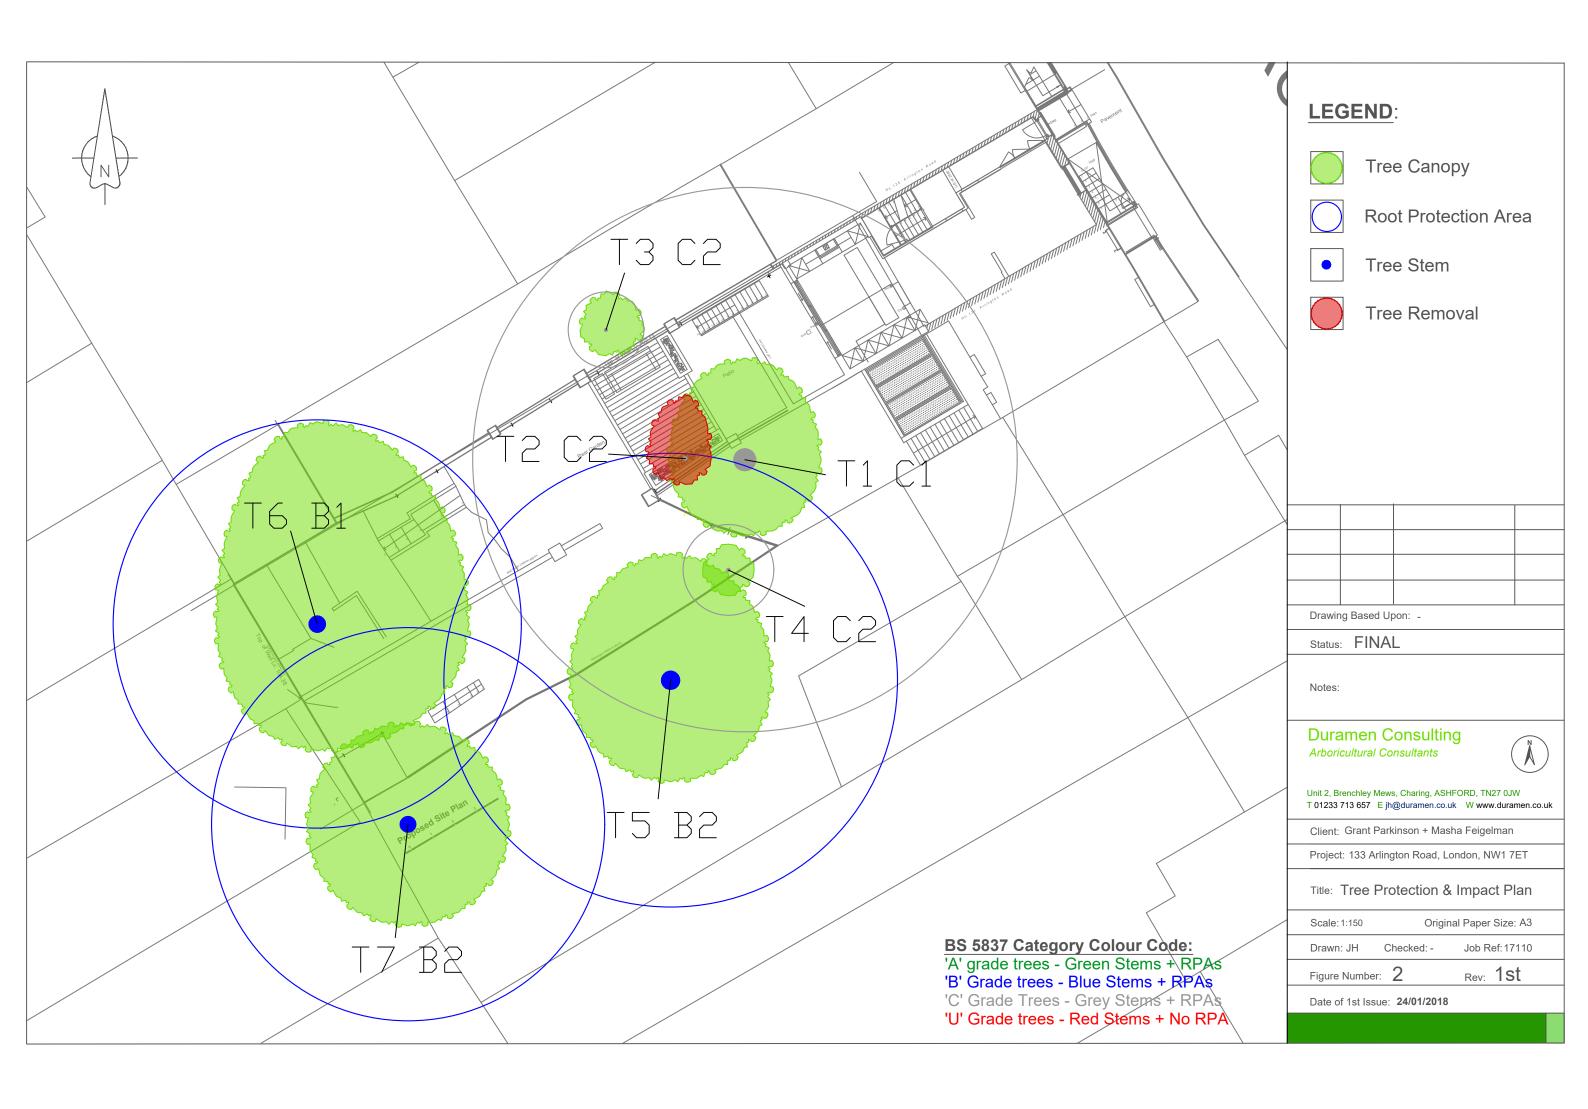
10 Tree Impact & Protection Plan (Figure 2)

- 7.1 A Tree Protection & Impact Plan is provided as Figure 2 in section 10 of this report. The plan shows trees to be retained, removed, areas where tree protection is required and areas where a more detailed arboricultural method statement is recommended.
- 7.2 Specific tree protection for this development is not deemed to be required. However it is recommended that the existing decking area in the garden is retained during construction so that it acts as ground protection within the RPA of T1. If the storage of materials or machinery is required in the rear garden it should therefore be places on the decking.
