Landmark Trees

ARBORICULTURAL IMPACT ASSESSMENT REPORT FOR:

33 Belsize Avenue
London
NW3 4BL

Ref: KSR/33BLS/AIA/01a

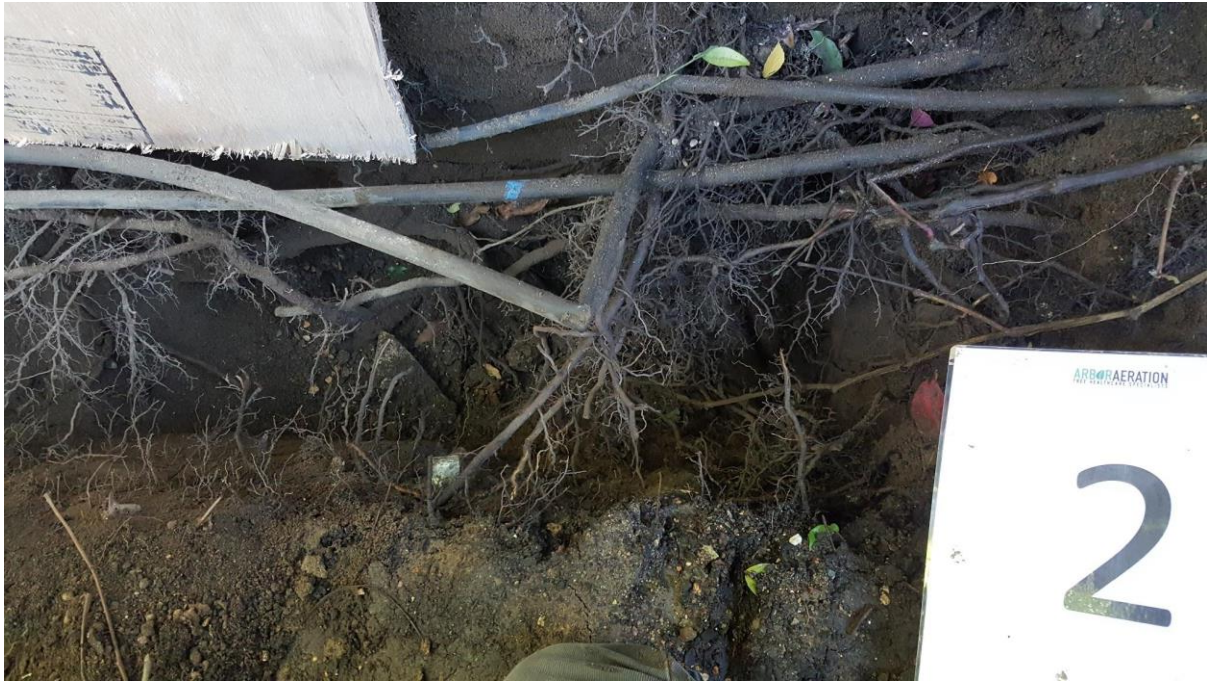
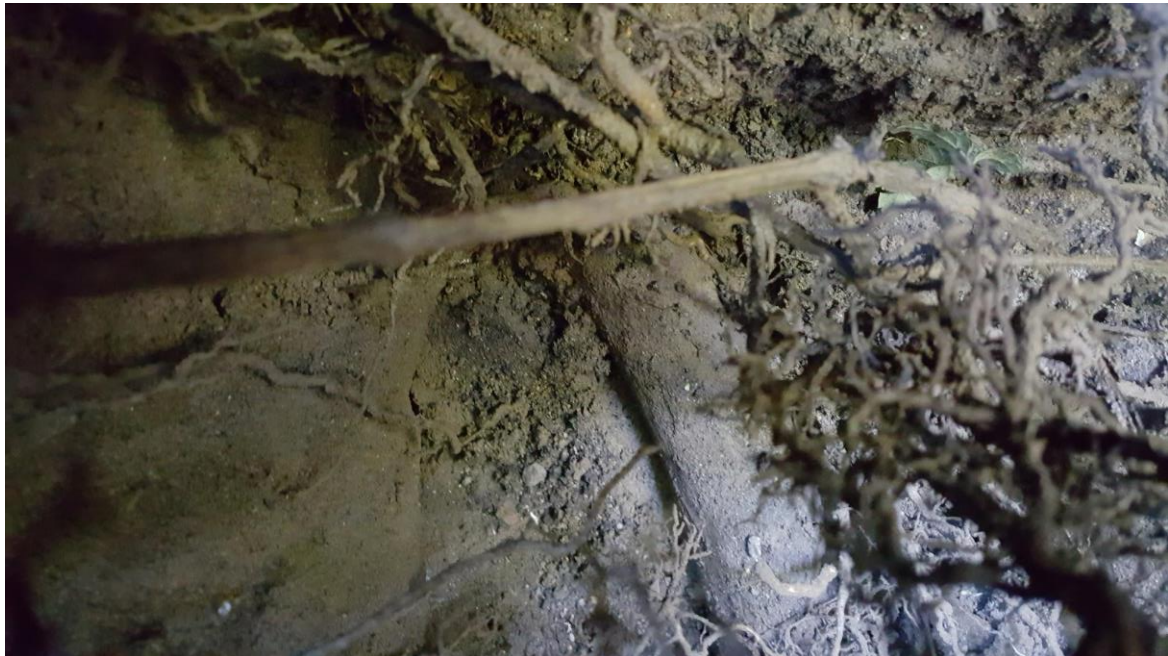
Trial Pit 2

4.1.5 It should be noted that whilst a 70mm diameter root was discovered in Trial Pit 2, this immediately turns at right angles to run parallel to the boundary wall whose footings extend to at least 700mm depth.

Trial Pit 1 was not excavated after consultation.
Trial pit 2 was halted due to the large root at 700mm below surface level and trial pit 3 was added in closer to the centre of the property.

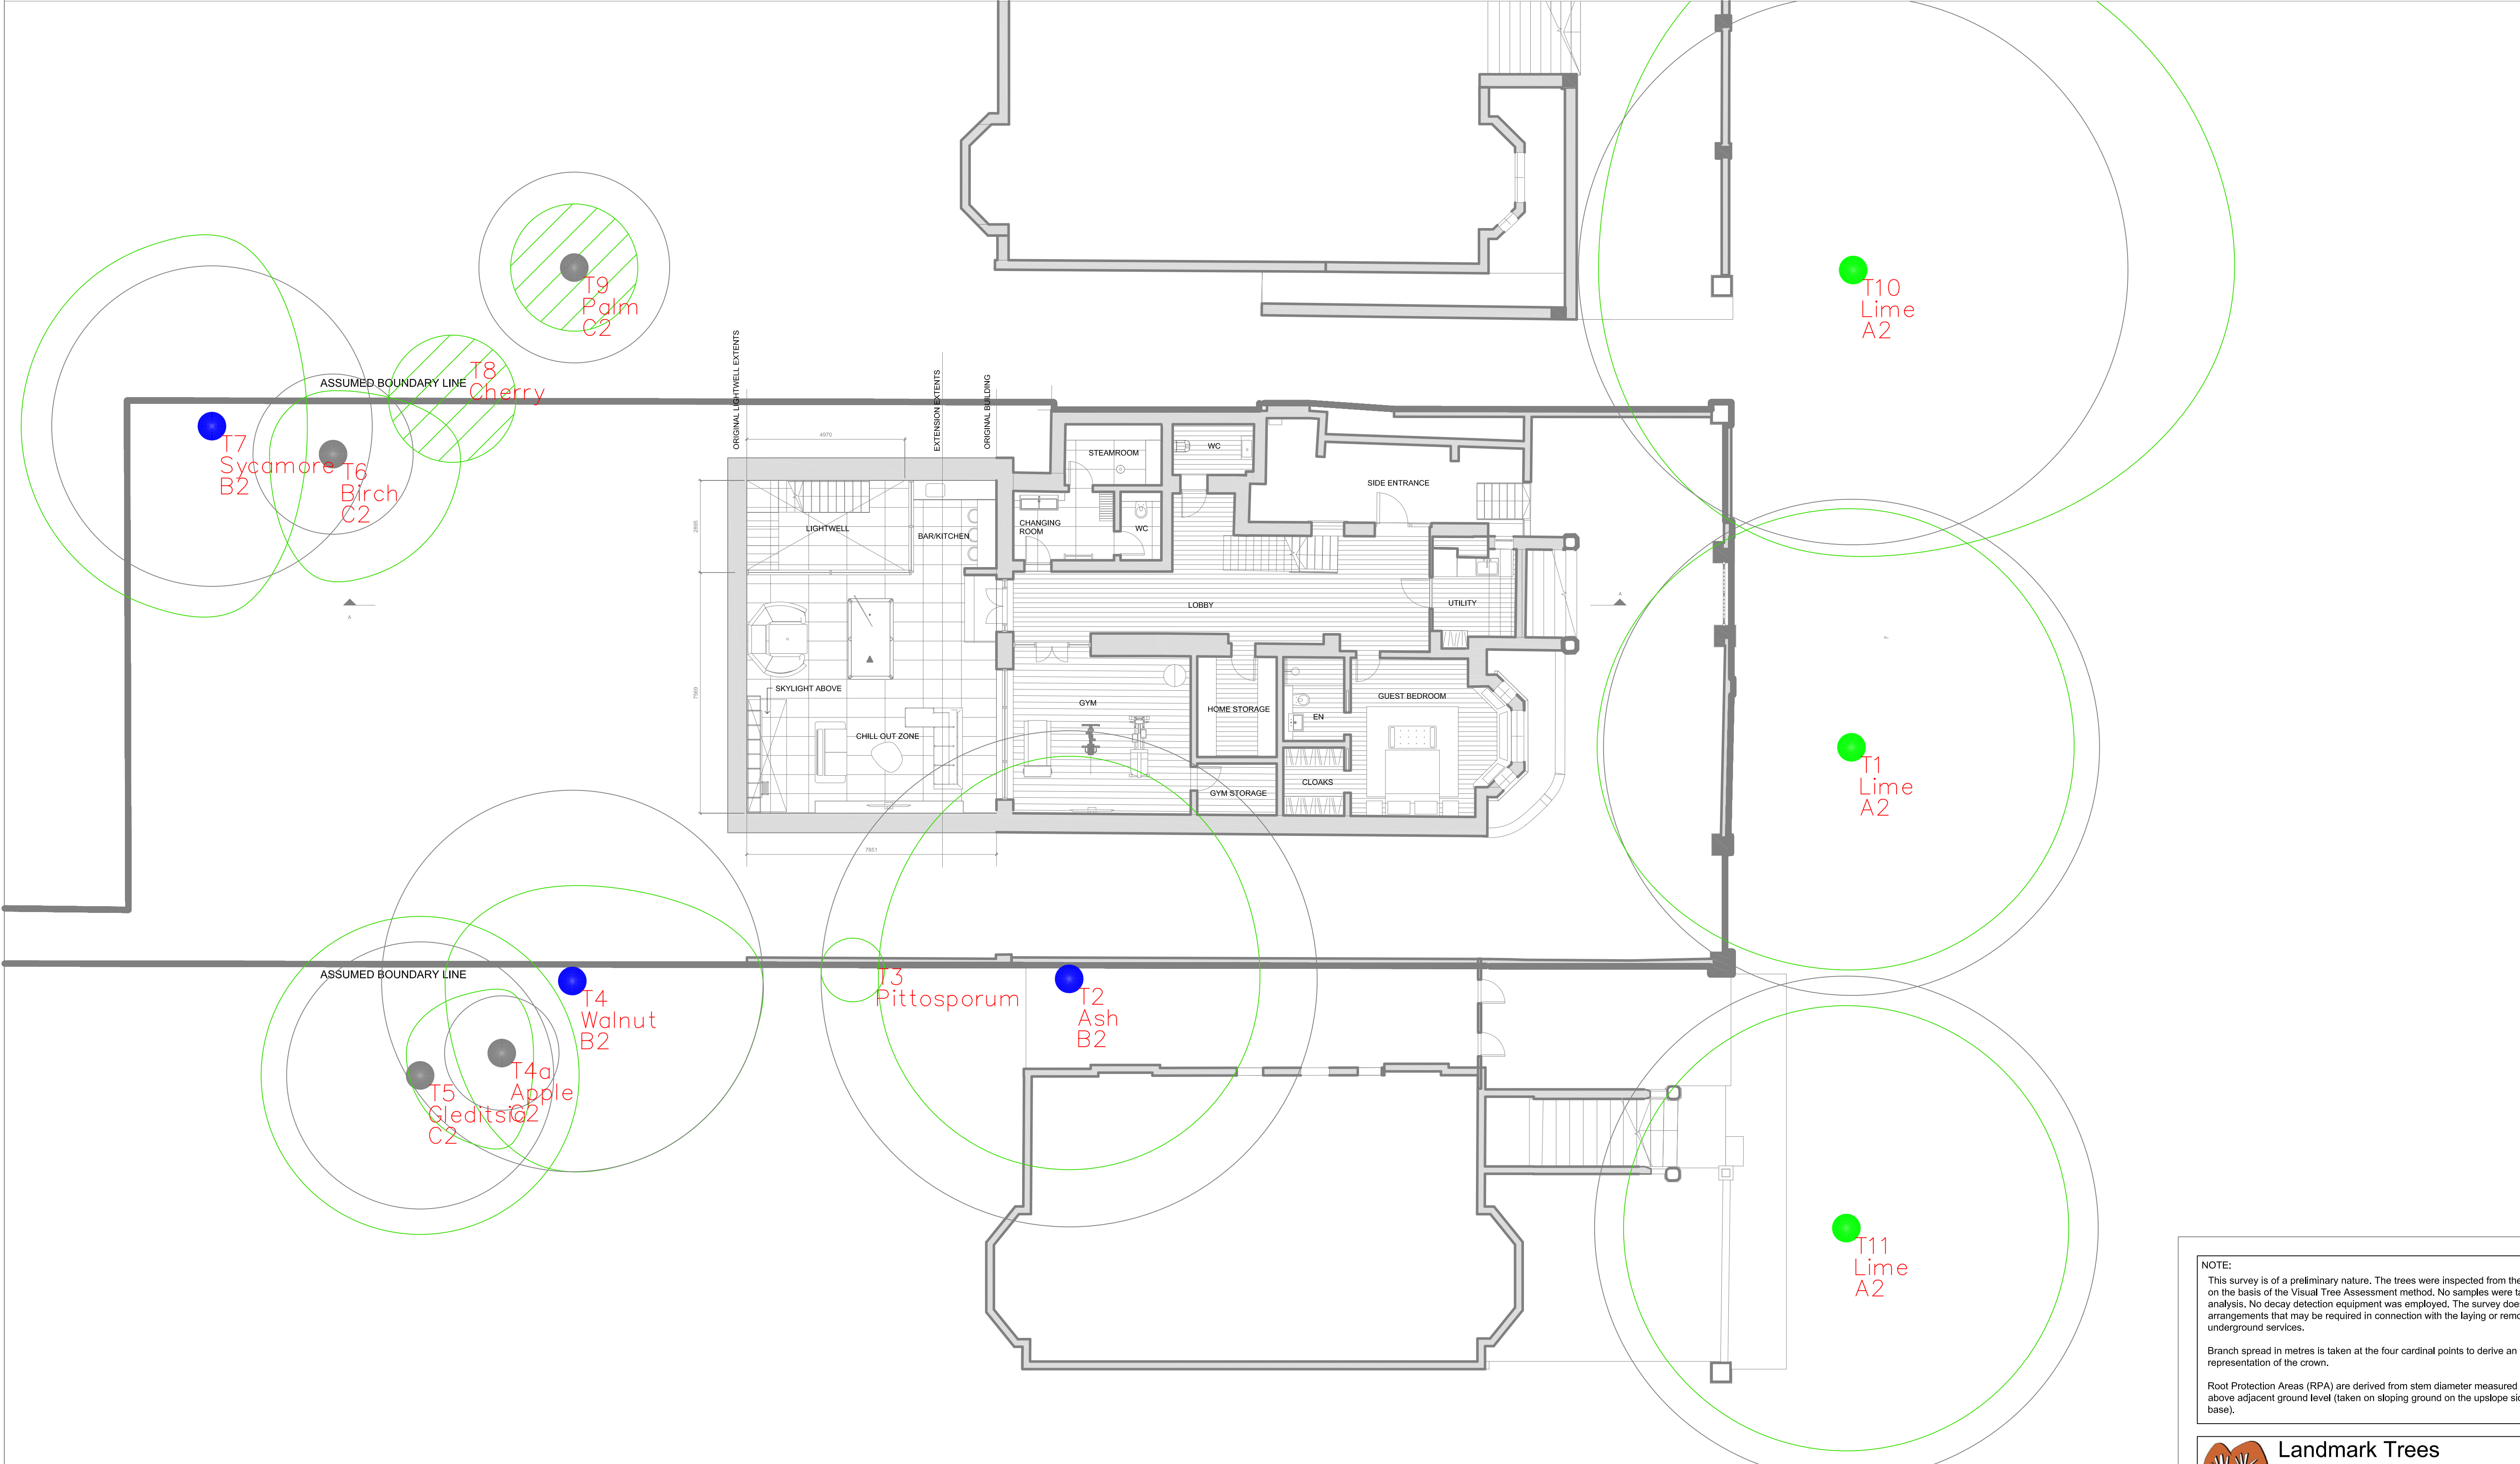
Proposed Lower Ground Floor Plan

6.1.1 The arboricultural impacts of the proposals are theoretical only. Whilst the basement extension encroaches within the conventional, circular RPAs of T2 and the new hard landscaping within that of T4, the existing basement will have prevented root development by T2 into the proposed footprint whilst the trial pit findings indicate no significant rooting by T4 into the footprint. Notwithstanding this, it is proposed as a precautionary measure to manually excavate the top 750mm of the basement line through the conventional RPA of T2 and to manually excavate line of the garden walls within the conventional RPA of T4 in conjunction with pre-emptive root pruning.

6.3.1 The path of foundations through the RPA of T2 will be manually excavated to 750mm depth under arboricultural supervision; any roots encountered within the trenches / pits will be cleanly pruned back to an appropriate junction with a sharp pruning saw or secateurs back to a junction.

6.3.2 The limits of excavation within the RPA of T4 will be undertaken manually; any roots encountered will be cleanly pruned back to an appropriate junction with a sharp pruning saw or secateurs. Roots larger than 25mm diameter may only be cut in consultation with an arboriculturalist.
