TREE PROJECTS

REPORT ON TREES AT

13a Pond Street
London
NW3 2PN

For

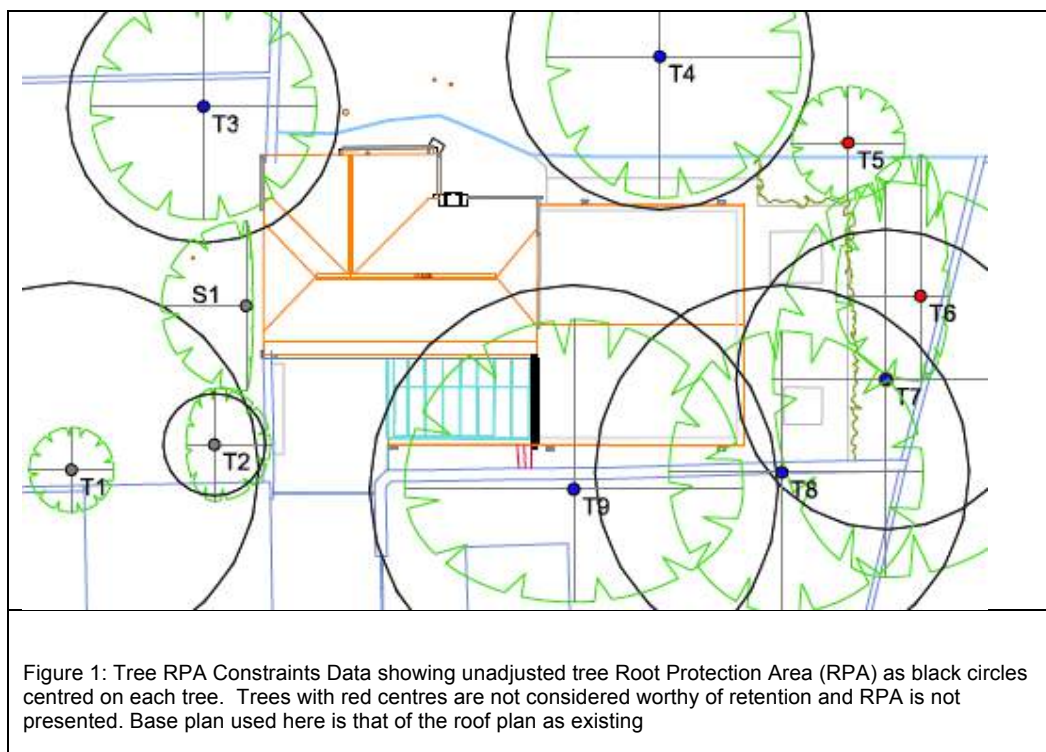
Figure 1: Tree RPA Constraints Data showing unadjusted tree Root Protection Area (RPA) as black circles centred on each tree. Trees with red centres are not considered worthy of retention and RPA is not presented. Base plan used here is that of the roof plan as existing

In respect of this project, RPA has been presented as a circle centred on each tree's trunk. It can be seen (Appendix 2 and Figure 1) that this extends into the site and overlaps parts of the existing buildings footprint. This will be discussed further in this report with more specific reference however suffice to say now that physical impediments to root distribution, such as foundations below ground level, are likely to cause roots to be directed and contained such they do not necessarily occur where the theoretical model suggests.

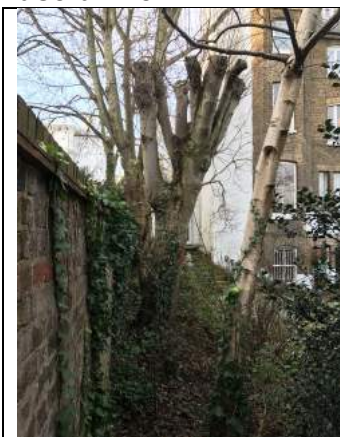
2.2.1 **Tree T1: Sycamore, in poor condition with 10+ years safe useful life.**

Photo 1 T1 Sycamore

Located within the rear garden of 33 Hampstead Hill Garden and probably self-seeded in origin, this tree has relatively recently been lopped to a stout pollard framework. What amenity value it possessed has been lost, and although in time it may re-grow, what regrowth is evident appears to lack vigour. See Photo 1. The proposed scheme will not impact this tree.

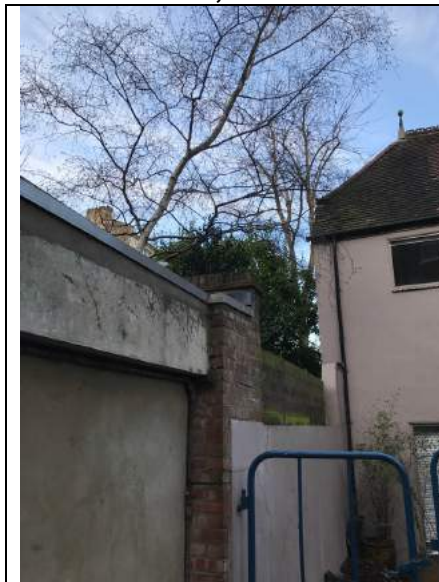
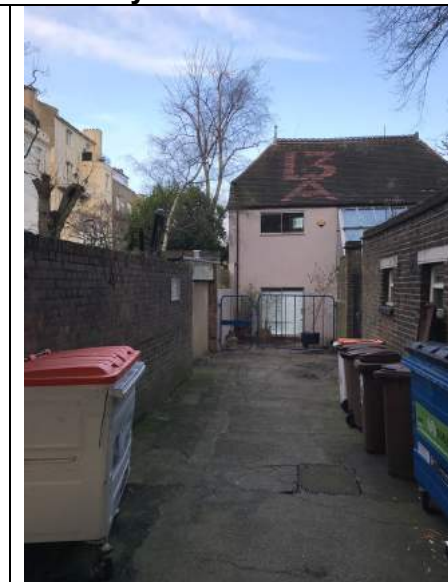
2.2.2 **Tree T2: Birch, in fair condition with 10+ years safe useful life.**

Photo 2: T2 Birch (foreground)

Photo 3: T2 Birch (foreground)

As with T1, this Birch appears to be within the rear garden of 33 Hampstead Hill Gardens. An easterly lean is likely to have developed naturally through light induced suppression when T1 was larger. From our site survey it is estimated that the ground level where the tree is rooted is 1.2m higher than that at 13a Pond Street. The proposal should not have an adverse impact on this tree subject to detailed consideration of boundary wall related works to ensure no harm to roots or, the upper parts where these lean close to the boundary.

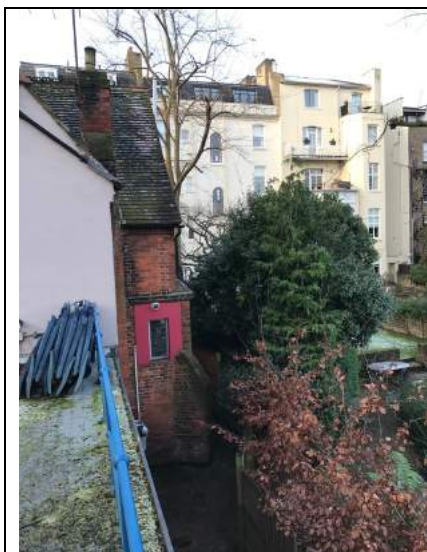
2.2.3 Tree T3: Robinia/ False Acacia. In good condition with 20+ years estimated safe useful life. Tree in background of photo's 2 and 3 and also in photo 4. Appears to be within the rear garden of 33 Hampstead Hill Gardens.

This Robinia was out of leaf during the inspection and so it was not possible to determine if it is the yellow leaved cultivar 'Frisia'. Typically vigorous, this tree has been reduced in the past at approximately 15m and has 3m regrowth. The garden in which it is rooted is some 700mm higher than that of 13a Pond Street. Care will need to be taken during demolition and reconstruction of the boundary wall. In all likelihood the roots of this tree do not extend into site due to the boundary wall and its footings.

Photo 4, T3 Robinia in background: evergreen shrub in mid ground not considered materially significant to the application.

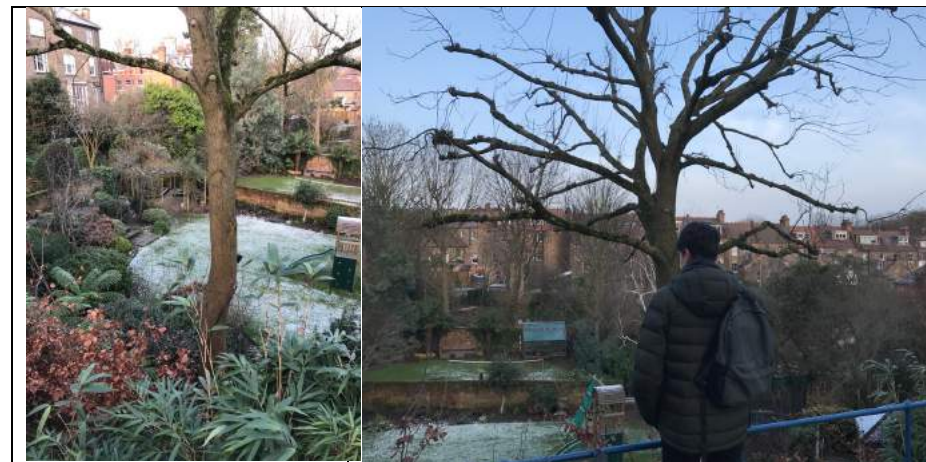
2.2.4 Tree T4, Ash. In good condition with 20+ years safe useful life.

Photo 5 & 5a, T4 Ash

Located in a private garden to the north of the site, this early mature tree has recently been crown reduced. The proposal is unlikely to have any impact on this tree.

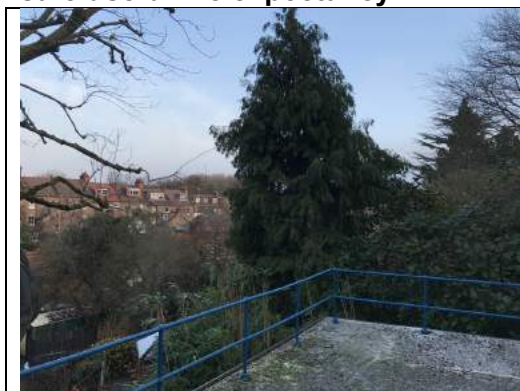
2.2.5 Tree T5, Lawsons Cypress. In poor condition with <10 years safe useful life expectancy.

Located in a private garden to the west of the site this early mature tree divides into two main stems at around 1 m above ground level. The union between both stems appears to be a tight 'compression fork' an accepted weakness at risk of failure. No adverse impacts anticipated.

Photo 6, T5 Lawsons Cypress

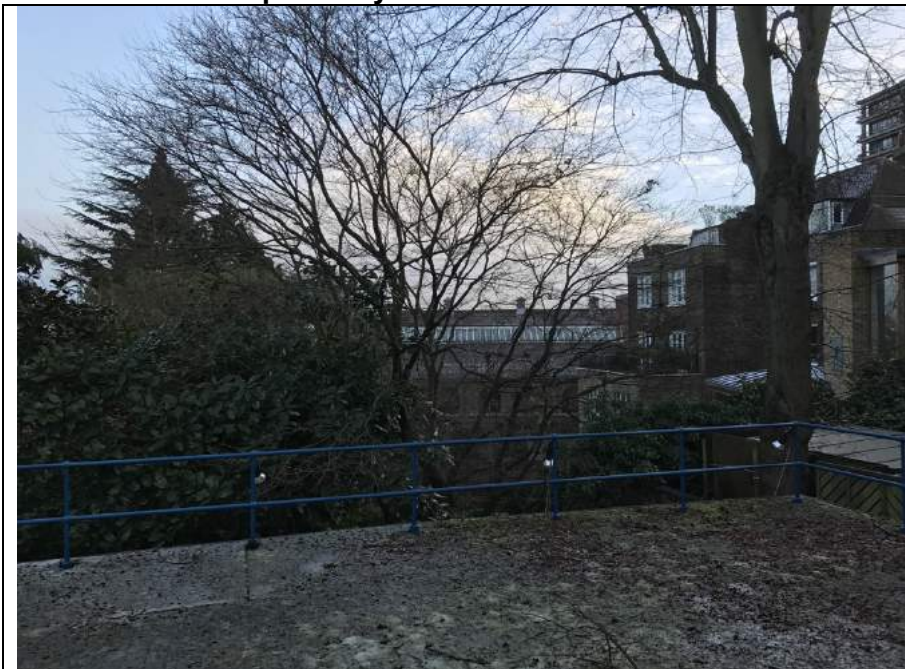
Photo 7, T6 Evergreen Magnolia (dark foliage left of shot) & T7 Japanese Maple (no leaves-centre of shot)

Seen from the first floor roof of the Foster Extension the Evergreen Magnolia can be seen to the left hand side of photo 7. behind railings. This tree is heavily suppressed having developed beneath the influence of adjacent Japanese Maple T7. Although presented as for retention within the scheme, it is considered that the amenity value of this tree is very limited given its position. Furthermore, thinking about use and enjoyment of the garden post construction, and in terms of competition with the more desirable Japanese maple and, the ability to sustain growth of smaller herbs and shrubs in ground it currently over shadows, removal is recommended in the short to medium term.

Visible to the right of the Evergreen Magnolia and central with the frame of photo 7, this is a useful tree that is in scale and proportion to its setting albeit nominally suppressed beneath T8. With a three stem break at around 500mm above ground level this tree is located to the east of the Foster Extension and away from the focus of construction activity. No adverse impacts are expected however existing paving should be retained for the duration of works up until replacement (commencement of landscaping) and a scheme of protection is warranted.

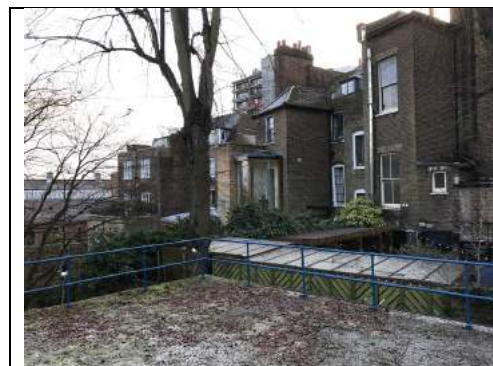
Photo 8, Lime T8

Both Limes T8 and T9 are judged to be in fair condition with 20+ years safe useful life. They are off-site trees located within the rear garden of The Roebuck public house No. 15 Pond Street: The condition of the trees is assessed as 'fair', with marking down due

primarily to the volume of dead wood within the crown which is at risk of falling and, due to the limitations of access which hindered careful inspection of the stem and lower parts of the trees.

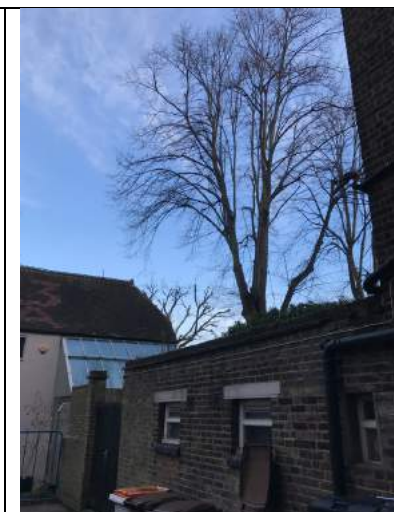
Photo 9, Lime T9

Tree T8 is of sufficient distance from the area of proposed works that no adverse impacts are expected to occur. Tree T9 is closer to the proposed basement formation: the interposing boundary wall that divides the two properties is thought likely to have curtailed root development across the boundary.

3.2.3 **Lime tree T9**, is considered to be a minimal risk of disturbance for very much the same reasons as outlined for Robinia T2 and T3. This tree is located behind a tall brick wall and the line of the proposed basement where the RPA of the tree overlaps the site is to be formed beneath existing structure. Notwithstanding these considerations, T9 (and T8) are in pressing need of arboricultural work and should probably be reduced to previous reduction points. Even were there to be a concern about the potential impact of the scheme, the very act of pruning will cause an imbalance in root to shoot ratio such that even in the unlikely event that some root pruning was required, this is highly unlikely to result in any discernable negative impact for what is a hardy and resilient tree.

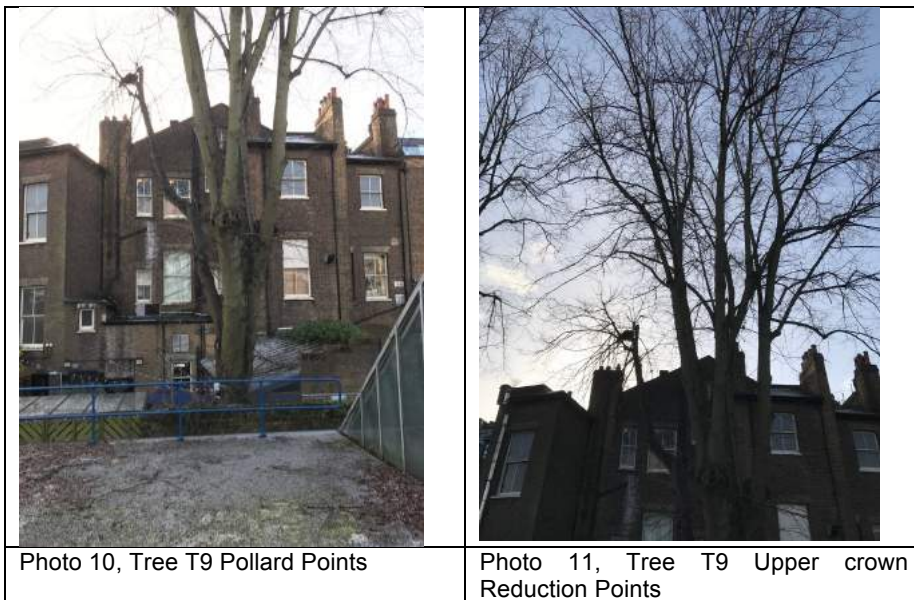
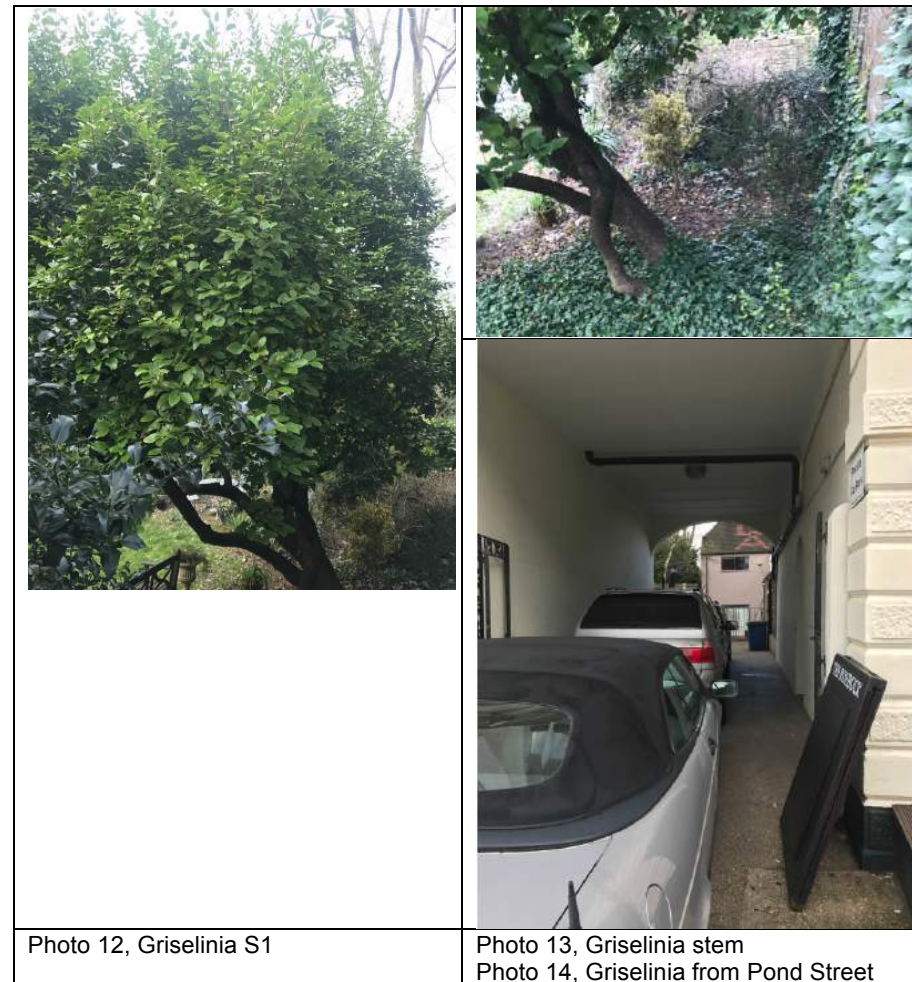
2.2.9 Shrub S1, *Griselinia littoralis*,

A mature *Griselinia littoralis*, shrub, appears to be in good condition abutting the western elevation of 13a Pond Street. Previously reduced. Limited access to view plus ivy covered root collar, this plant is inclined from the western elevation and is rooted approximately 500mm from it. The garden in which it is rooted is estimated to be

900mm above the internal floor height of 13a Pond Street on basis that T2 is measured to be 1200mm and T3 700mm above adjacent ground on the site side. As with T2 and T3, it is expected that roots are contained within its own garden due to raised levels and effects of the boundary wall and its footings on root development. Care will need to be taken during demolition and reconstruction of the western elevation of the new property.

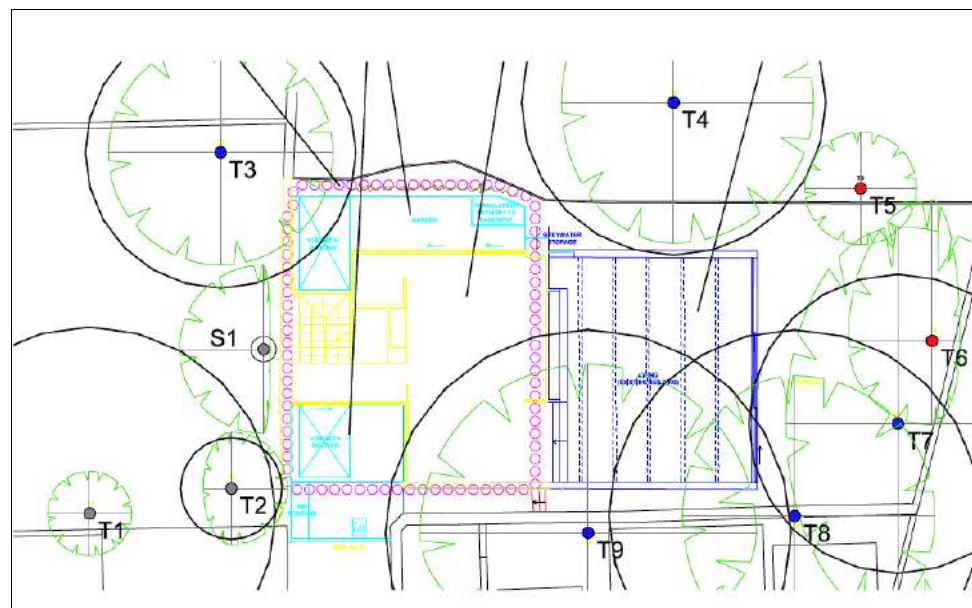
Figure 2: Tree RPA Constraints Data showing unadjusted tree Root Protection Area (RPA) as black circles centred on each tree. Trees with red centres are not considered worthy of retention and RPA is not presented. Base plan used here is an amalgamation of the site and basement as proposed plans where: Foster extension to be retained is in blue, basement as proposed (line of piles) in magenta, external garden areas in cyan (light blue) and proposed ground floor in yellow.
