COOKE
FAWCETT
ARCHITECTS

Rose Cottage, Vale of Health, NW3 1AX
Addendum to planning application 2018/0887/L
21.02.2018

180221_135_REP_RenderUpdate

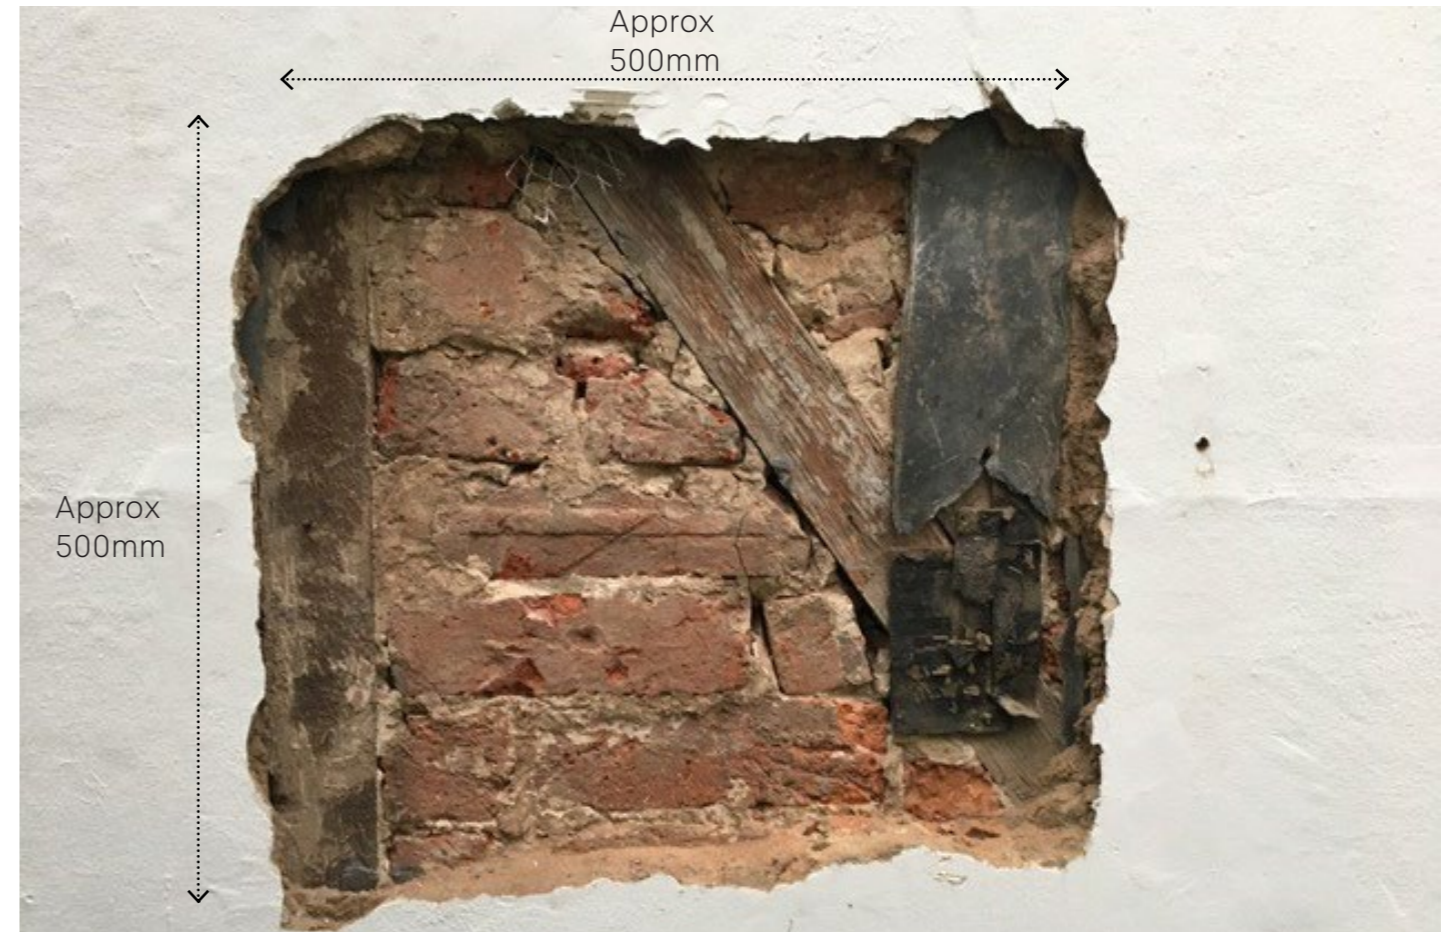
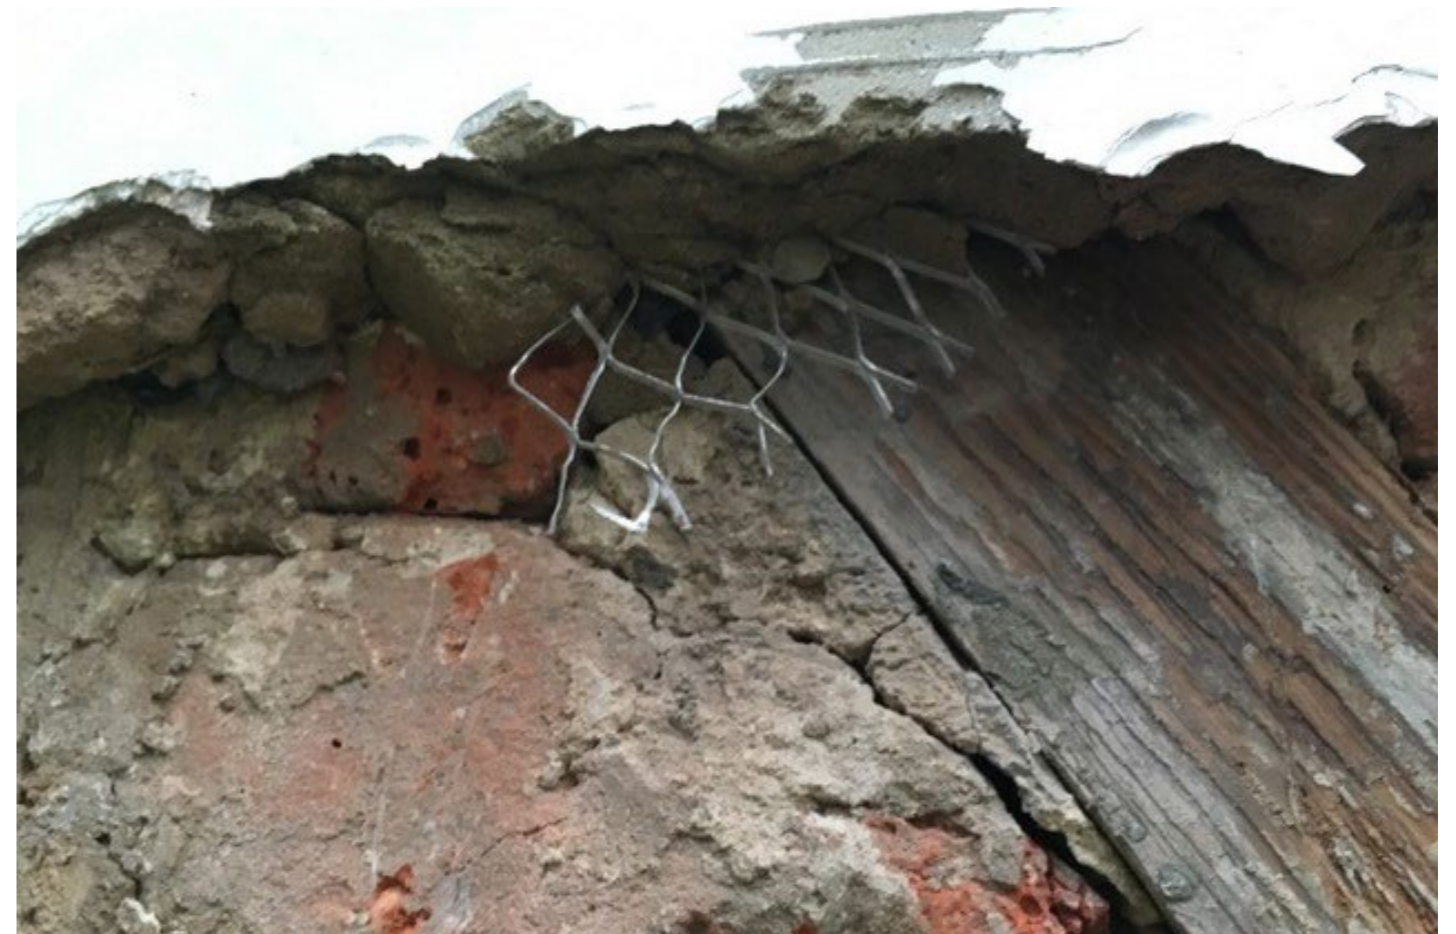
Observations from area of test removal

- Contractor followed proposed method statement
- Render comes away easily with no damage to brickwork, pointing or timbers
- From this section of the wall the conclusion would appear to be that the wall is at least partially comprised of timber structure with brick infill.
- In some areas slate coverings appear to be forming a form of DPC protection to the timber. This is not consistent.
- Brickwork is in reasonable condition with some areas of loose pointing requiring attention
- Modern mesh found in render coat confirms expectations that Render is non-original

- Method statement is fit for purpose
- Render is non-original
- Extensive use of timber as part of wall structure
- Render can be removed effectively without damage to brickwork

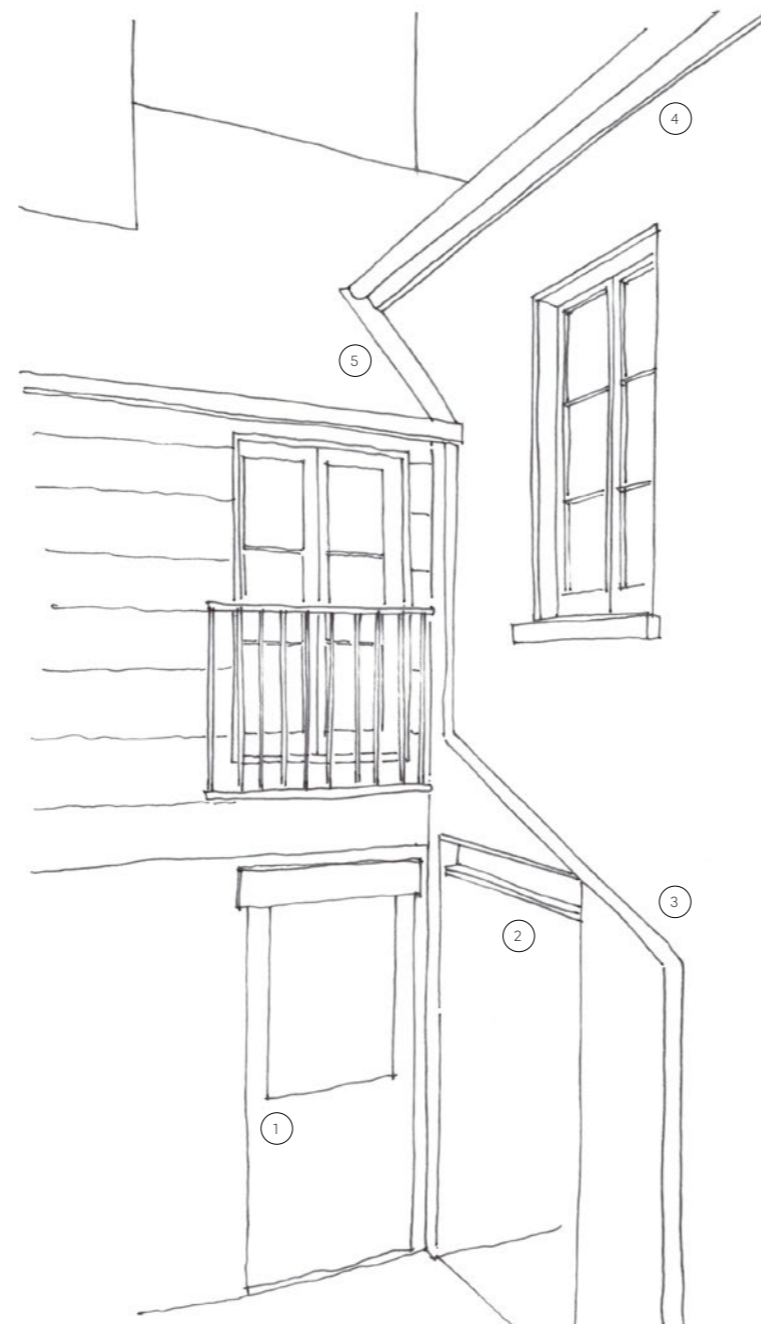
- 1. Existing door
- 2. Exposed steel lintel
- 3. Downpipe
- 4. Fascia board
- 5. Lead flashing detail
