30 Euston Square

*Fire protection for the heritage rooms of
the Royal College of General Practitioners*

**Design and Access Statement
Incorporating a gazetteer of doors**

March 2018

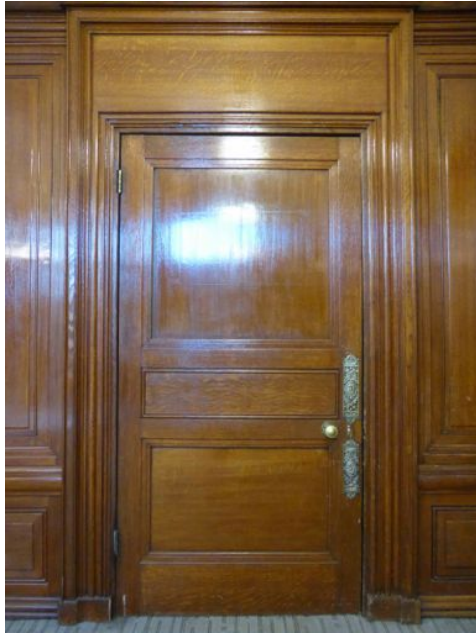
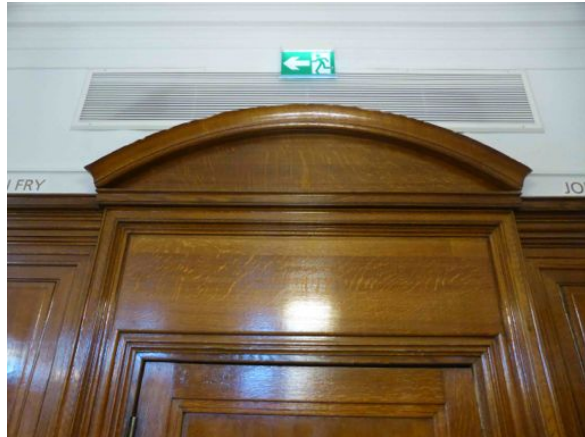
The entry door and access door to Ireland (noted under ‘walls’) are integral to the panelling. The leading edge of the pedimented door has noticeable deterioration at odds with the generally excellent condition of the mouldings around the walls. Repairing this edge could be achieved with a filler product but it may be more straightforward to leave it as existing, noting that any redecoration must take extreme care in its vicinity to prevent accidental damage making the situation any worse.

Figs. 3, 4 Boardroom entry door – high gloss varnish / pedimented head with friable edge – AC grille above

Attaining equivalence to FD30 performance will require consistent 3mm gaps on three sides with fire rated hinges and smoke seals, which will need to be addressed as a matter of urgency along with the other minor board rooms on the first floor.

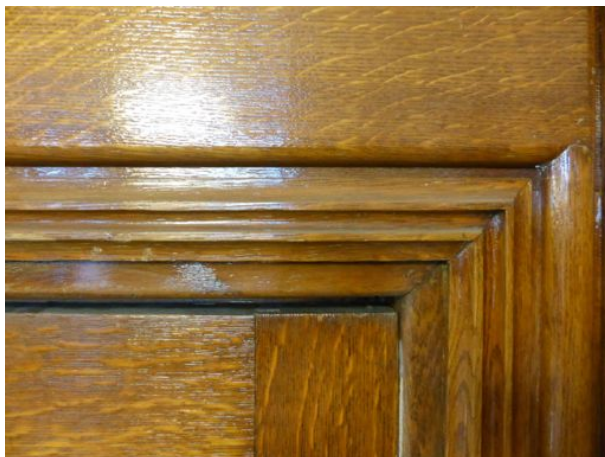
Fig. 5 Boardroom entry door moulding to frame jamb/head – high gloss varnish, door fit is a fire issue

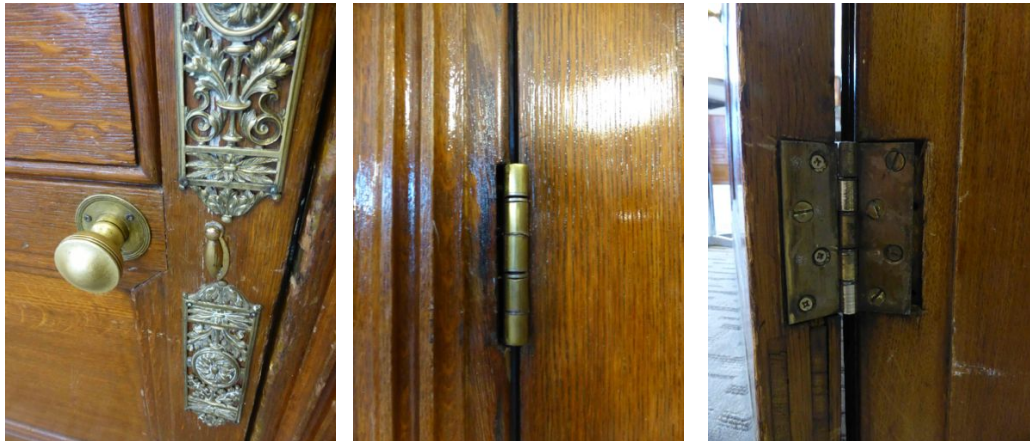
The entry door has original ironmongery – the handle is worn but serviceable with a good patina, the fingerplates are pierced and clogged with 'Brasso' or similar brass polish residue and should be carefully removed and washed out before drying and re-fixing. The use of posidrive screws to fix the fingerplates, escutcheon plates and doorknob must be addressed, well fitting brass pan or flat head C/S slot screws must be used wherever original fittings are in place or new fittings are visible within a heritage context.

The washered hinges are very worn and have contributed to the door leaf dropping, adding to the problem of unacceptable gaps around the door with regard to smoke ingress.

Figs. 6, 7, 8 Boardroom entry door – original handle/push plate / excessively worn hinges / poor fitting in 2012

The existing hinges are relatively modern brass that do not fit exactly the rebates in the door edge for them. New screws poorly chosen indicate the correct countersunk slot head that should be used. The hinge pins are worn as are the washers, the hinges are not appropriate for FD30 doors.

The open joints of the door is of concern, when works to the door for fire upgrading takes place an experienced joiner should look at the stability of the joints. The damage through use to the edge of the frame is inevitable given the volume of use. The chipping of brittle lacquer finish begs the question as to using lacquer as opposed to an oiled finish that penetrates into the wood and is less visually affected by impact damage. An investigation of the original finish to the oak is recommended – if an oil is suitable it may be in the long term heritage and aesthetic interest of the room to remove the modern high sheen, slightly viscous lacquer and to utilize an oil finish such as teak or Danish oil. It is possible that the unfortunate finish to the lacquer is because it plays an inhibiting role in the spread of flame. This should be considered as part of the wider fire strategy for the significant heritage rooms on the first floor.

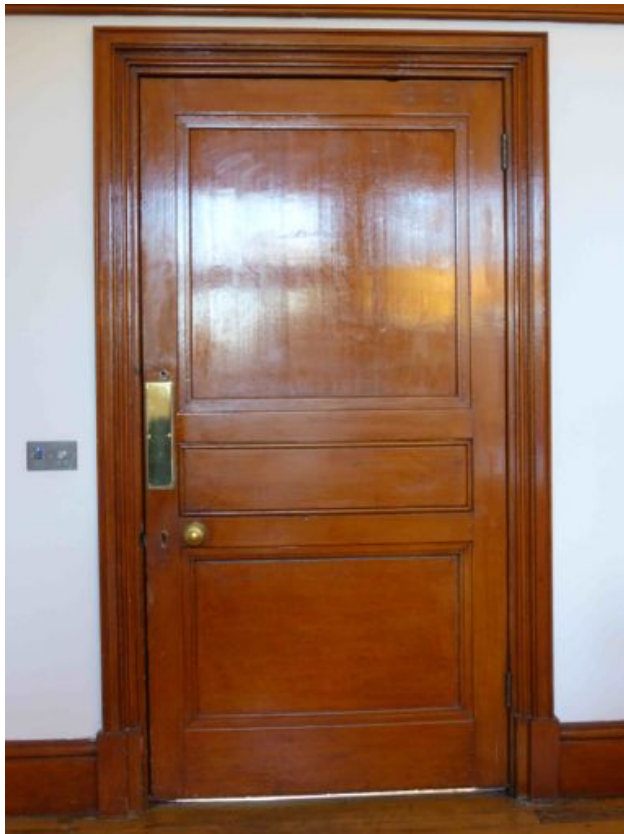
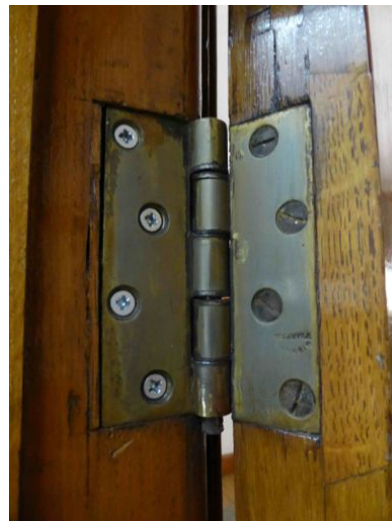
It should be noted that issues of non-compliance with Part B of the Building regulations has been previously identified, with significant perimeter gaps to all sides and an inadequate stopping to the frame. The definition of a compliant intervention is required that acknowledges the adequate thickness and construction of the doors to be equivalent to FD30 status, but that also addresses the worn hinges and gaps around the door is required well within the next 12 months.

Figs. 9, 10 Oak entry door inner face, original colour of doorframe - Note gap under door re. Part B fire regulations - relatively recent hinges in plated steel

The existing hinges are relatively modern brass plated steel that do not fit exactly the rebates in the door edge for them. New screws poorly chosen indicate the correct countersunk slot head that should be used. The hinge pins are worn as are the washers, the hinges are not appropriate for FD30 doors.

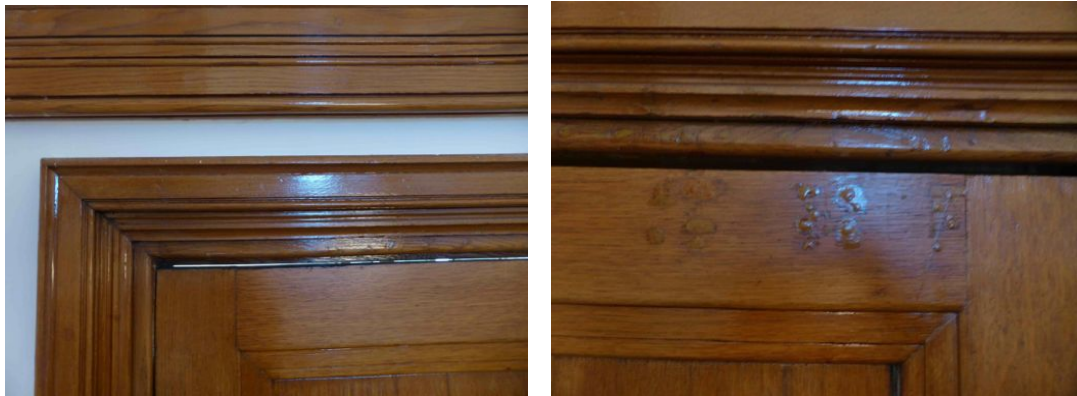
Comments on the Ireland doors regarding the overtly coloured staining apply. The condition of the doors is also applicable, the entrance door also has poor repairs to fixings related to a now absent door closer (Fig.), gaps particularly to the head of the door/frame are unacceptably wide from a fire safety perspective, as too are the worn hinges.

Figs. 11, 12 Oak entry door, gap to frame head / door closer repair

Remedial work to the gaps can incorporate careful remaking of the repairs to the door closer fixings such that the fixings are visible but only under close scrutiny. Externally the oak doorcase and pediment are in good condition, the colour of the oak is different from the interior, careful investigation is required to establish a finish that is consistent and appropriate. Original ironmongery is significant.

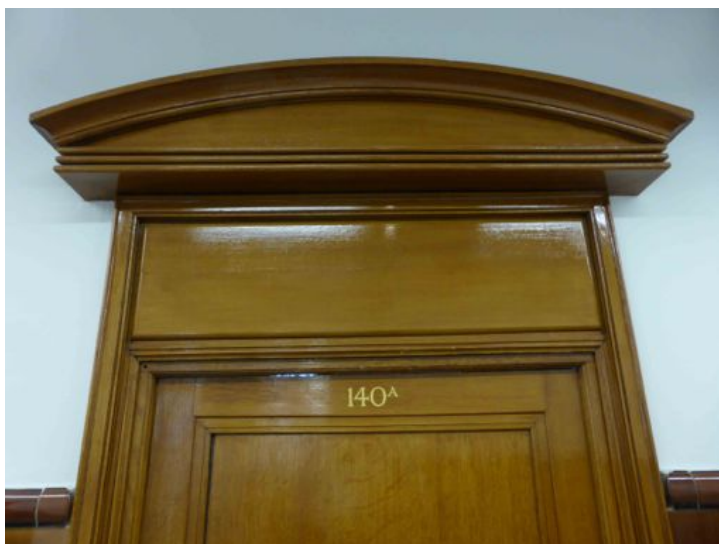
Fig. 13 Oak pediment common to minor boardroom doors – distinct colour difference to the interior

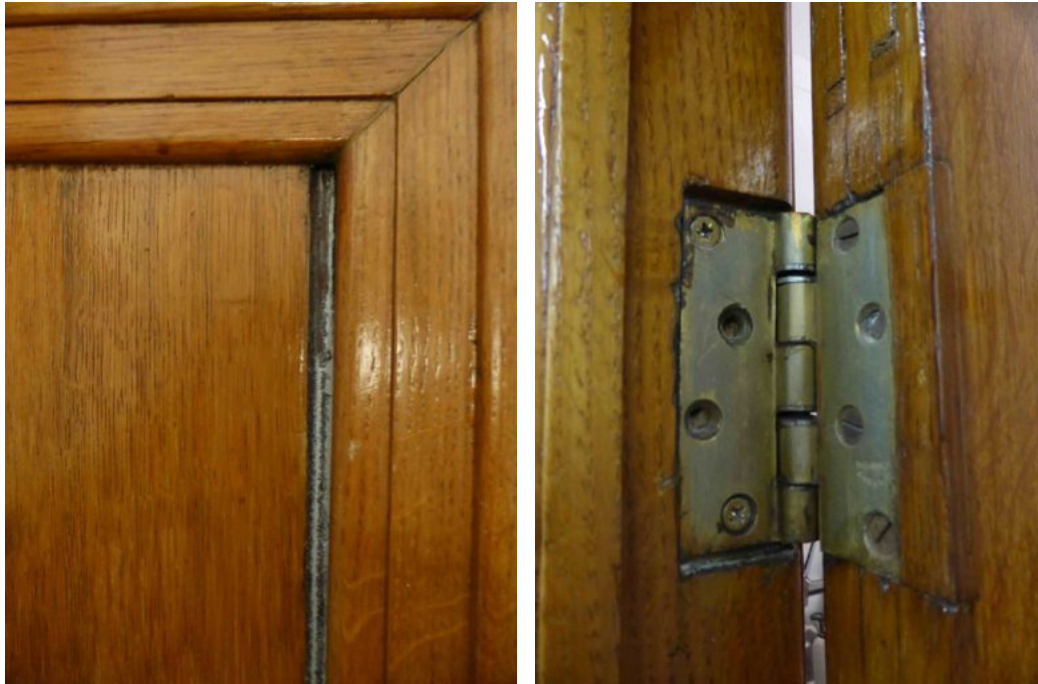
The upper panel has a split edge where it meets the right jamb (Fig. 14). This presents an unacceptable breach in its fire performance as well as its appearance, and should have a carefully selected piece of oak with matching moisture content to the existing panel spliced in and finished to appear unobtrusive.

Figs. 14 , 15 Oak panel requiring splicing in – plated steel washered hinge worn and a poor fit

The existing hinges are relatively modern brass that do not fit exactly the rebates in the door edge for them. New screws poorly chosen indicate the correct countersunk slot head that should be used. The hinge pins are worn as are the washers, the hinges are not appropriate for FD30 doors.

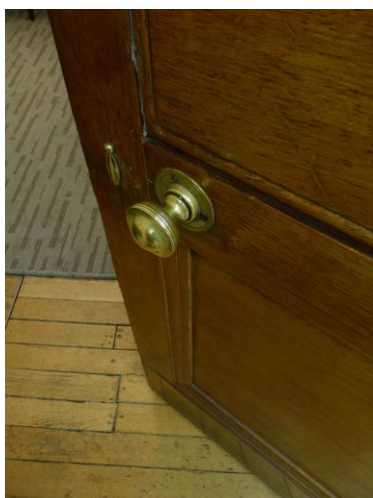
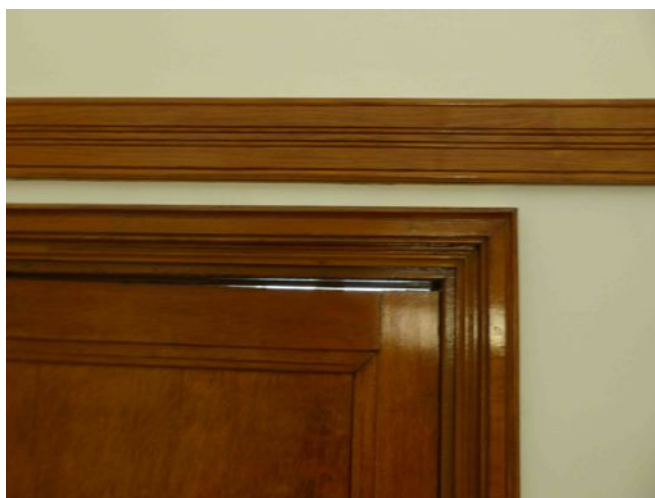
The entry door requires perimeter work to reinstate a close fit to the frame as part of achieving fire compliance. Original ironmongery is particularly important to the door. Any decorative works to the doors must ensure that the ironmongery is handled extremely carefully.

Figs. 17, 18 Original door with original ironmongery, gap to frame in breach of fire safety requirements

The existing hinges are relatively modern brass that do not fit exactly the rebates in the door edge for them. New screws poorly chosen indicate the correct countersunk slot head that should be used. The hinge pins are worn as are the washers, the hinges are not appropriate for FD30 doors.

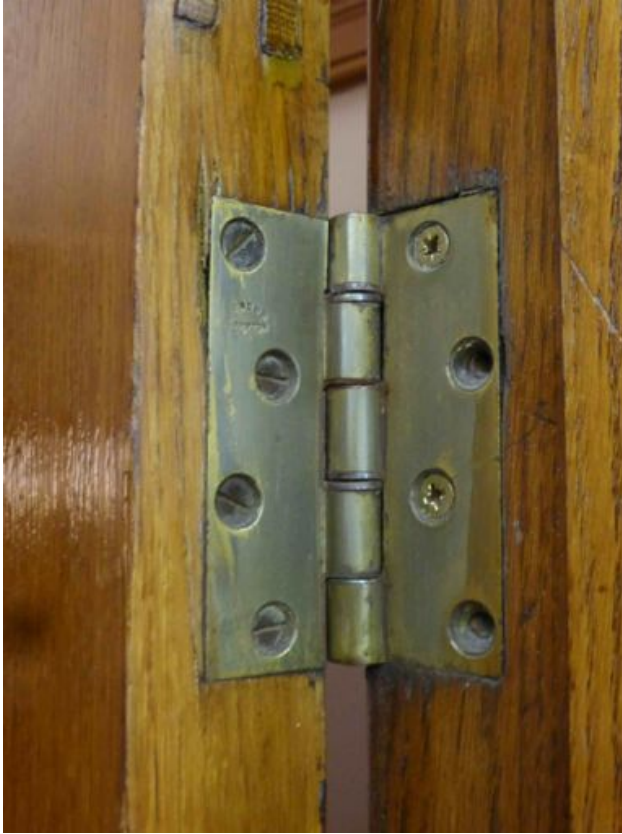
Fig. 19 Hinge detail to door – modern washed hinge showing wear

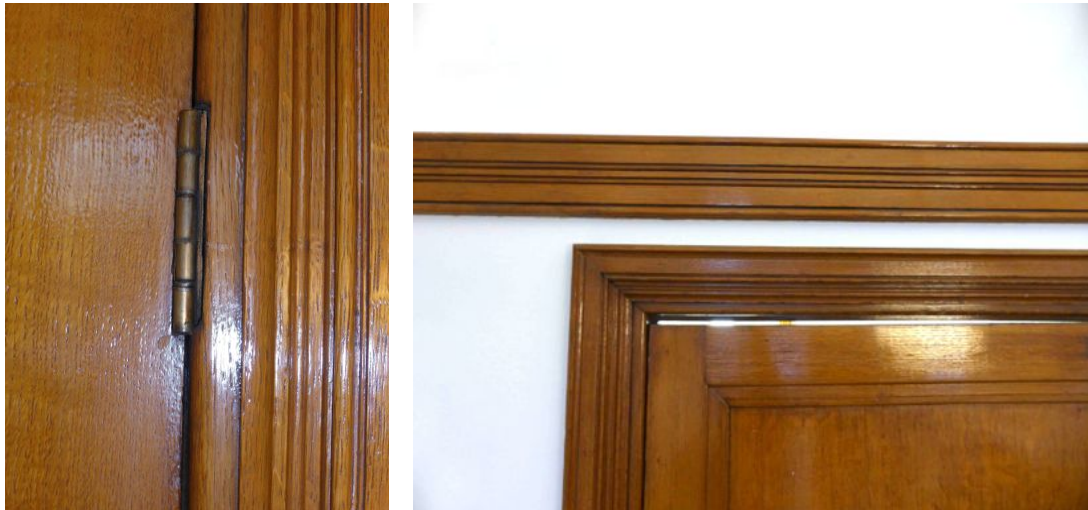
Good condition, with common issues of varnish colouration and gaps to the frame. New ironmongery attempts a match to adjoining doors, the polished lacquer finish is the most significant specification error and the removal of the lacquer and ability for natural patination through use is preferable.

Fig. 20 21 Oak entry door – significantly worn hinges - unacceptable gap for fire safety

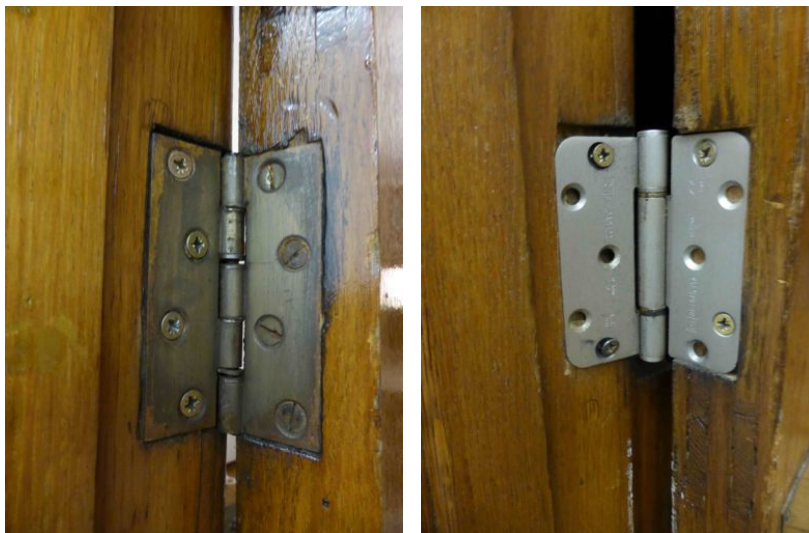
Fig. 22 23 Older hinge but poor fit shows unoriginality, modern replacement without consideration

The existing hinges are relatively modern brass that do not fit exactly the rebates in the door edge for them, and a new hinge from 2012 or later that is entirely inappropriate. New screws poorly chosen indicate the correct countersunk slot head that should be used. The hinge pins are worn as are the washers, the hinges are not appropriate for FD30 doors.

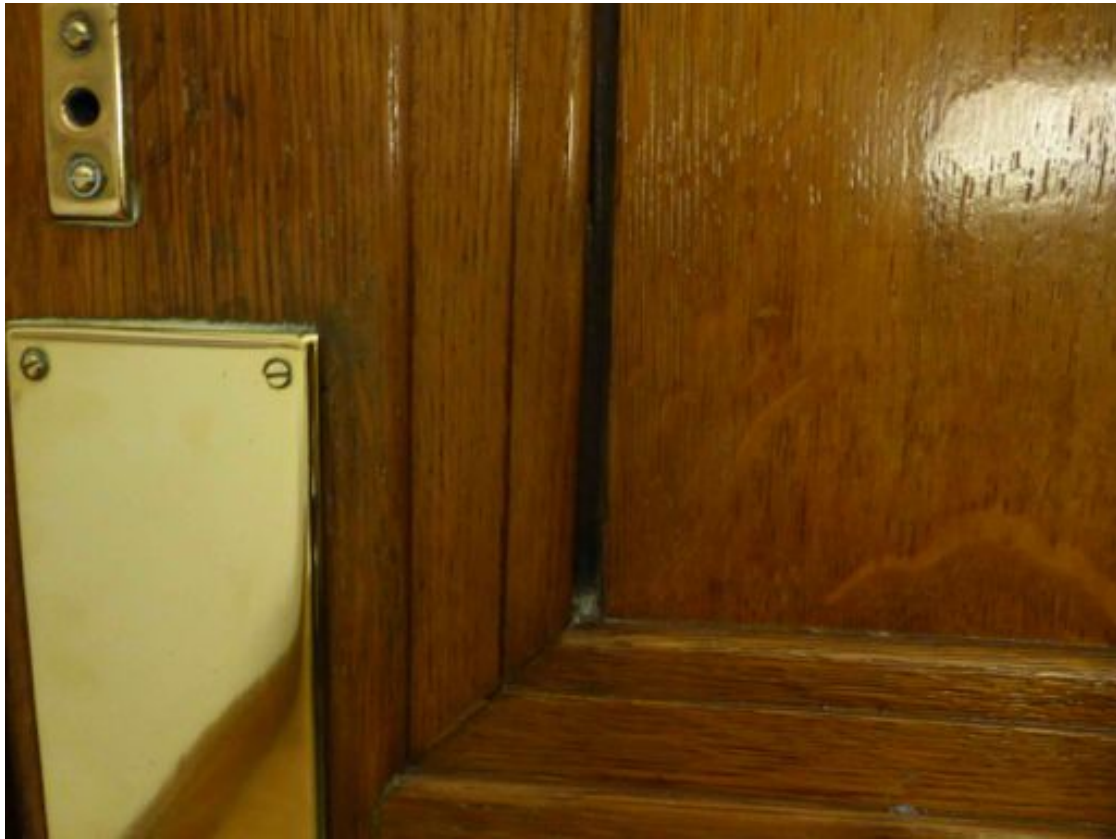
Fig. 24 Split in upper panel left edge requiring oak spliced repair

The upper panel has a split edge where it meets the right jamb (Fig. 24). This presents an unacceptable breach in its fire performance as well as its appearance, and should have a carefully selected piece of oak with a matching moisture content to the existing panel spliced in and finished to appear unobtrusive.

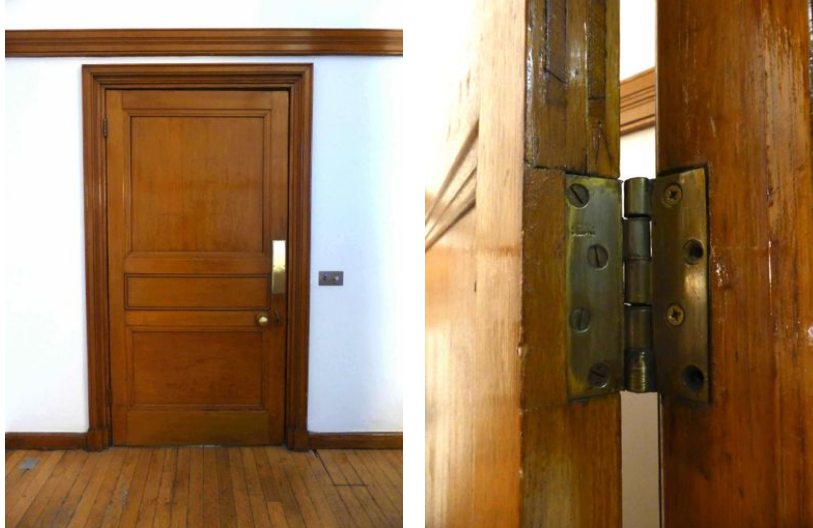
Condition and issues as per Ireland, original handles and latches in situ and fully operational – worn hinges. The door opens into a fire compartment separate from the main corridor containing doors 2-5.

Fig. 25 26 Oak entry door with original ironmongery – hinge with evidence of replacement

The existing hinges are relatively modern brass that do not fit exactly the rebates in the door edge for them, oak piecing in adjacent to both hinges indicates later fitting of smaller units. New screws poorly chosen indicate the correct countersunk slot head that should be used. The hinge pins are worn as are the washers, the hinges are not appropriate for FD30 doors.

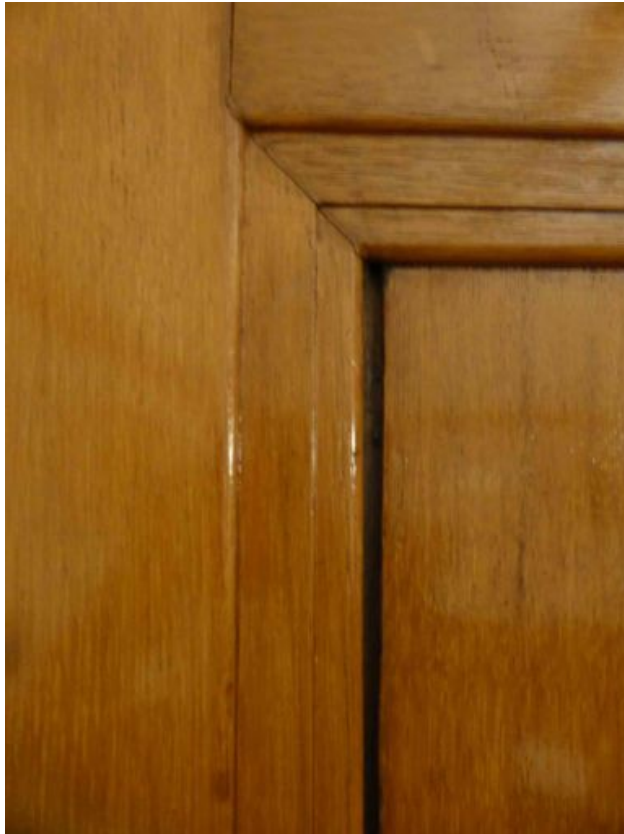
Fig. 28 Oak splice required for upper panel edge on the inside face

The upper panel has a split edge where it meets the left jamb (Fig. 28). This presents an unacceptable breach in its fire performance as well as its appearance, and should have a carefully selected piece of oak with a matching moisture content to the existing panel spliced in and finished to appear unobtrusive.

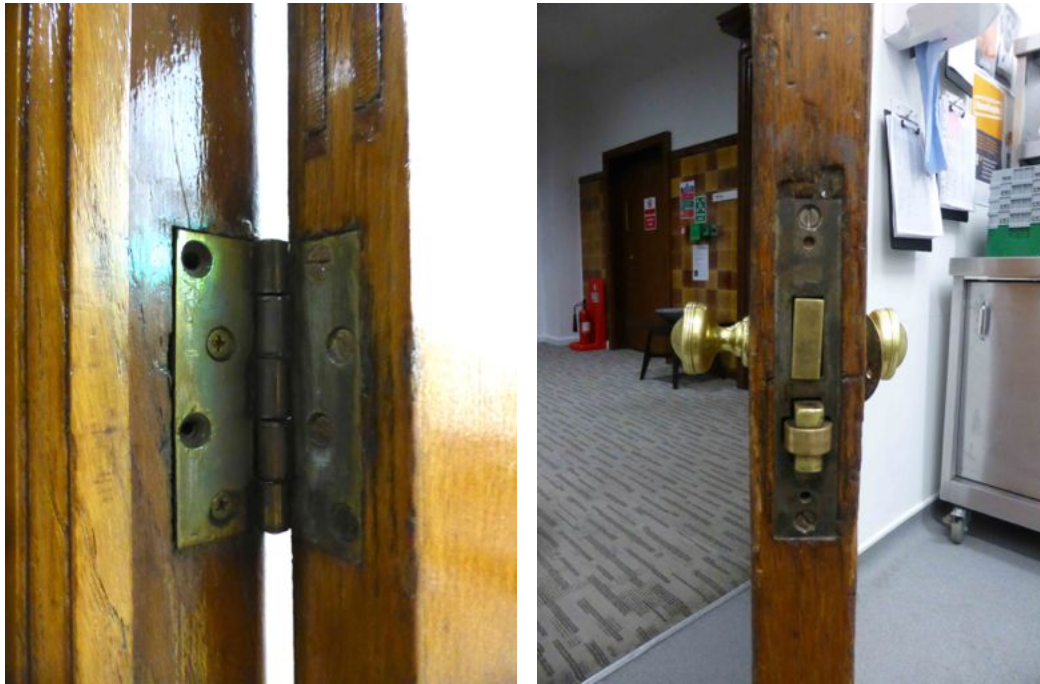
Figs. 32 , 33 Heavily worn washed butt hinges – original lock case with missing brass cover plate, rose is detached

New screws poorly chosen indicate the correct countersunk slot head that should be used. The hinge pins are worn as are the washers, the hinges are not appropriate for FD30 doors. The original locks are poorly maintained and requires a replacement brass cover plate and overhaul, which can be undertaken during upgrade works.

Careful joinery work will secure the future of the doors and allow the lock cases to be removed, overhauled and refitted, with any missing cover plates or brass pins securing rose plates (as in the Servery) replaced with exactly matching items. Slot head countersunk screws in a finish matching the new FD30 hinges should be used throughout, is existing slot head screws can be salvaged without damage to the heads then they will be reused.
