BS5837 Arboricultural Impact Assessment

8 Downside Crescent, London, NW3 2AP

Job Reference: 02873Rv2

April 2018

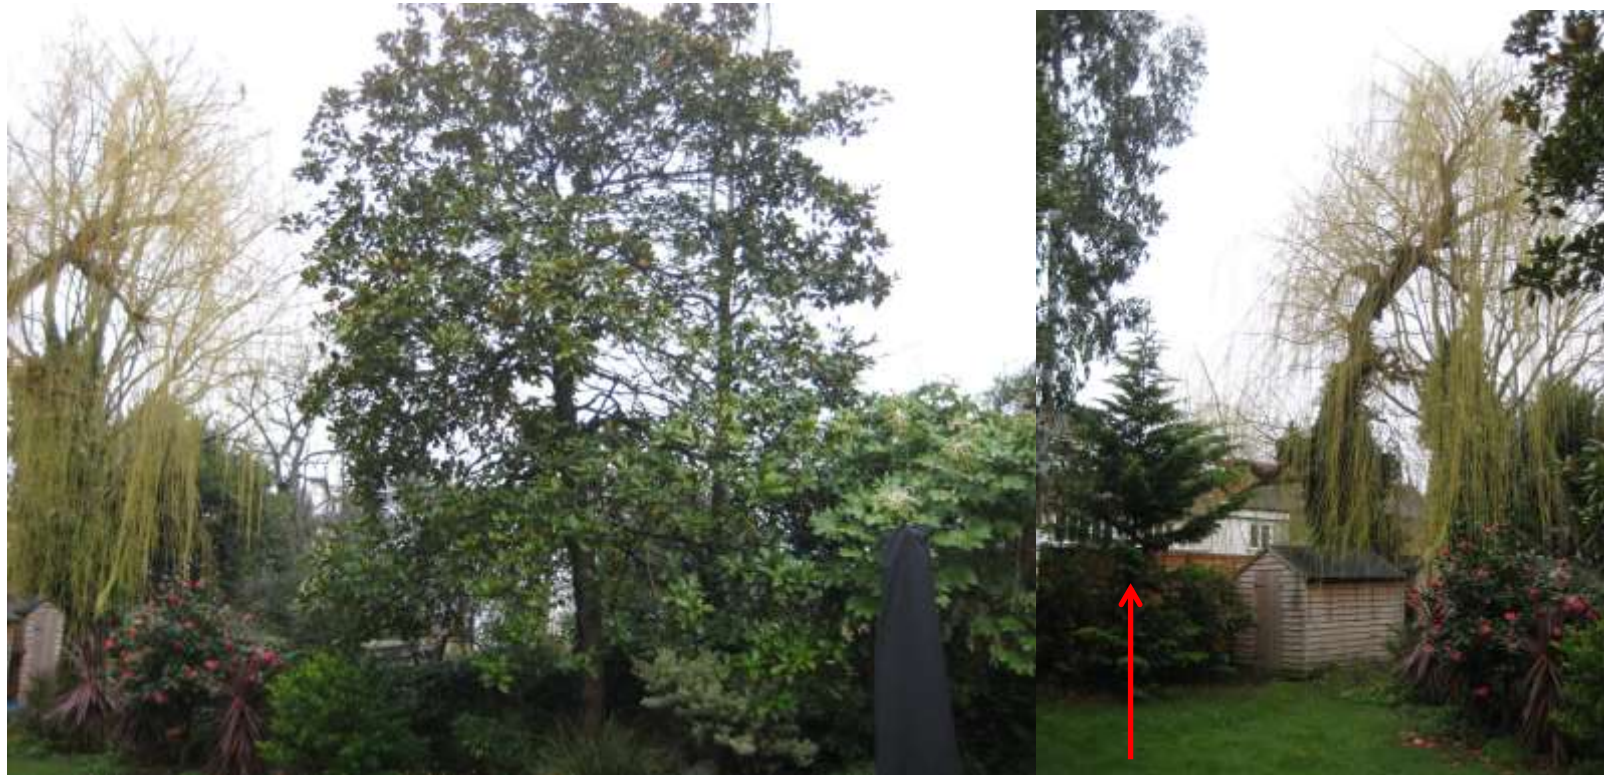
4.4 T3 (Cypress) is a small tree of no discernible wider amenity. This tree is proposed for removal.

Fig 1 – The rear garden with T6 (centre) in left image. T3 (indicated right) will be removed. This is a small tree poorly located for long term retention.

5.3.1 It is proposed to remove T3 (Cypress)

- 5.3.2 **Birds** – If the removal of T3 will be completed between 1st March & the 31st July (inclusive) a due diligence check for nesting birds must be completed before work starts in order to comply with the Wildlife & Countryside Act 1981. This check should be recorded in the Site Specific Risk Assessment. If active nests are found work should not take place until the young have fledged.
- 5.3.3 **Bats** – It should be noted that in England and Wales, the relevant legislation is the Wildlife and Countryside Act (1981) (as amended); the Countryside and Rights of Way Act, 2000; the Natural Environment and Rural Communities Act (NERC, 2006); and by the Conservation of Habitats and Species Regulations (2010).

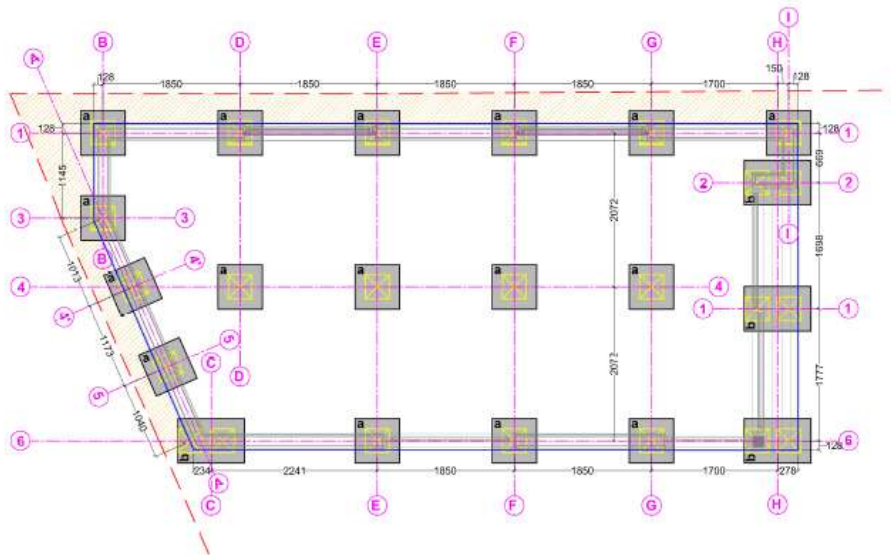
Fig 2 – Foundation incursion overview

- Pad footings used to minimise impact.
- Hand dug with localised repositioning to avoid roots >25mm.
- The level of works is such that no special foundation measures are proposed. In summary at this level and in this location we believe there will be no discernible impact on the trees health or stability.
- Service trench hand dug and pipes fed below roots >25mm (although the presence of these is considered to be unlikely).

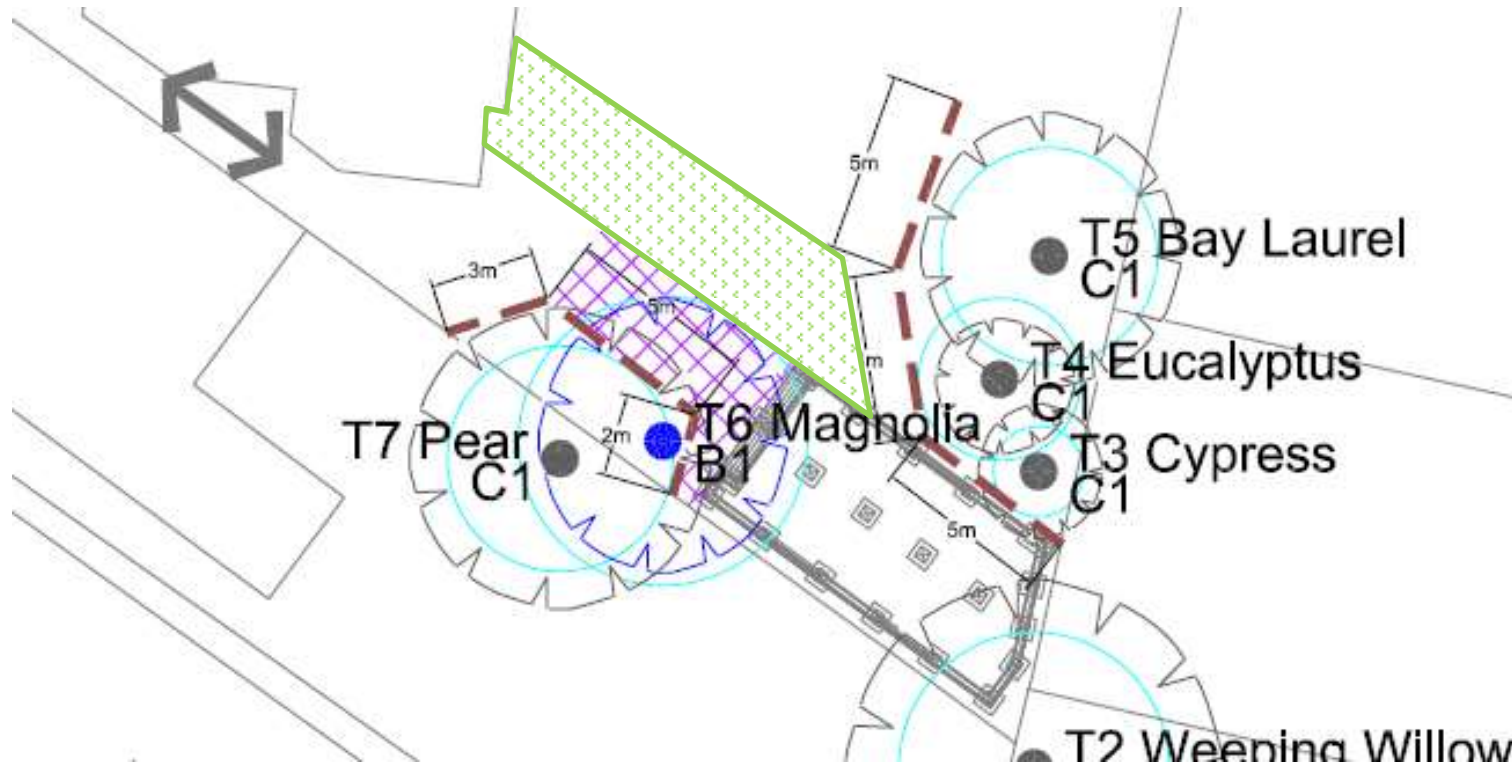
Fig 6 – A large zone (indicated above) is available for service trench installation outside retained tree RPA's

- 5.6.1 The new service trench will be hand dug. It will be positioned to be located outside the RPA of retained trees and will be hand dug as an extra precaution adhering to the principles of hand digging outlined in section 5.4.

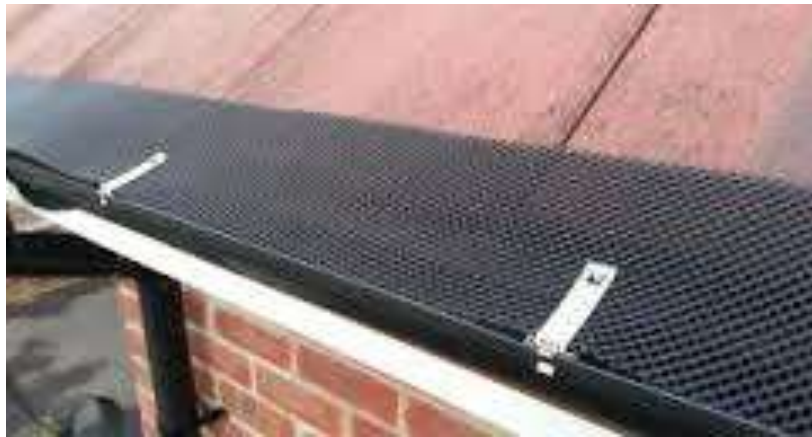
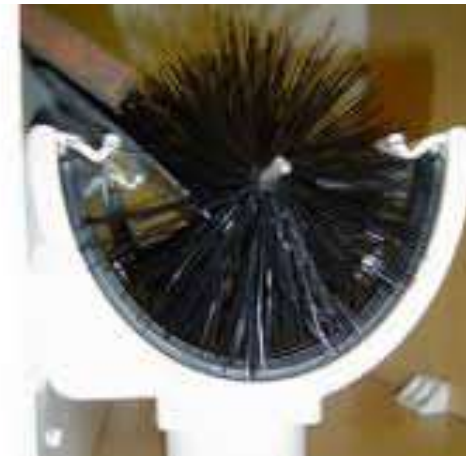
Fig 8 - Suitable gutter guards (2 types shown above) should be fitted to ensure that leaf drop from adjacent trees does not block new guttering leading to potential pressure for tree works.

5.6.3 To limit maintenance impact to the garden room from leaf drop given the proximity/ overhang of trees it is proposed that [gutter guards](#) be installed.

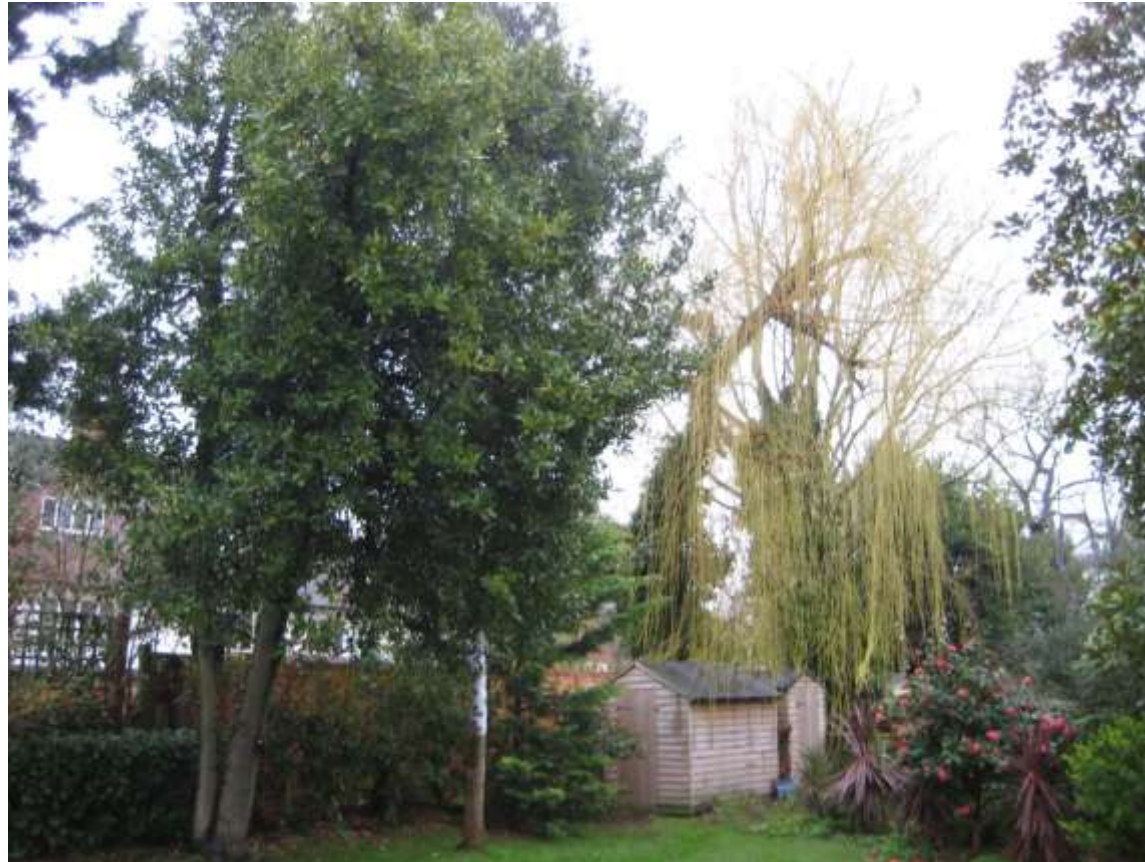
Image 1 – Rear garden with T5, stem of T4, T3, T2 & T1 visible

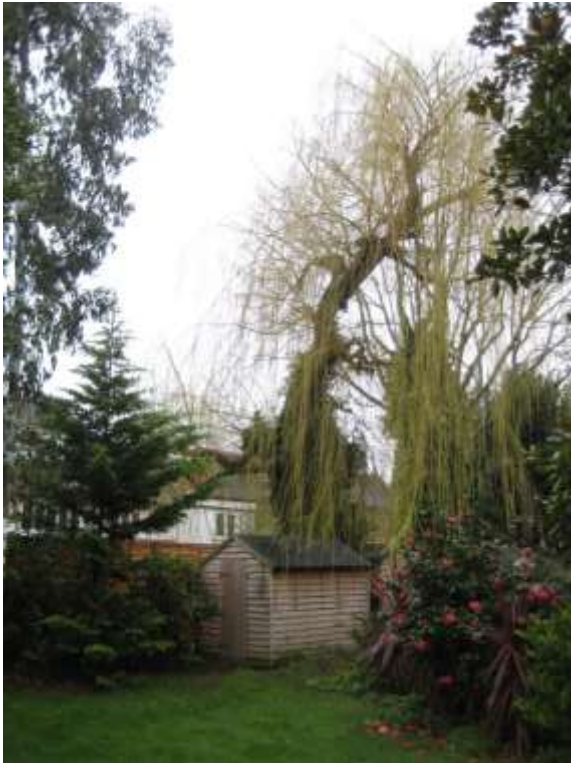
Image 2 – T2 & T3

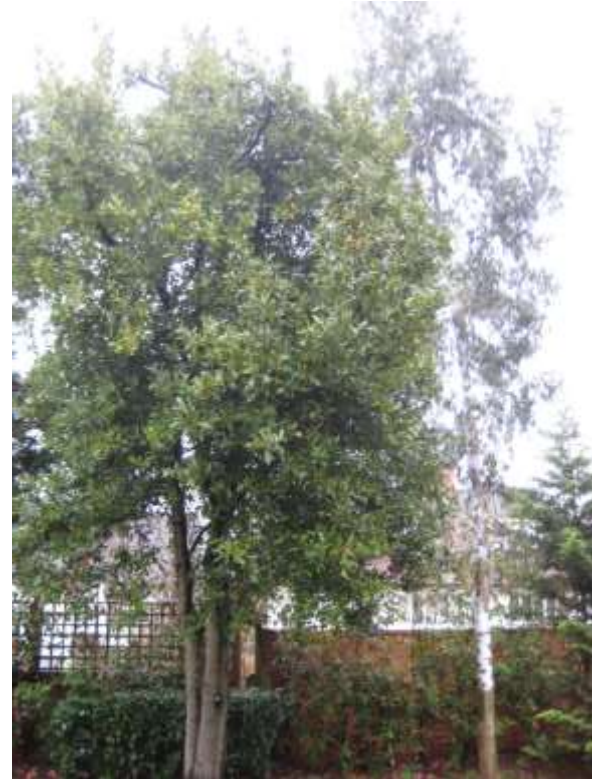
Image 3 –T4 (right) and T5

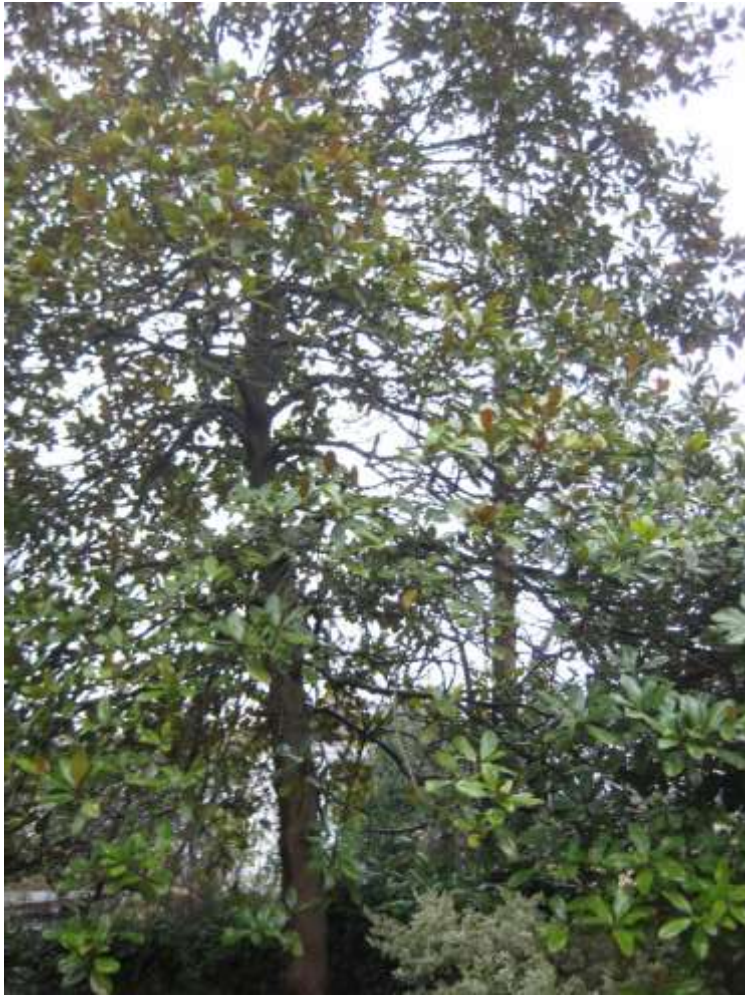
Image 4 – T6 & T7

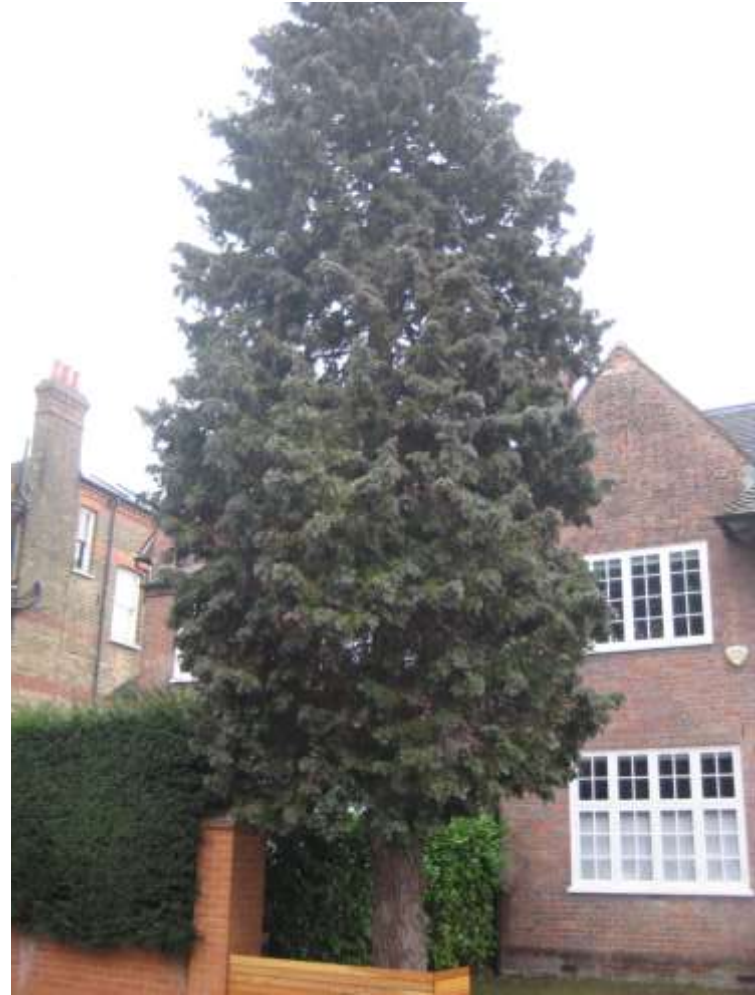
Image 5 –T8
