## ARBORICULTURAL IMPACT ASSESSMENT REPORT FOR:

South Lodge  
Heathside  
London  
NW3 1BL

Ref: GWY/SLG/AIA/01b

Date: 4<sup>th</sup> May 2018

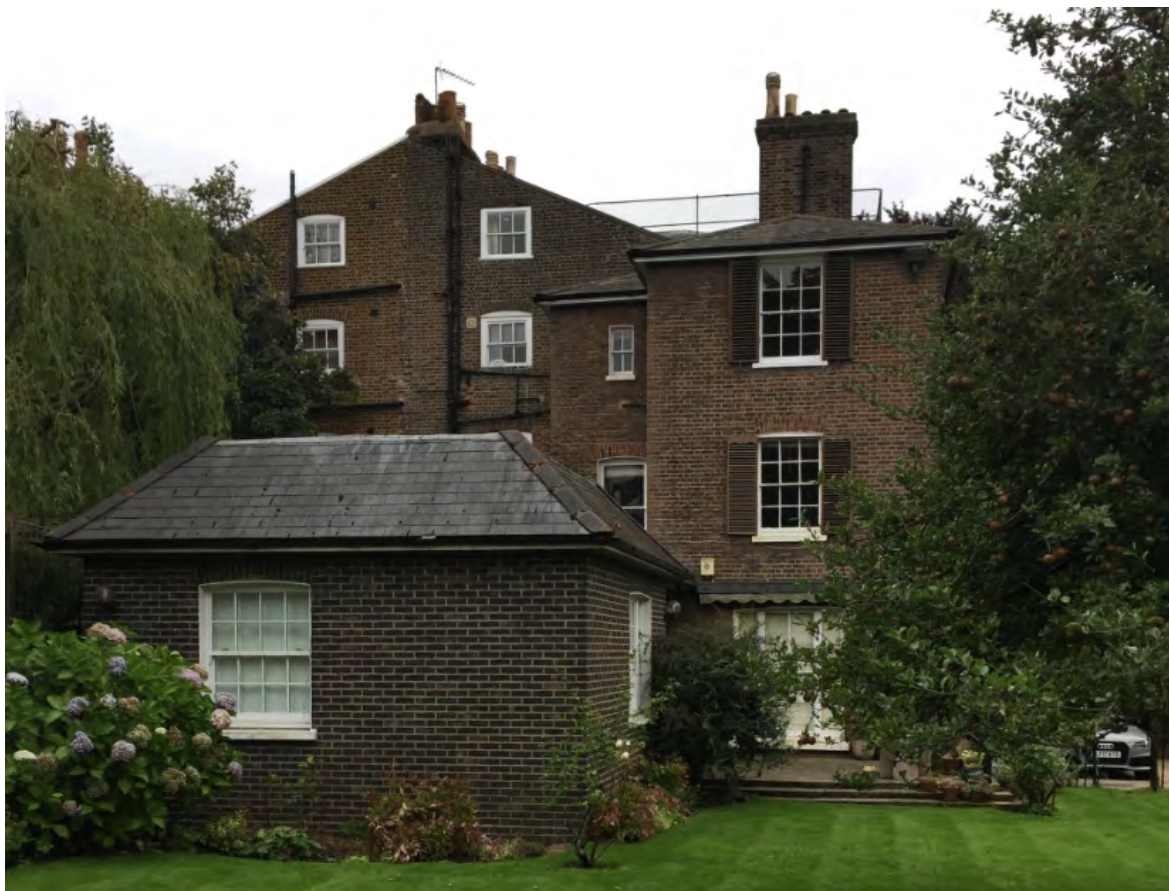
Photograph 1: Existing rear extension to South Lodge, Heathside, London NW3 1BL

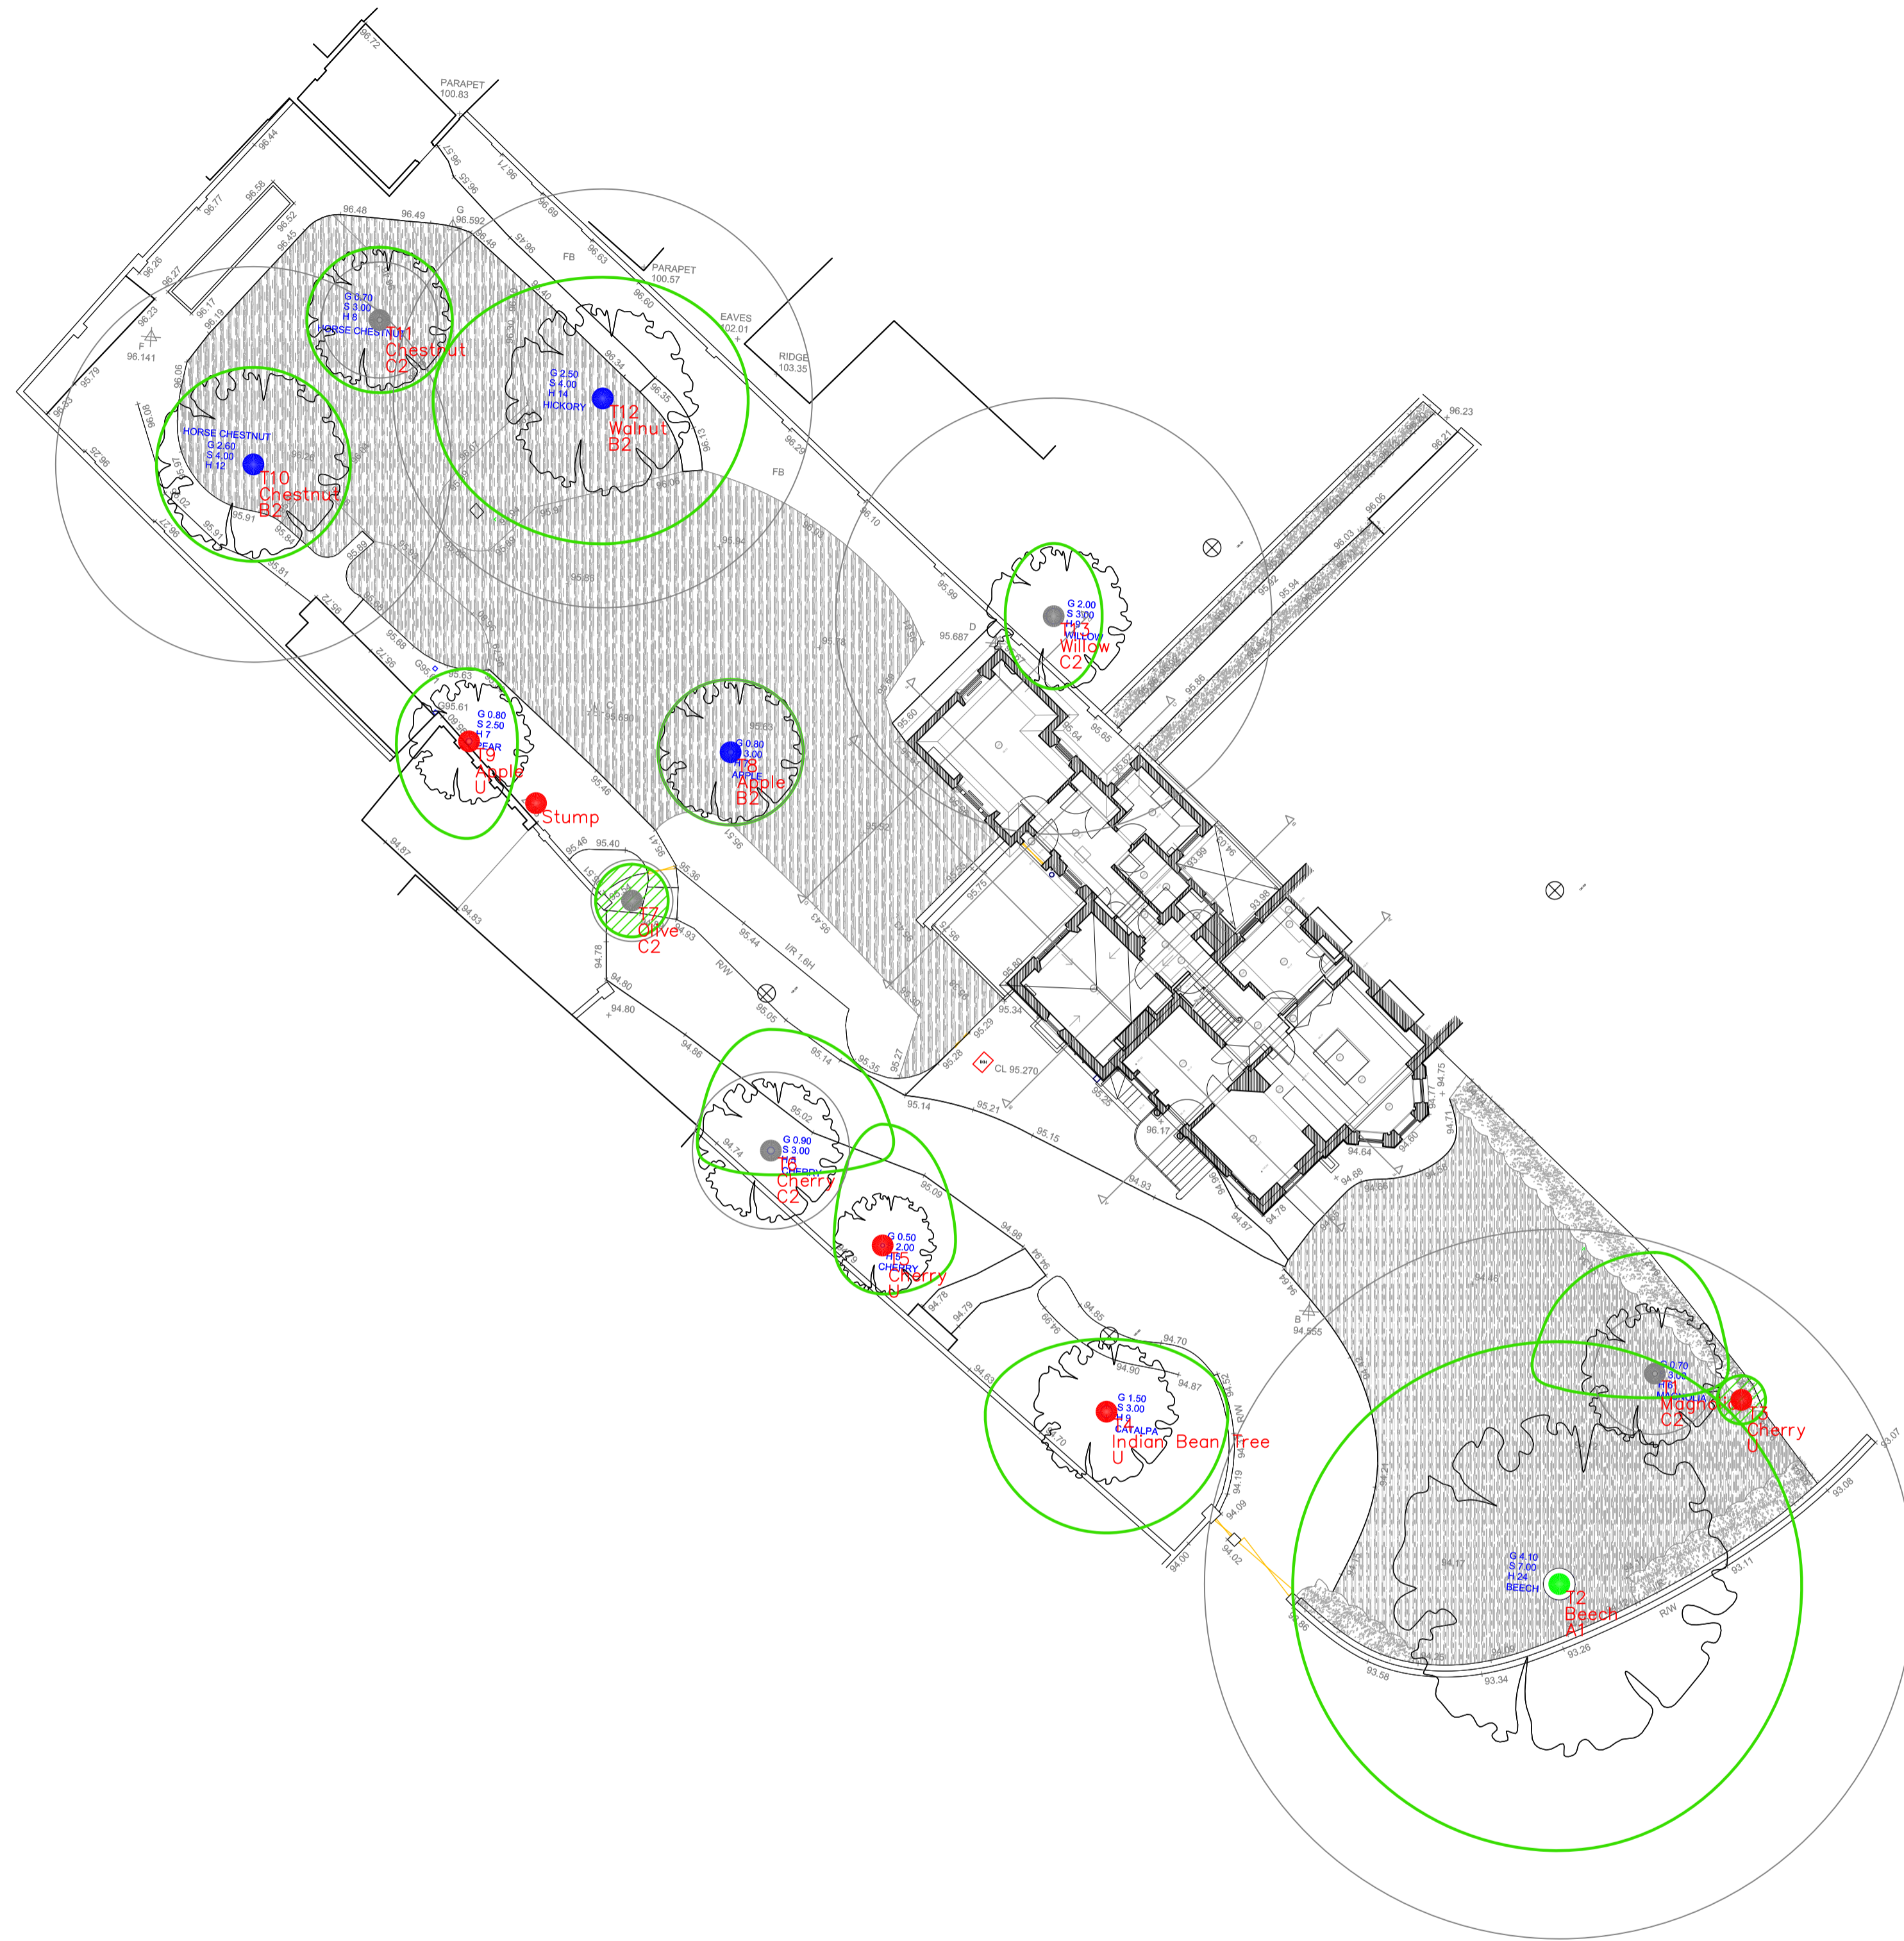
**TREE CONSTRAINTS PLAN**

4.1.8 In this instance, the high and moderate quality trees have the potential to pose significant constraints upon development. Low-quality willow, T13, lies outside that range.

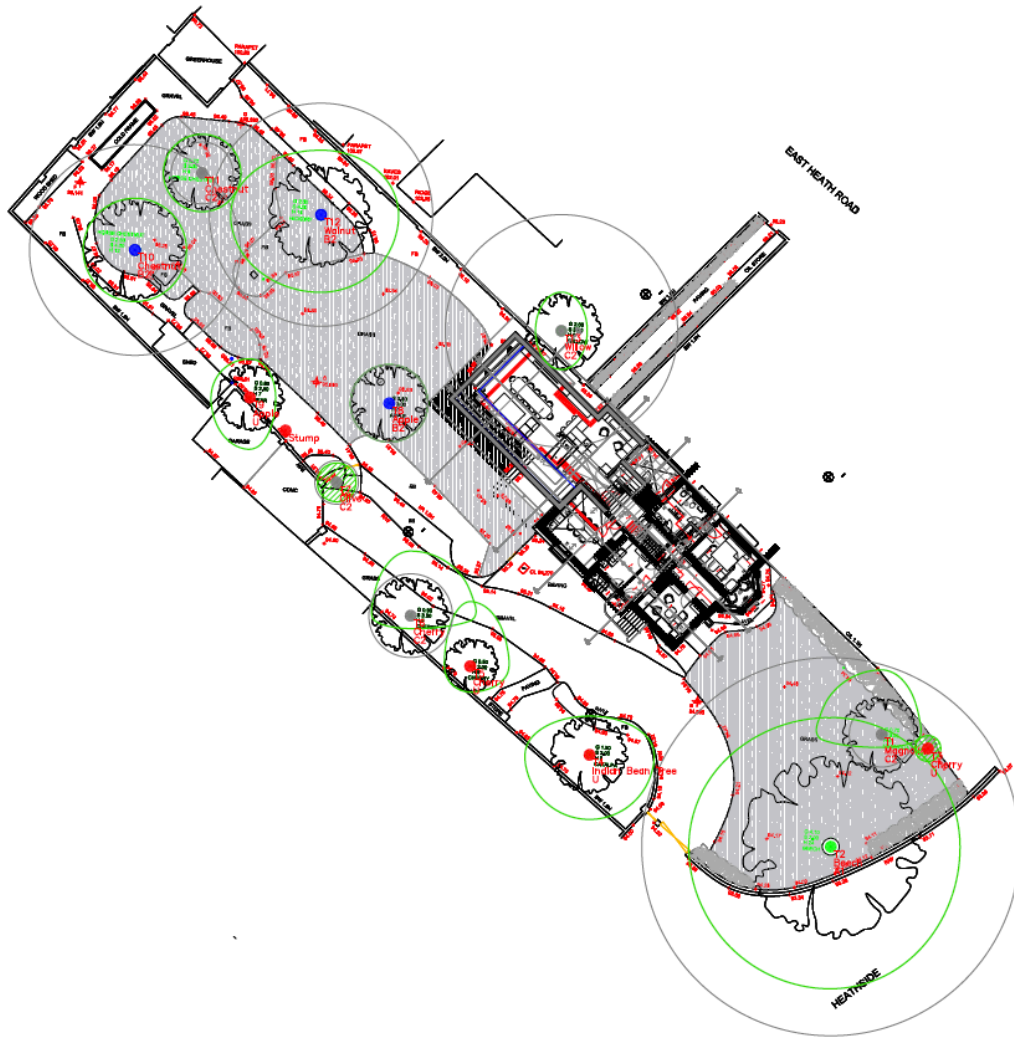
- i. Ground Floor

- 1.4 The report has assessed the impacts of the development proposals and concludes there would be at most a low impact on trees: A small proportion (7%) of the RPA of the off-site T13 would be impacted by the proposals. However, this gross figure is based on an even distribution of roots into the site / circular RPA, rather than their likely disruption by boundary wall foundations and existing hard standing. Net impacts are assessed as being very low – low impact.

- 6.1.1 The principal impact in the current proposals comprises the removal and replacement of the existing extension within the theoretical circular RPA of the off-site willow T13. The slightly larger footprint of the replacement extension means that the existing encroachment of the RPA will increase by 7%. In gross terms, this is assessed as being of very low impact to the tree with the actual impact likely to be significantly less due to the inhibiting effect on root development the existing boundary wall will have. Trial pits can of course be provided to confirm this assessment.

6.3.1 All plant and vehicles engaged in demolition works should either operate outside the RPA, or should run on a temporary surface designed to protect the underlying soil structure. The demolition of the building should proceed inwards in a “pull down” fashion. Hard surfacing can be lifted with caution by a skilled machine operator again working away from the tree.

6.3.2 The path of foundations / limits of excavation through the RPA will be manually excavated to 750mm depth under arboricultural supervision; any roots encountered within the trenches / pits will be cleanly pruned back to an appropriate junction with a sharp pruning saw or secateurs back to a junction. Roots larger than 25mm diameter may only be cut in consultation with an arboriculturalist.
