HERITAGE STATEMENT

**Proposed Reconstruction of Garden Walls
at
27a Mornington Terrace,
Camden, London.
NW1 7RS**

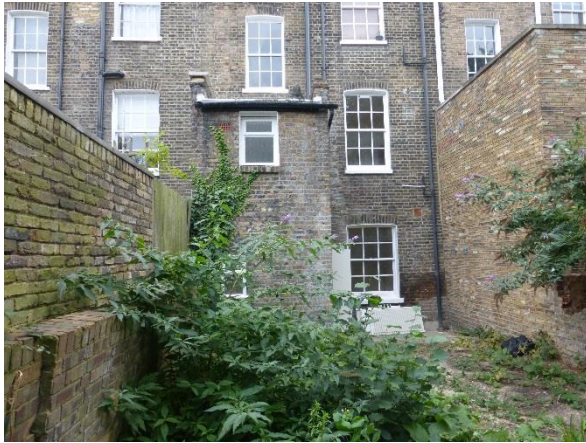
- 3.3 This wall is suffering from progressive structural damage and movement. Ultimately parts are likely to collapse. They are in poor repair with missing pointing and significant vertical cracks. The walls also have a pronounced lean.
- 3.4 The condition of the walls is such that patch repair is inappropriate and would not stabilize the condition.
- 3.5 The precarious condition of the walls is self-evident.

Rear Elevation
Showing damage to
walls garden separating
walls

- 6.1 The existing walls are structurally compromised and in very poor condition.
- 6.2 Presently damage affects the entire length of the walls.
- 6.3 To ensure structural integrity and consistent finished appearance the entire length of both walls is to be rebuilt.

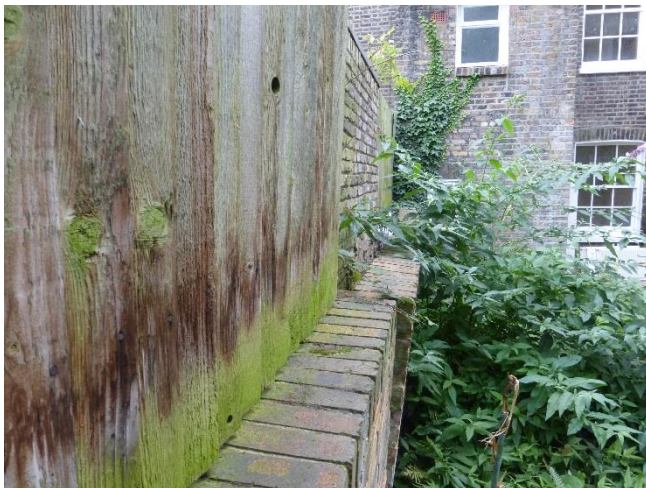
Displacement of wall to
No 26
