Arboricultural Report

Client: Mulberry House School (On behalf of BDG architecture and design)

Site: Mulberry House School 7 Minster Road Cricklewood, London

Survey undertaken: Trees in relation to design, demolition and construction – Recommendations.

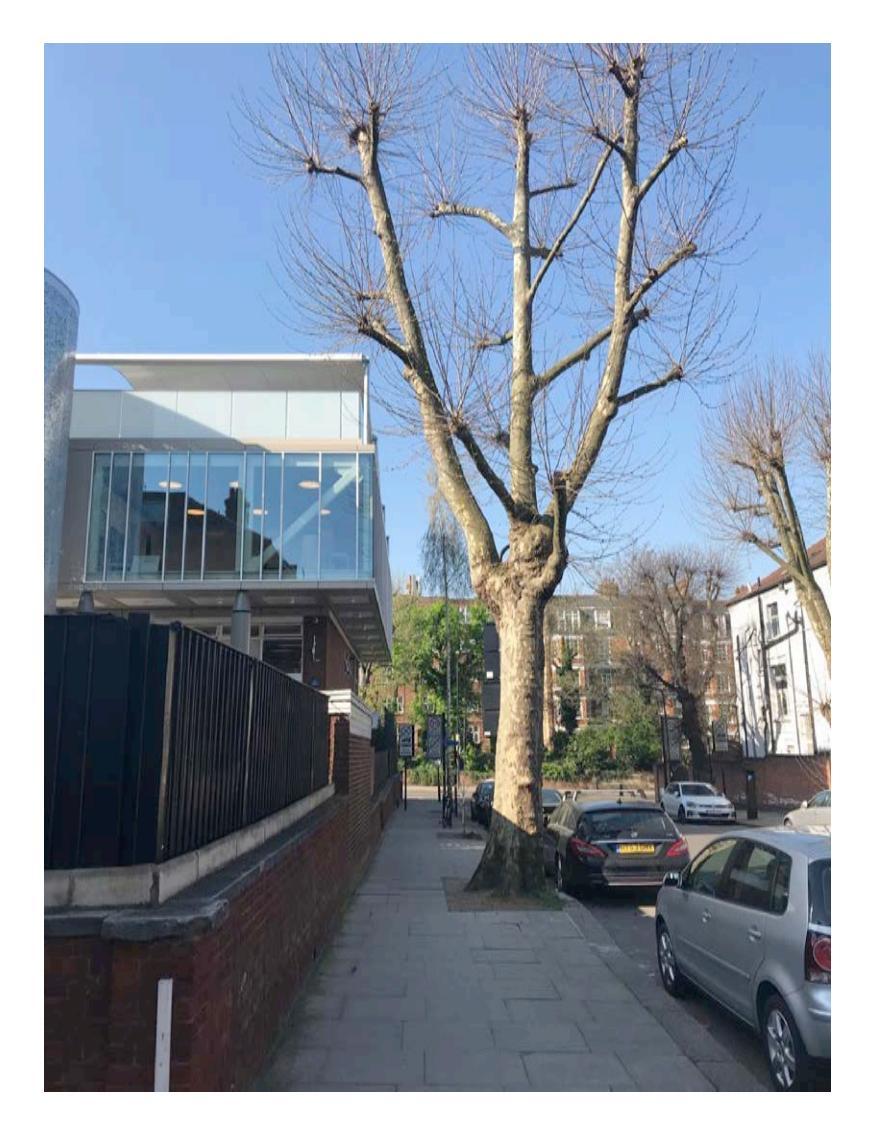
T1 has been recently reduced to approximately 11m in height; it has a street tree management plan and is regularly maintained. The ground level in the playground at the location of the proposed development slopes up towards no1. Minster Road and pavement ground level is on average 0.5m below that of the playground. The rooting area of T1 will continue into the school grounds but at approximately 1m below pavement ground level. Proposed plans indicate new foundations to be installed at existing depth without excavation below pavement surface level. In this case the rooting area of T1 will be undisturbed during the proposed development with regards to foundation design. The south-east limb of T1 will potentially come into contact with the proposed building once installed, this will cause future issues of encroachment if not dealt with prior to installation.

Photo 1: Illustrates proximity of T1 to school boundary wall (proposed site of new design build)

Construct and install 3m-timber hording around the tree stem prior to demolition and construction. No crane activity to be carried out underneath the canopy of T1.

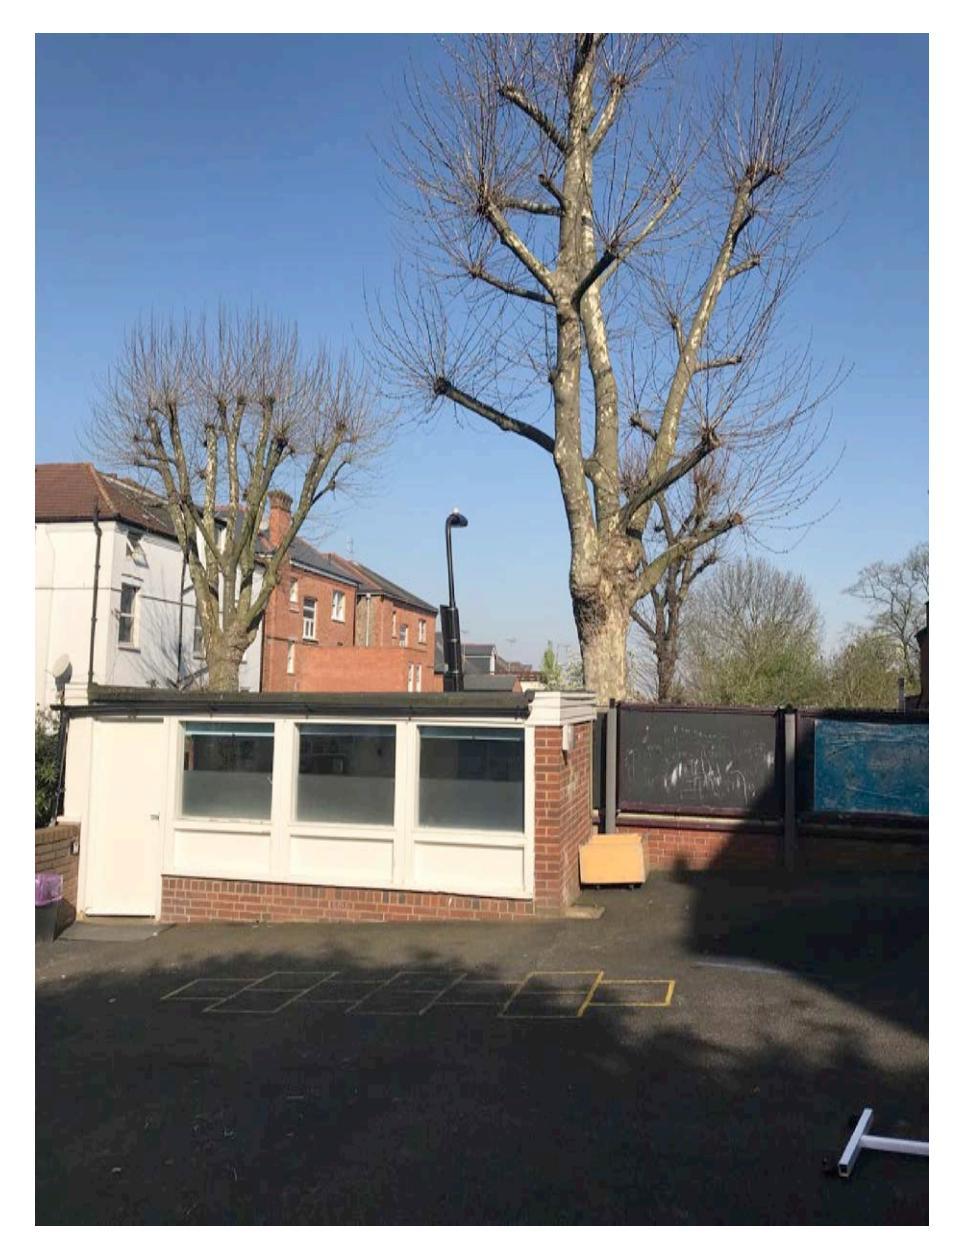
Photo 2: Existing staff room in playground. Ground level slopes up right towards No.1 Minster Road. Area of proposed development.

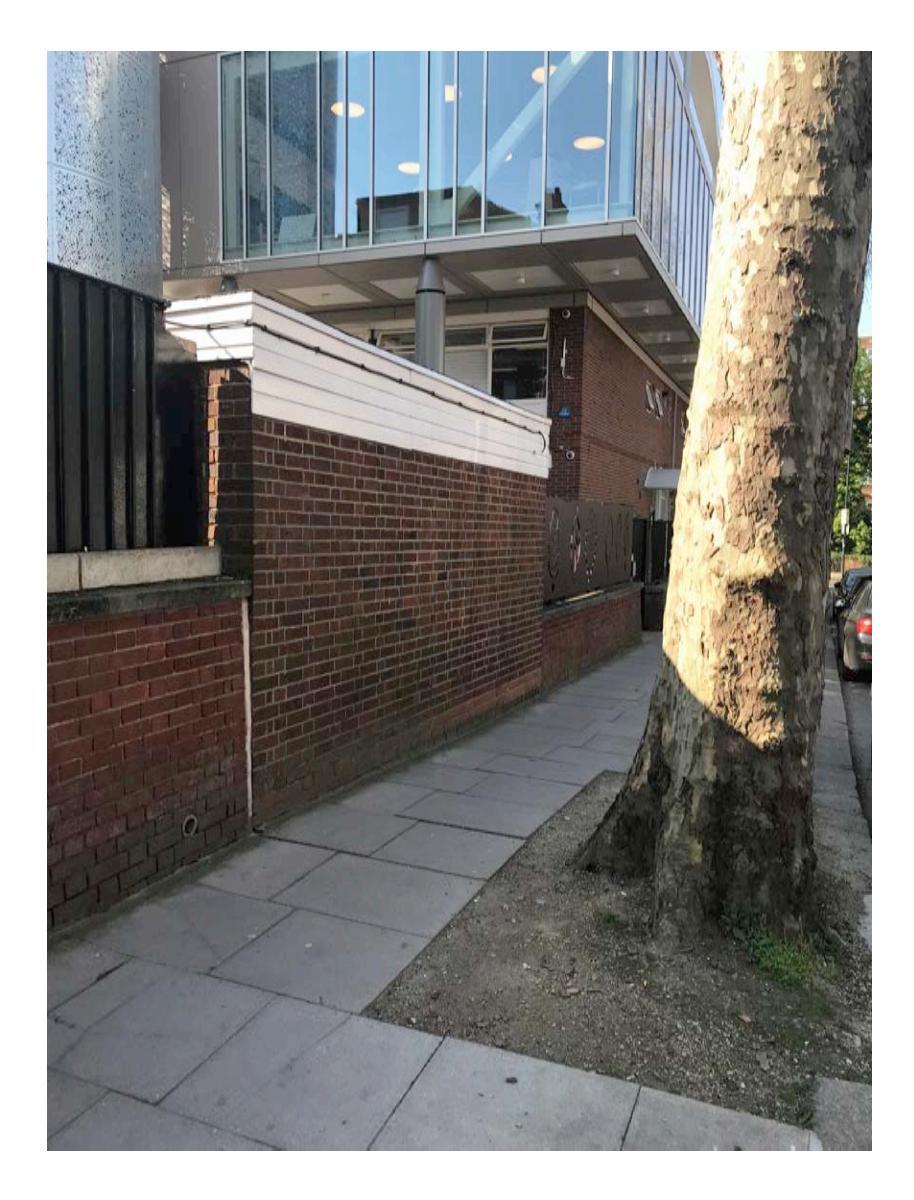
Drainage channels run into Minster road from the School grounds and construction materials are likely to seep into these channels and contaminate the T1 planting pit causing ill health in the tree. Crane and hiab operations underneath the canopy of T1 may cause mechanical damage to the stem and canopy branches. Similarly the stem of T2 adjacent to the school on Minster road is liable to this also.

Photo 3: Brickwork wall adjacent to tree stem is the street side boundary of the staff room. Drainage channel present left of staff room. Measurement between tree stem and boundary wall: 180cm.

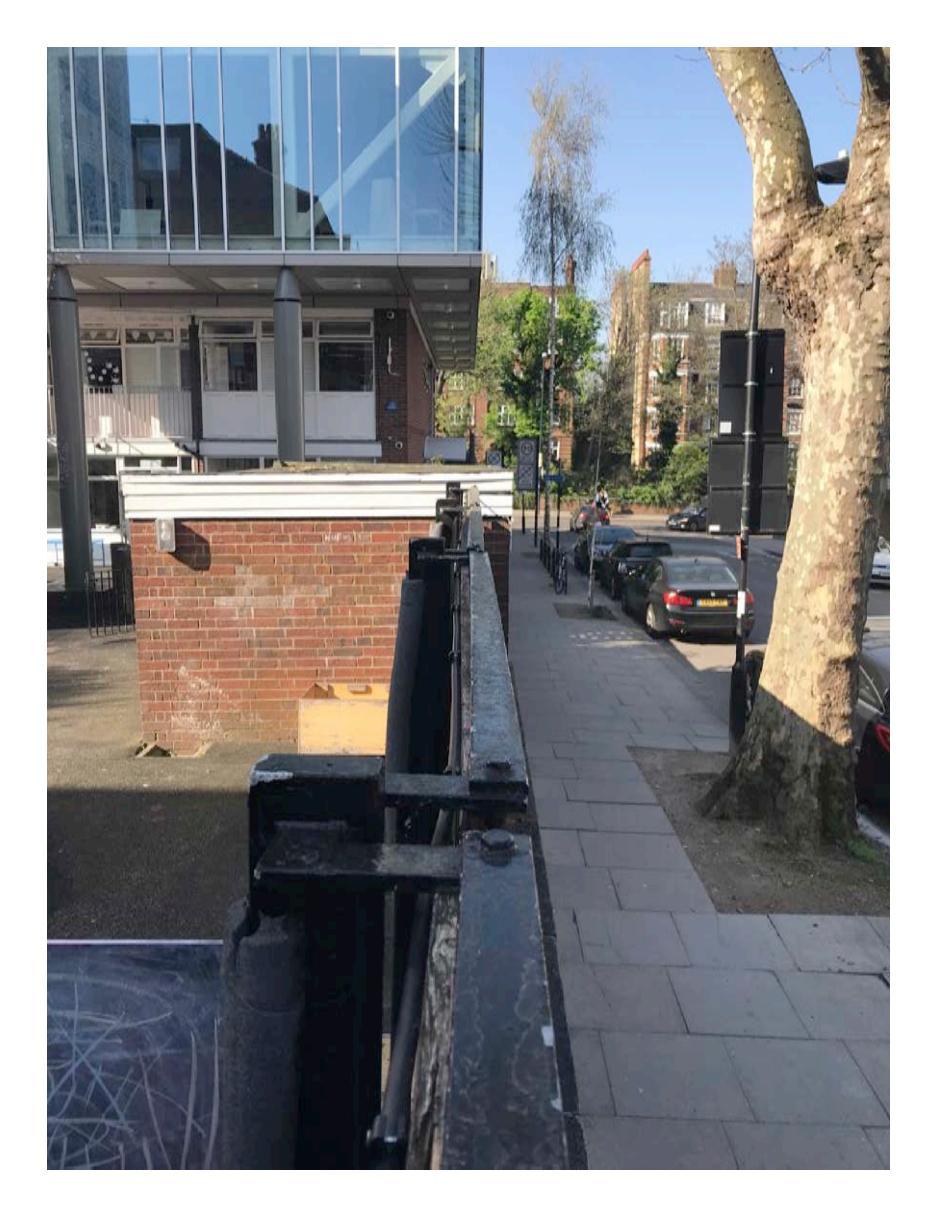
Photo 4: Taken from boundary line facing south-west. Further illustrating the site of proposed development and changes in ground levels.

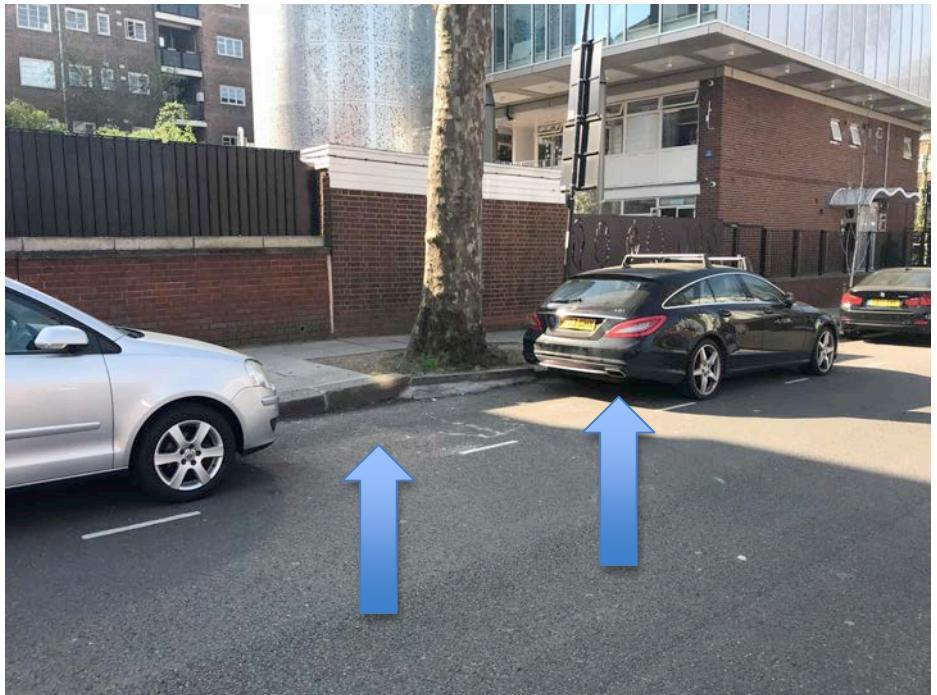
The 2 parking bays adjacent to the tree stem of T1 should NOT be used for construction vehicle activity to safe guard the health of this tree. Photo illustrates where not to unload materials and if the use of a crane is specified it must be away from the canopy of this tree:
