BS5837 Arboricultural Impact Assessment

1 Rona Road, London, NW3 2HY

Job Reference: 02906Rv2

June 2018

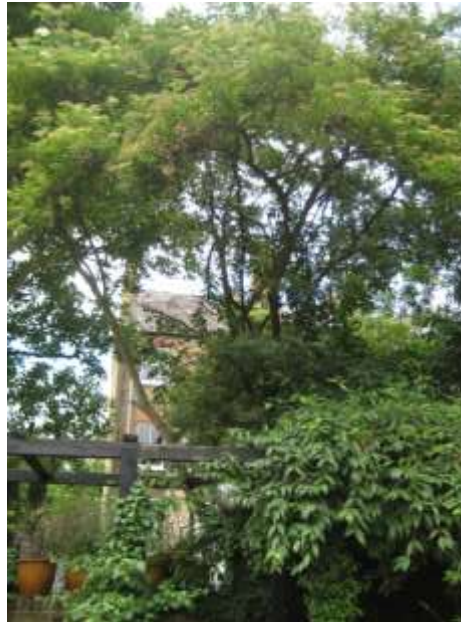
Fig 1 – Localised crown lifting and reduction to overhanging 3rd party trees T1 – T3 (all Elder) will be undertaken. T2 shown above.

- 5.3.1 No trees will be removed to facilitate the proposal but localised cutting back and crown lifting of T1, T2 & T3 (all Elder) will ensure adequate clearance.

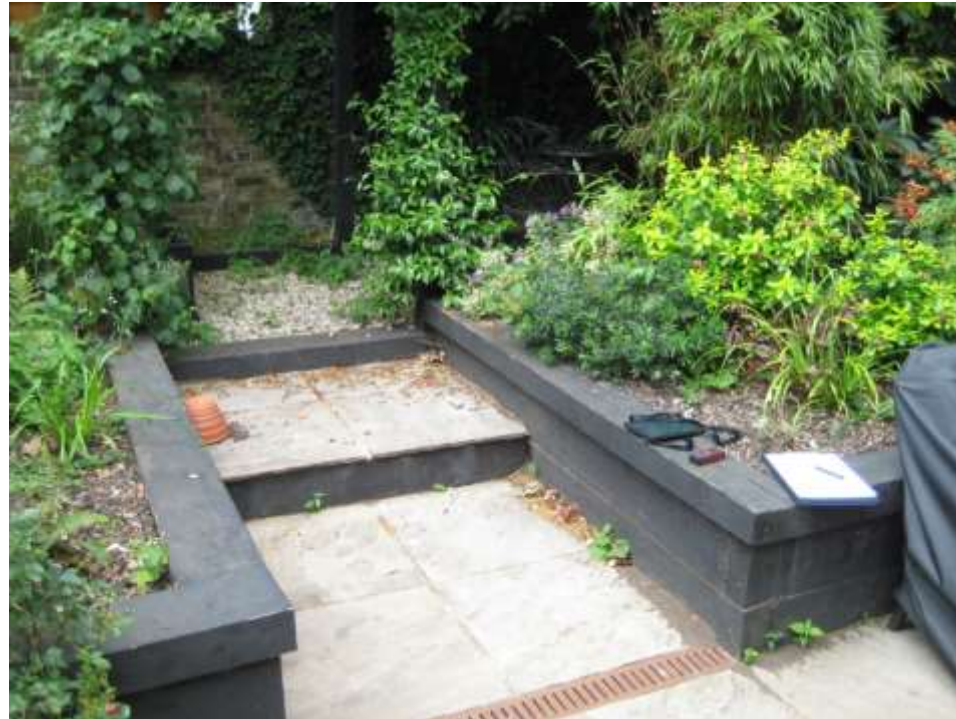
- 5.7.1 No ground level changes within the RPA areas of retained trees are proposed other than the installation of the pad stones detailed elsewhere. It appears the area of installation has previously been raised given surrounding ground levels.

Fig X – It appears that the rear garden ground level has previously been raised. This was most likely undertaken when the rear extension was added.
