BS5837 Arboricultural Impact Assessment

59 Broadhurst Gardens, London, NW6 3QT

Job Reference: 02915R

July 2018

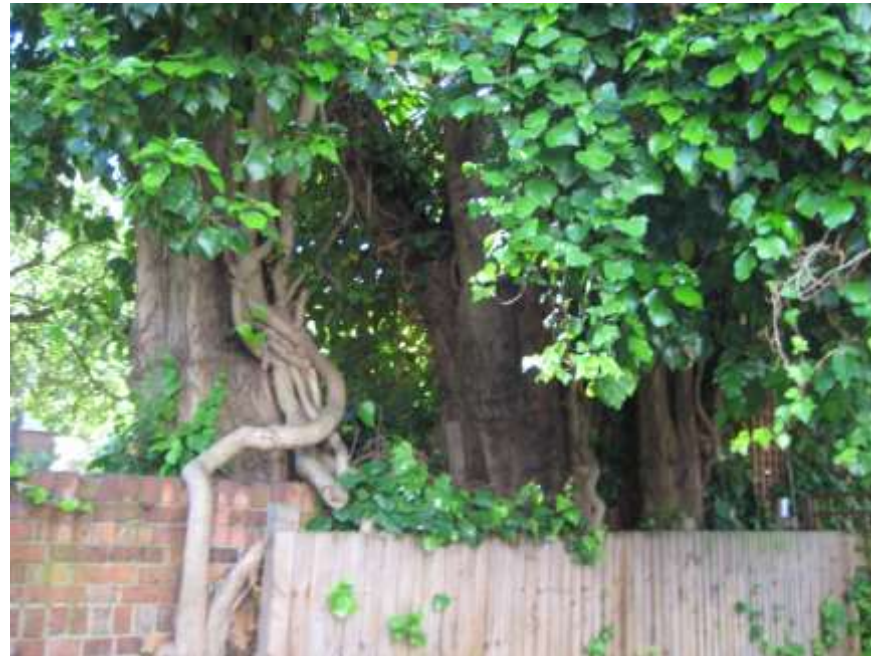
5.3.1 No trees will be removed to facilitate the proposal but we would advise the complete severing of all Ivy stems on the lower trunks of TG1.

Fig 1 – There are very large Ivy stems on the lower trunks of TG1 and given the tree sizes and locations we would advise this is severed to allow better future inspections.

Tree No.	Species	Proposed Tree Works	BS Cat
TG1	Lombardy Poplar x 3	Sever all basal Ivy and advise 3rd party to re-inspect trees	C1

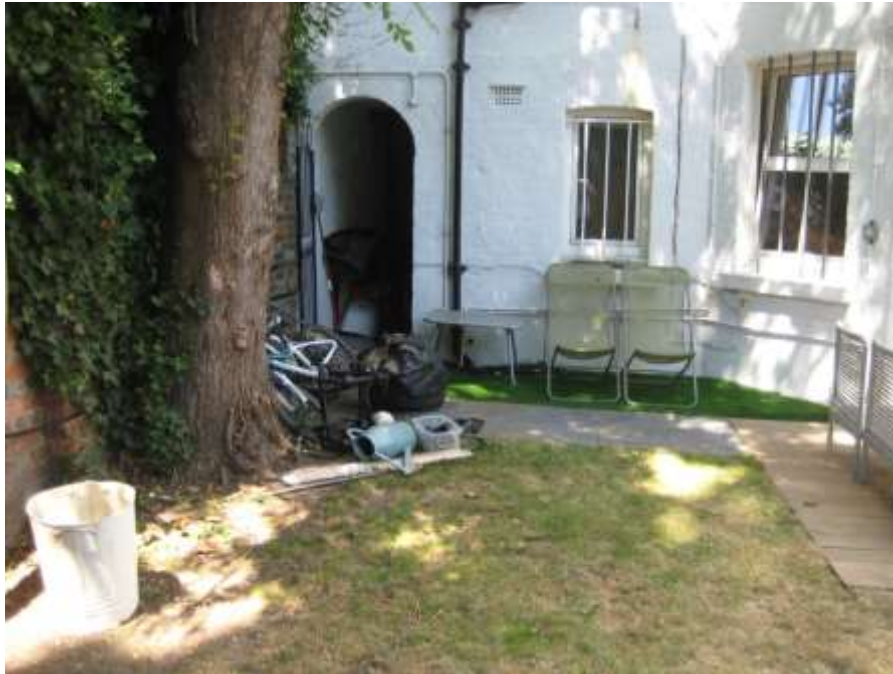
Fig 5 – The site benefits only from access through the property significantly limiting potential for machinery to access the site

- Access through existing property.
- Protective fencing for T2 visible left and ground protection for TG1 as indicated on Tree Protection Plan (Appendix 5)
-

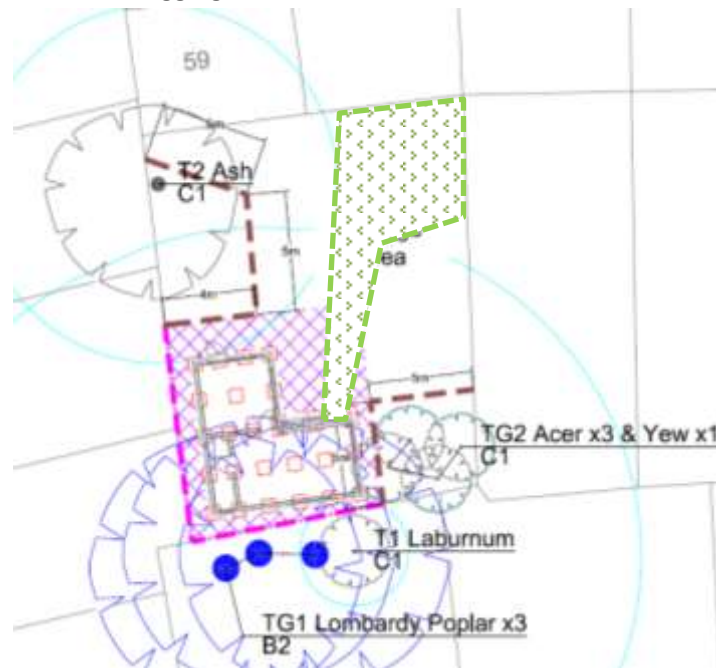
Fig 6 – A large zone (indicated above) is available for service trench installation outside retained tree RPA's

- 5.6.1 The new service trench will be hand dug. It will be positioned to be located outside the RPA of T2 and track away from TG1 and will be hand dug as an extra precaution adhering to the principles of hand digging outlined in section 5.4.

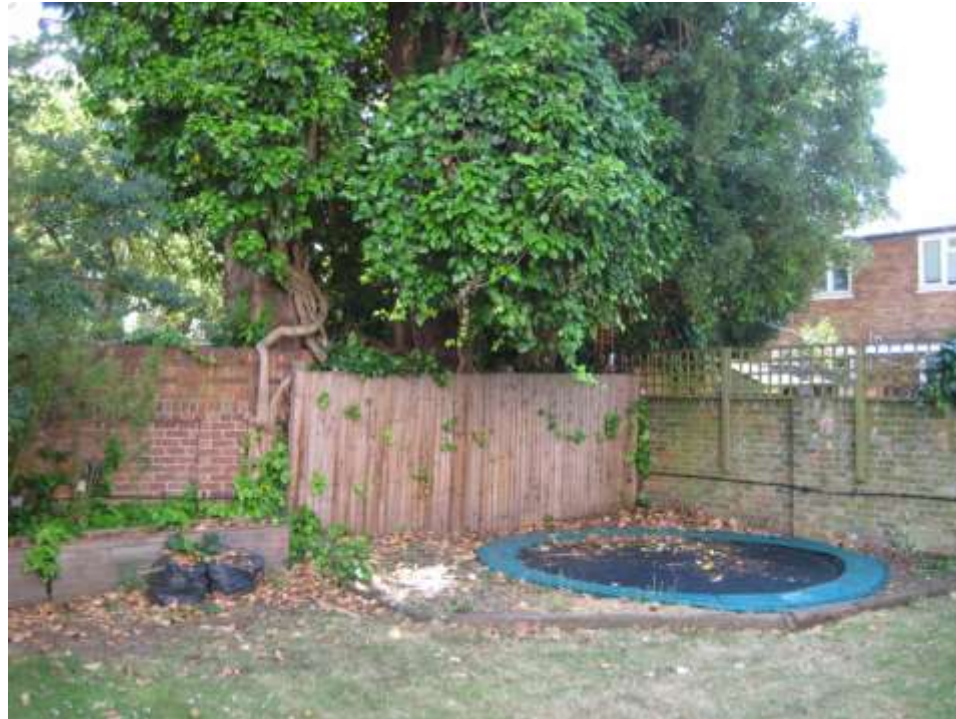
Fig 9 – There is an existing excavation for the trampoline which will be filled during the construction with material excavated from the other pad locations.

5.7.1 No ground level changes within the RPA areas of retained trees are proposed other than the installation of the pad stones and infill of the trampoline area below TG1.

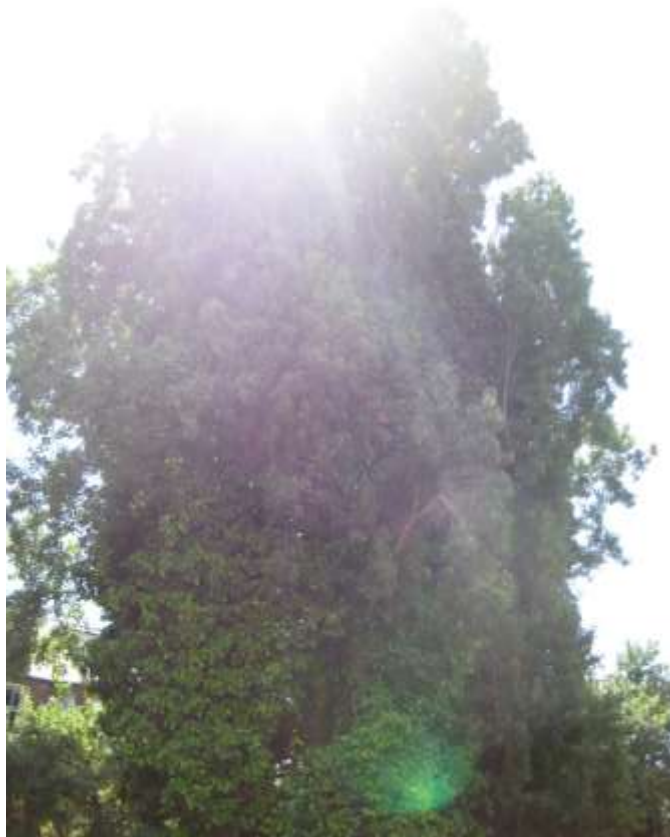
Image 1 – TG1 Lombardy Poplar x 3

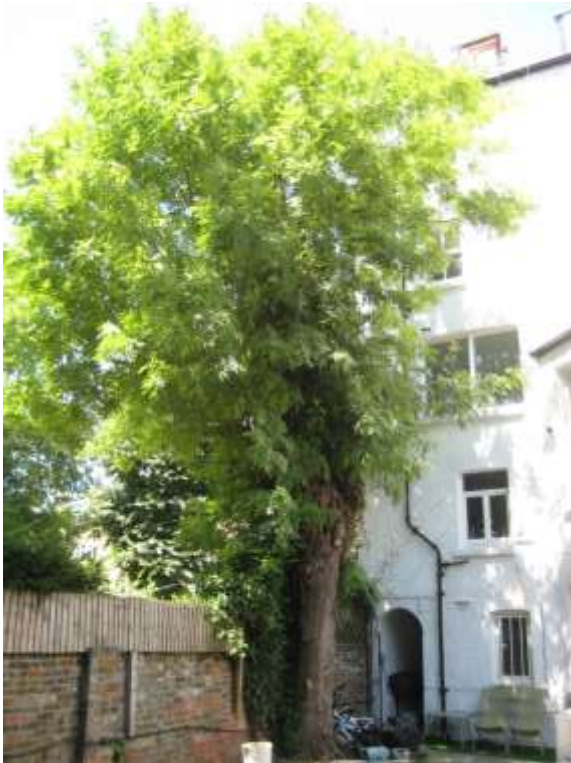
Image 2 – T2 Ash
