PROPOSED RESERVOIR AT MILBURN

Inspection Report of the reservoir (Lewin, Fryer and Partners, 1975)

SHOOT-UP HILL RESERVOIR

Report of the Result of an Inspection made under Sections 10 and 26 of the Reservoirs Act 1975.

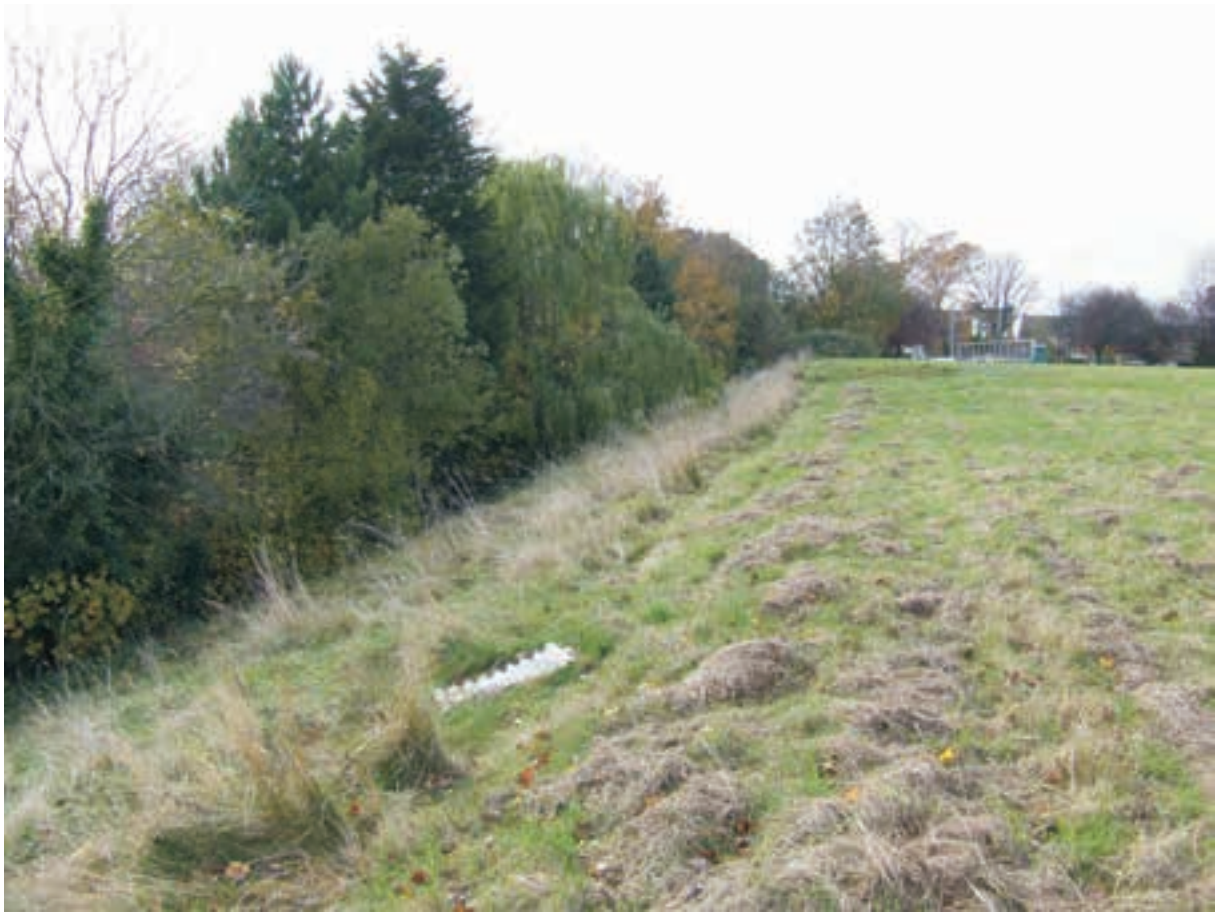
Plate 1: Large bank at the south of the site

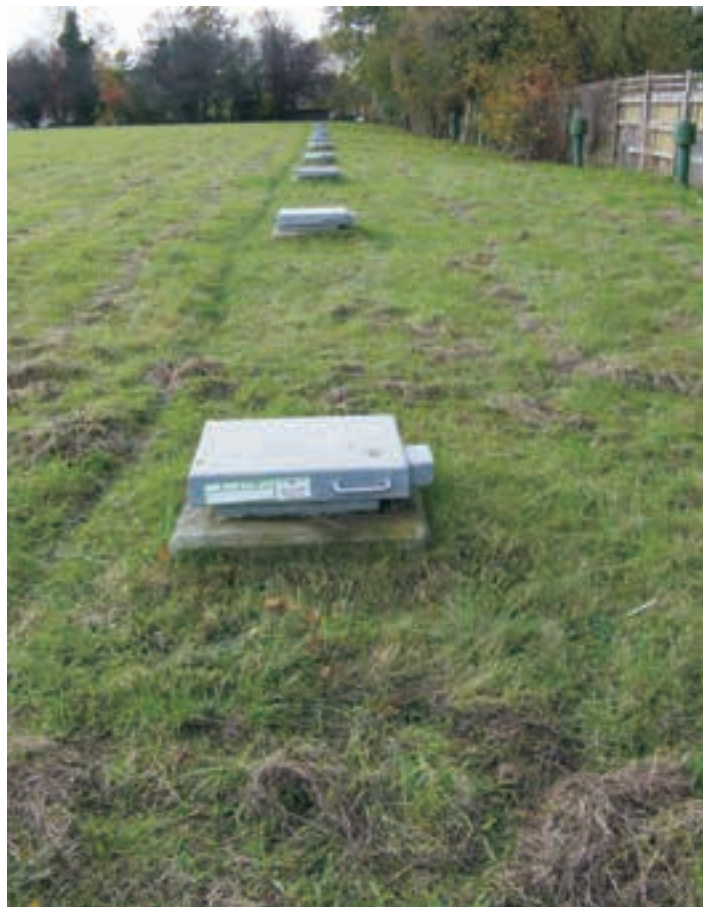
Plate 2: Evidence of the reservoir above ground

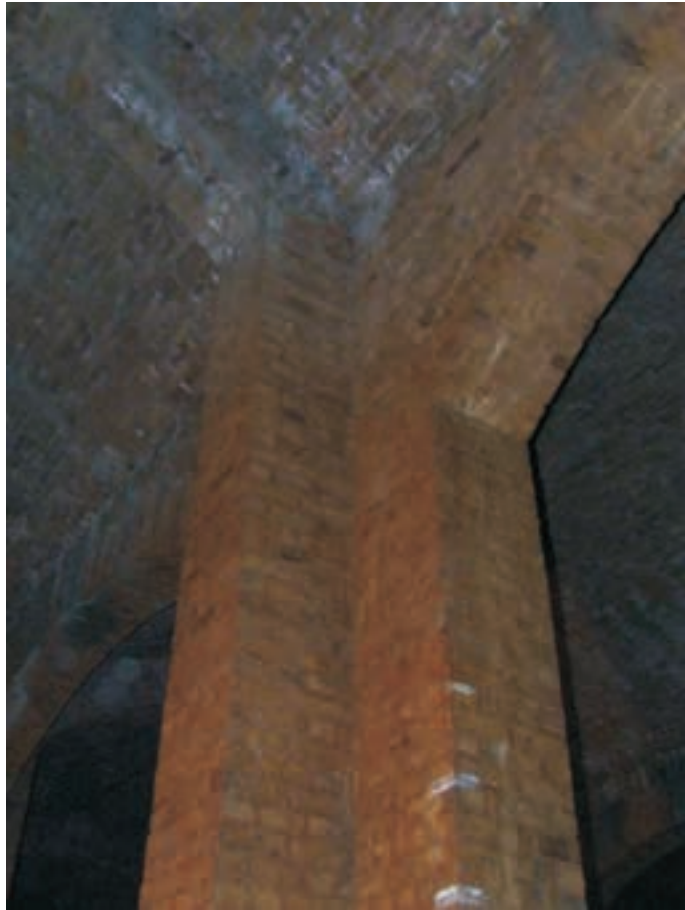
Plate 5: View up at the brick arches within the reservoir
