Proposed Services Risers

Mechanical and Electrical Services Risers

Roof and Loft Level

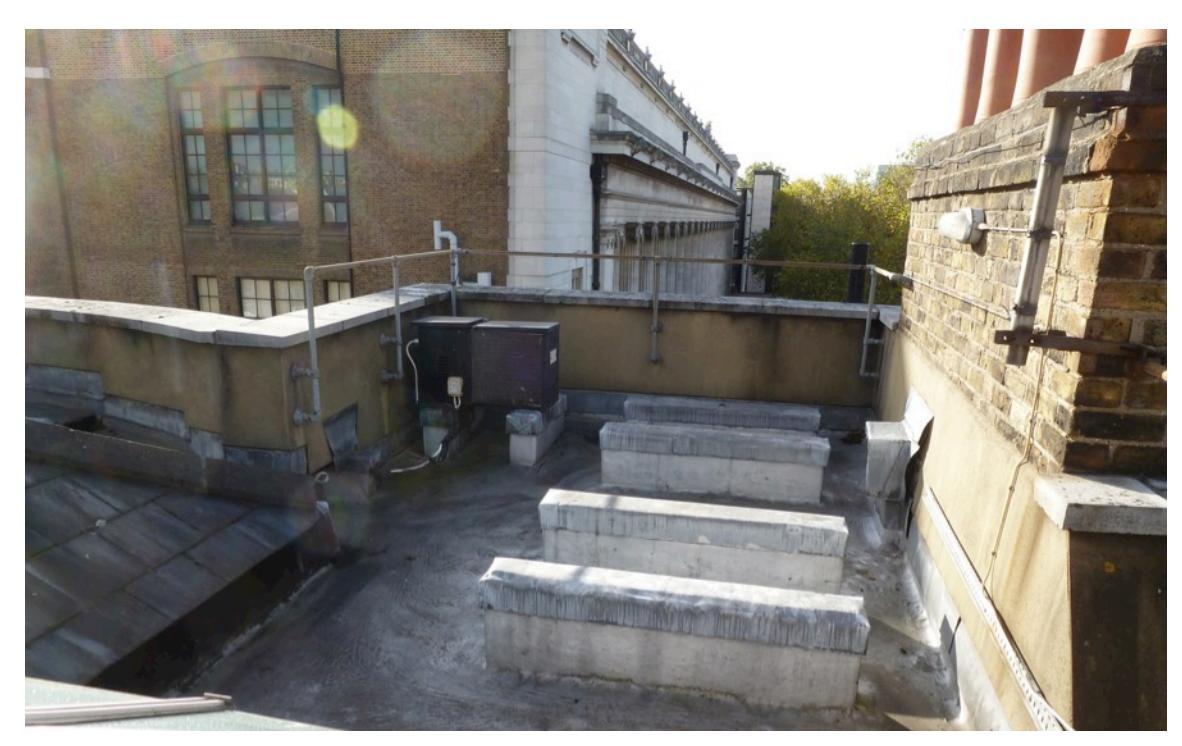
Above: Existing concrete plinths on flat roof area to be removed. New VRF units on 'big foot' system to be located behind existing chimney stack. Below Left: Repair works to skylight and roof are essential to achieve waterproofing. Below Right: Existing man safe system to be tested. If upgrading is required, new system to be provided as a like-for-like replacement.

- Remaining plant footings to be removed. Flat roof surface to be repaired or overlaid with new membrane applied over asphalt flat roofing surface.
- New VRF units to be located on roof level behind existing chimney stack to minimise visual impact ٠ from long views at street level. A background noise assessment has been carried out informing that acoustic screening to the plant would not be required. Screening to conceal condensing and ventilation external plant units if necessary. Plant mounted on big foot type system.

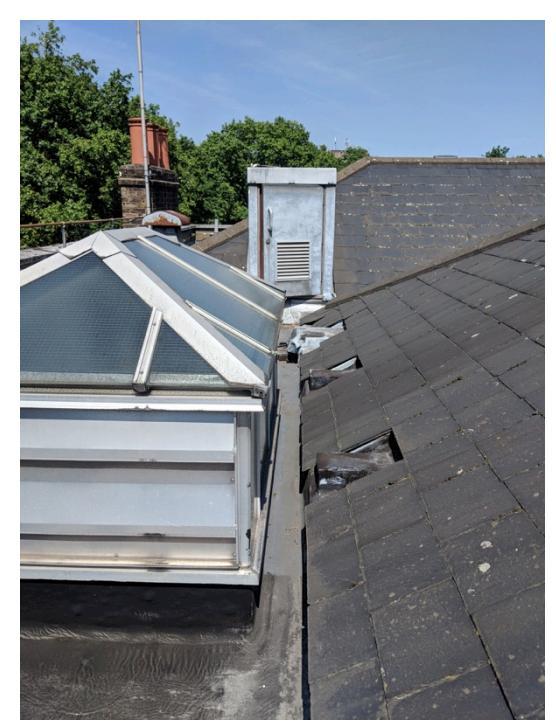
- Lightning protection may be required. To be advised.
- Existing skylight to be refurbished, repaired, and redecorated. Cracked glass to be replaced. • Weather seals and ventilation filters to be replaced with new.
