External works

British Museum Annexe Building

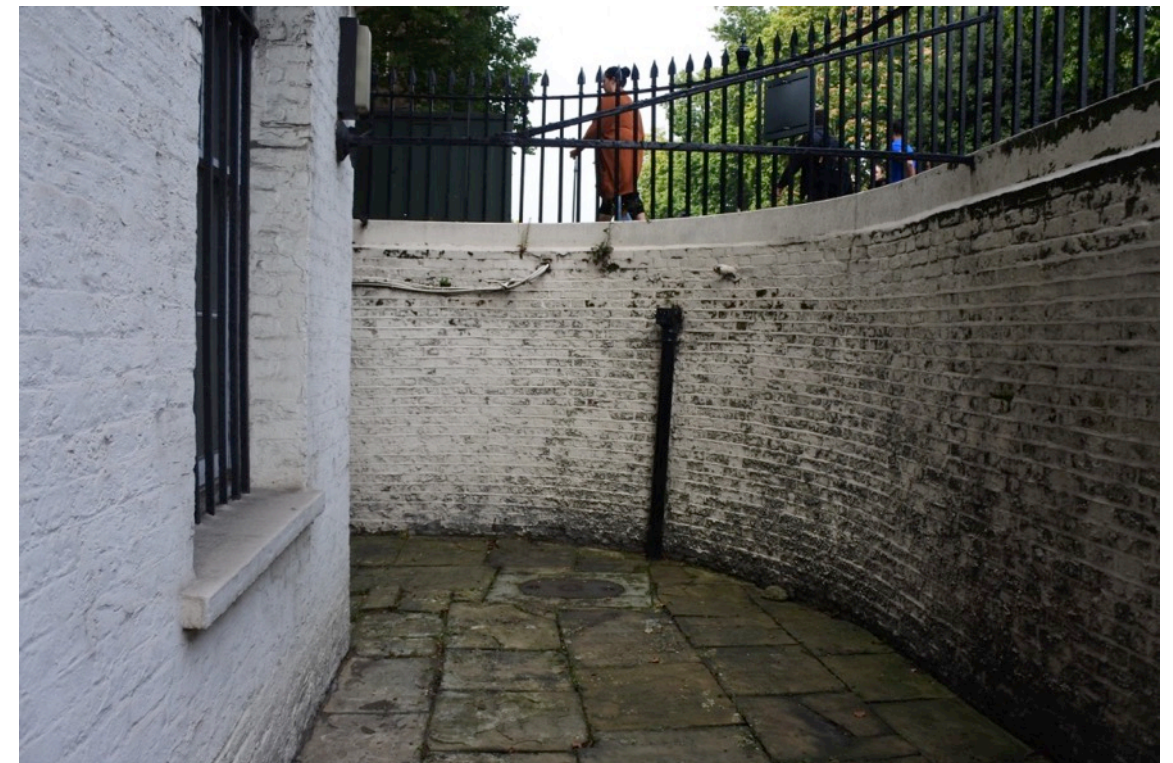
Top: Front Basement yard. Brickwork walls to be cleaned, repaired and repainted.

- Basement yard stone floor and brickwork walls to be cleared of organic growth and debris.
- Painted brickwork walls to be repaired, cleaned and repainted. Silicate based paint in cream colour to match existing.

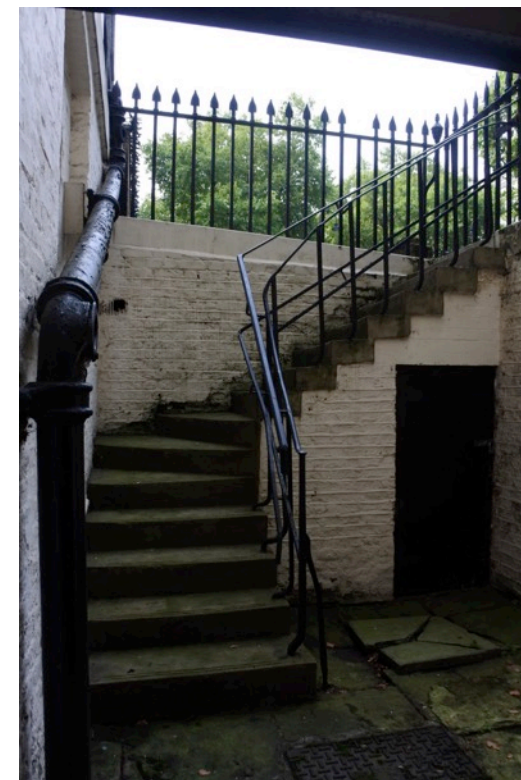
Left: Side Basement yard. Existing stone staircase and York stone paving to be cleaned and repaired. Essential maintenance works to be carried out to unblock drainage gullies.

- York stone paving to be cleaned and replaced/ repaired where slabs have cracked.
- Replacement of external metal walkway and stair in rear yard to suit new circulation.

- Stone paving to be repaired where concrete bases for walkway removed in rear yard.
- Drainage gullies to be cleared of debris and unblocked where necessary.

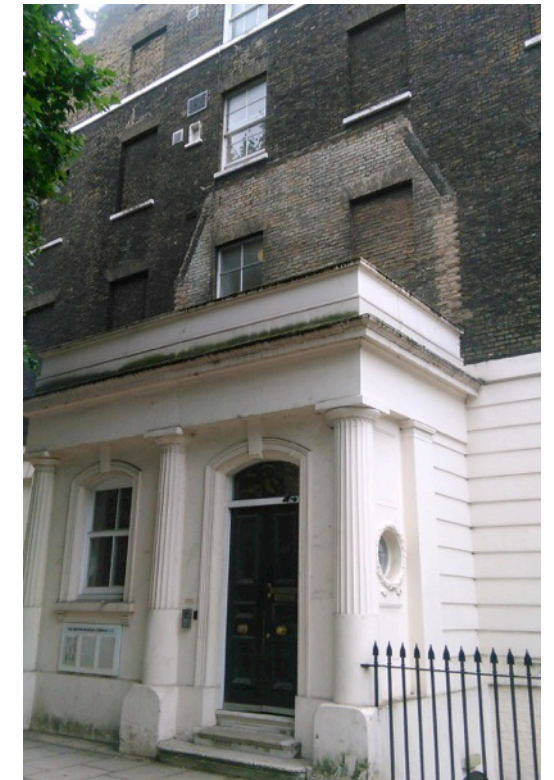
Right: Entrance portico to be cleared of organic growth, repaired and redecorated. Brickwork to main elevations to be cleaned to achieve a consistent tone.

- New metal handrail and balustrade to external terrace.
- Flat roof over entrance portico to be cleared of debris and organic growth. Any necessary repairs for weather tightness and integrity to be carried out as recommended following condition survey.

- Brickwork to main elevations to be cleaned to achieve a consistent tone while retaining its character. The level of cleaning is to be agreed with the Conservation Officer. Suggested mild clean to tone down brickwork to match original patina. Refer to Russell Square properties to the north of Montague Place for consistent brickwork appearance. Apply method of cleaning beginning with water and the least invasive methods to avoid damage to bricks.
