Lauderdale House, Waterlow Park, Highgate Hill, N6 5HG

Lead Flat Roof Replacement & Cupola Works

Lauderdale House, Highgate, London Cupola Report Site Survey & Scheme of Works Conducted on Tuesday 6th June 2017

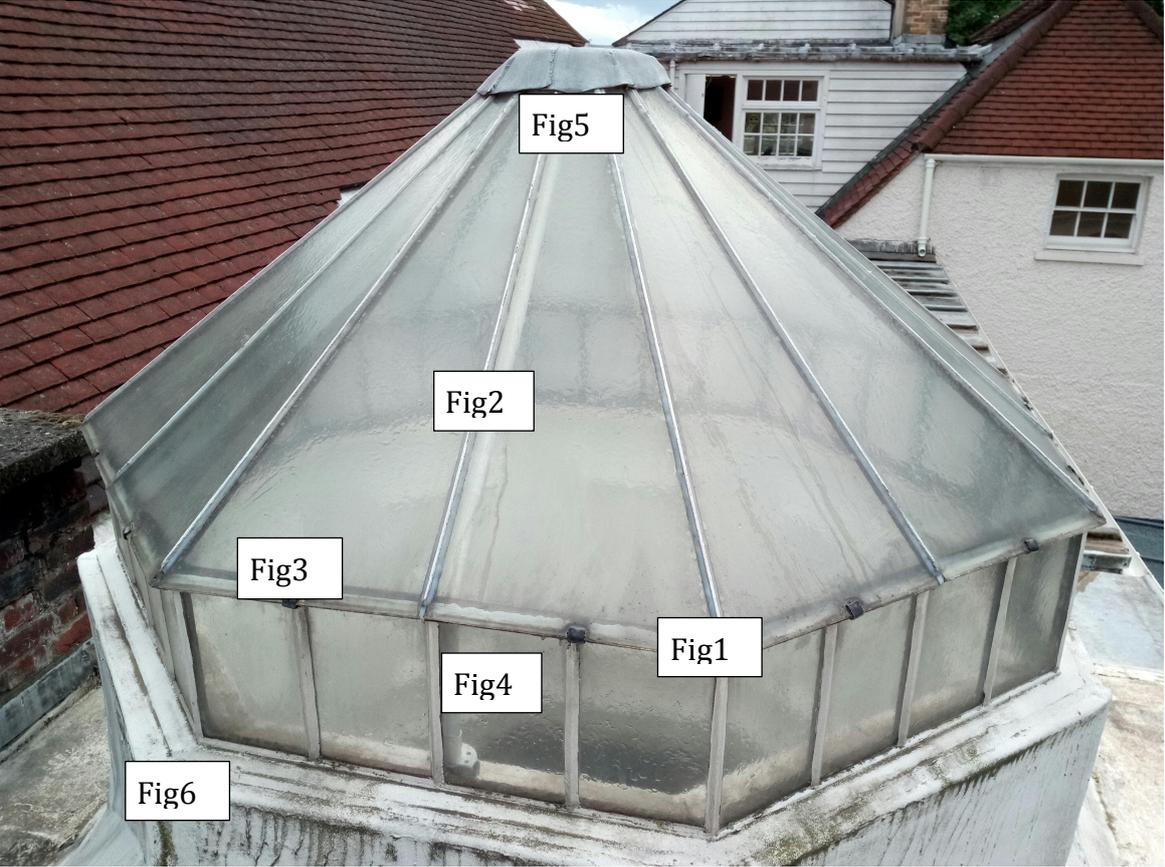
Glazing – The top sections of glass are laminated with a very poor rough edged finish. These do not overhang enough due to the sloping steel sections being too short that hold the glass in place, causing any water run off to not clear properly. See Fig1

Glass Fixing – The glazing would have been fitted with a traditional linseed oil putty. The bottom glazing is putted with many layers of paint applied on top but the above glazing has been bedded in with a clear silicone which is very unsightly and incorrect. Also, the steel section that holds the top glazing in place is of an insufficient sized profile to take the thick laminated glass as there is limited room to apply a good sized bead of putty. See Fig2

The top glazed sections are also held back by safety clips incase the putty fails which prevents the glass slipping away. These are made of lead and are very weak and insufficient. See Fig3

Ventilation – There is a slight gap between the top of the bottom glazing frame and the underside of the top glazing all the way around, but this has been sealed up with silicone all the way around probably in an attempt to stop any leaks. This should act like a trickle vent that you get in modern day windows. A Trickle Vent does exactly that and allows air to trickle into an area at a reasonable rate so that you will not feel a cold draught, keeping condensation at bay and giving you a balanced environment all year round. The gap also provides an escape route outside for any moisture that could potentially built up on the underside of the top glazing. See Fig4

There is a leaded cap on the very top point of the cupola which is for weather proofing and also ventilation. The removal and further inspection of this when work starts will provide evidence to see if it is sufficient enough for ventilation. See Fig5

weatherproofing and sealing around the outside seems to be inadequate as the lead sheeting appears to just butt up to the steel frame. This was difficult to see due to paint treatments to the lead and steel. See Fig6

Recent photo of Cupola during visit. See for Figure codes.
