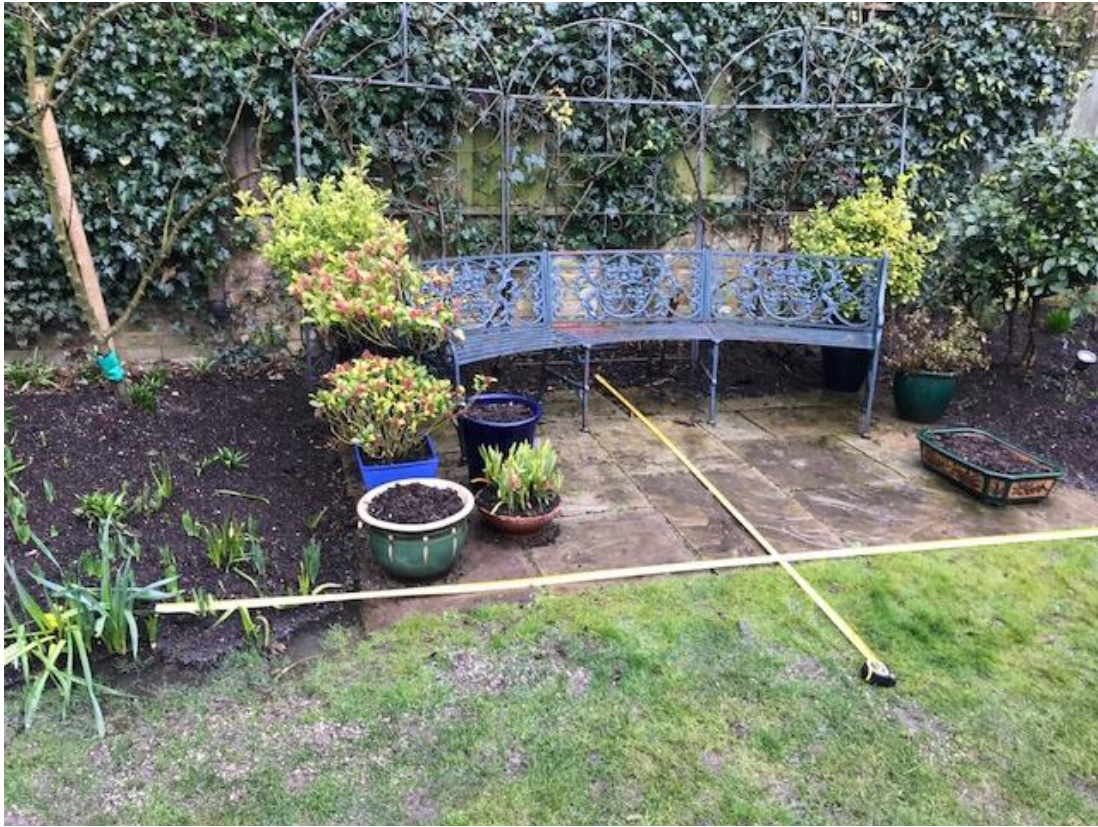
Area prior to build

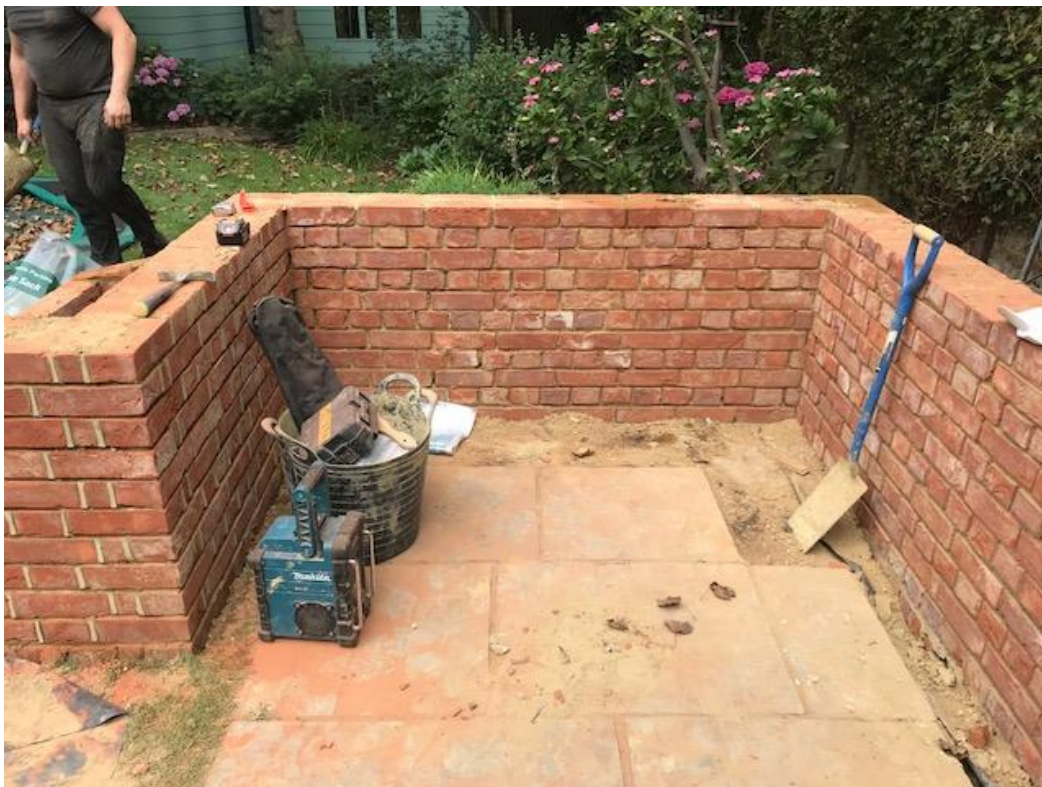
Internal view after wall built showing original paving minimally disturbed.

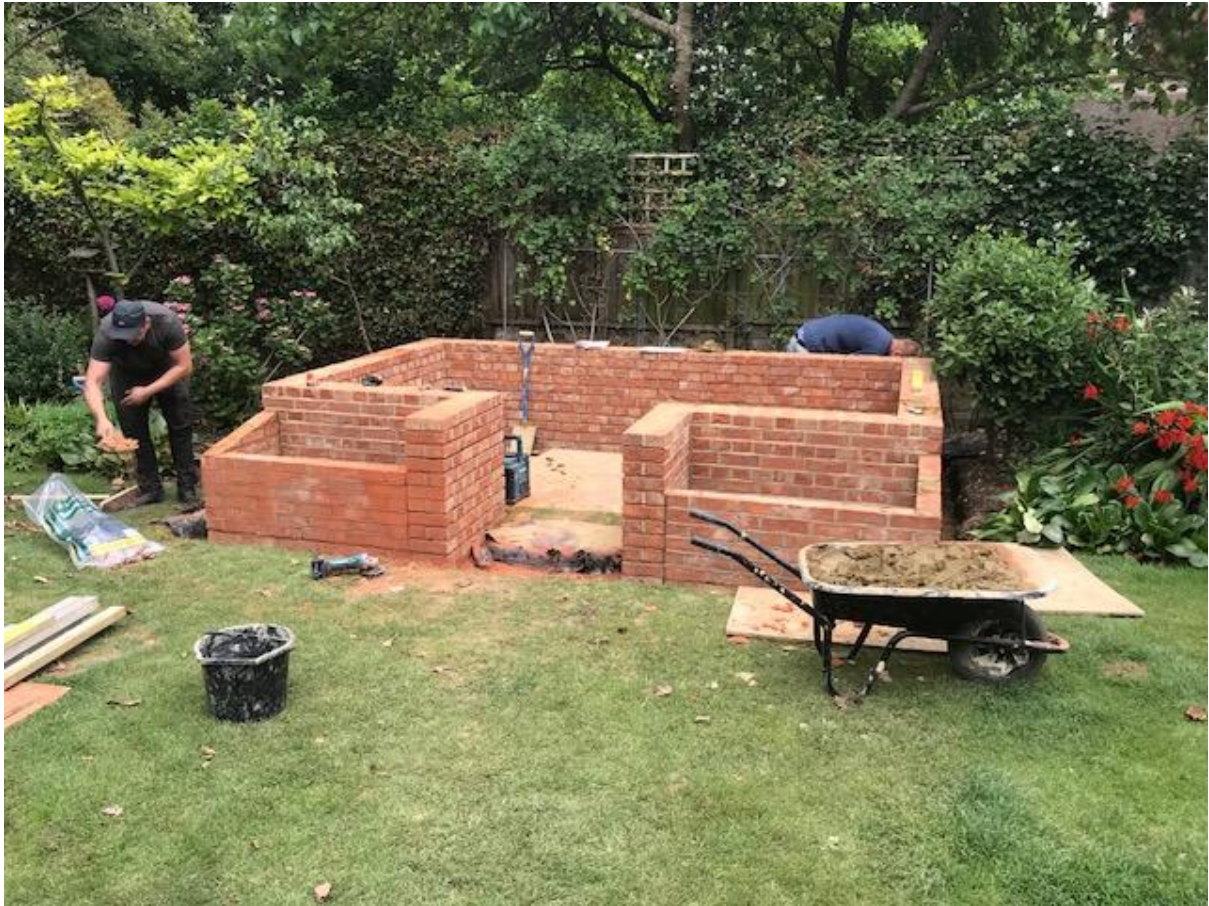
Trenches for wall were cut as narrow as possible to minimise disturbance.  
Also note condition of surrounding grass. Only hand tools used no machinery to dig.
