ARBORICULTURAL IMPACT ASSESSMENT REPORT FOR:

38 Glenloch Road
London
NW3 4DN

Ref: NBA/38/AIA/01b

Date: 23rd February 2018

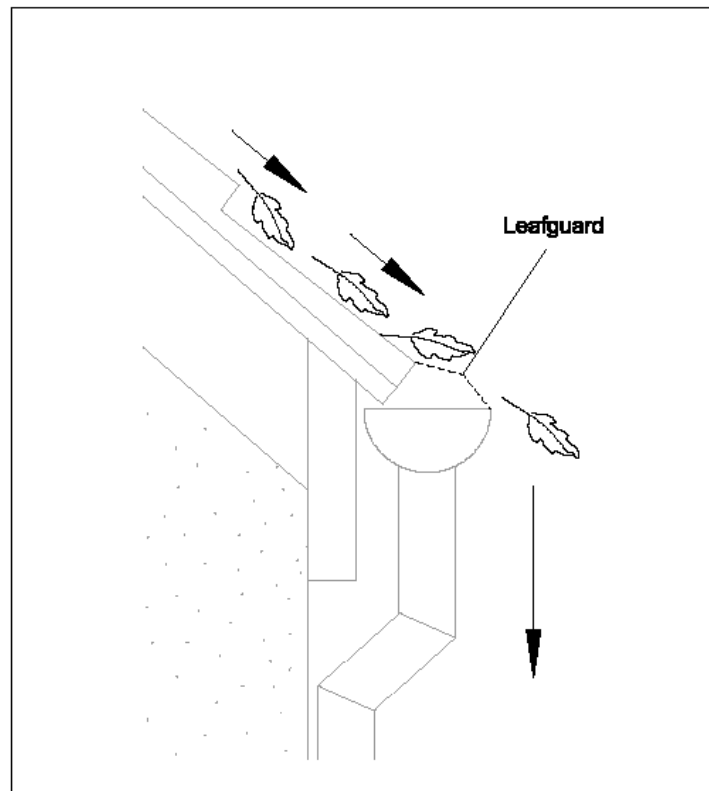
Figure 5: Filtration traps, as shown above, could be fitted on the gutters which can easily be maintained at 2-3m above ground.

- 6.3.4 Nuisance deposition can be further mitigated with routine maintenance, light pruning / deadwooding and the fitting of filtration traps on guttering (see Figure 5 below).

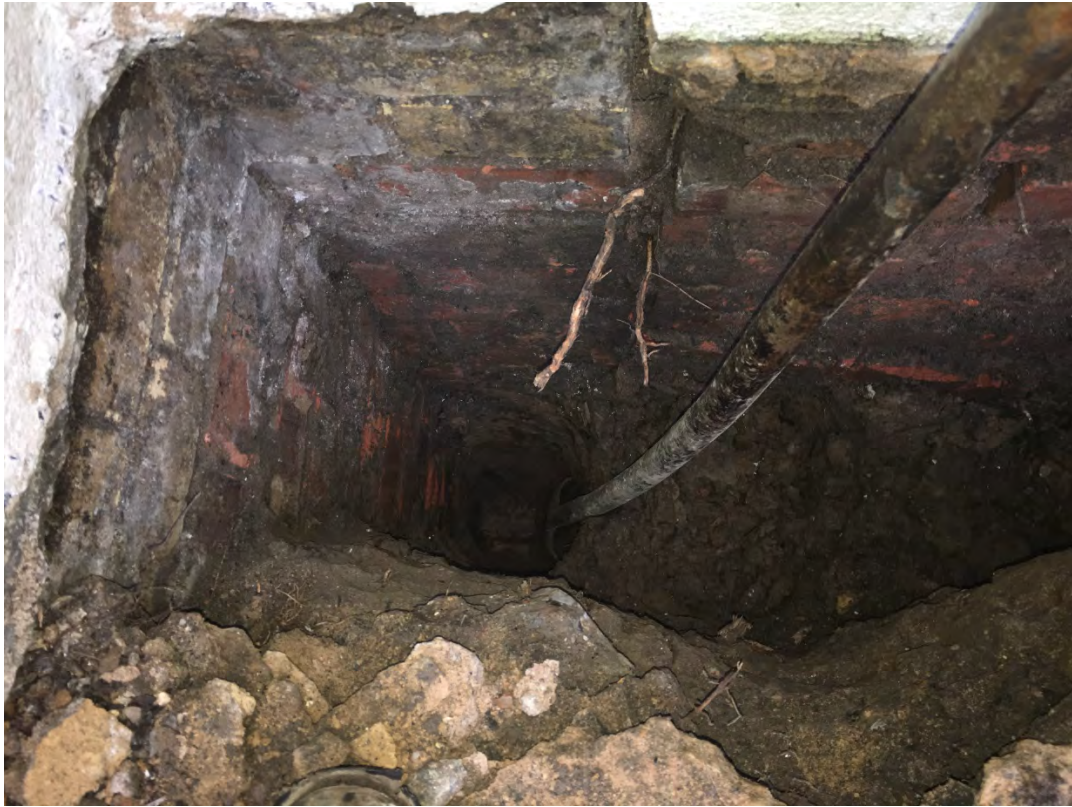
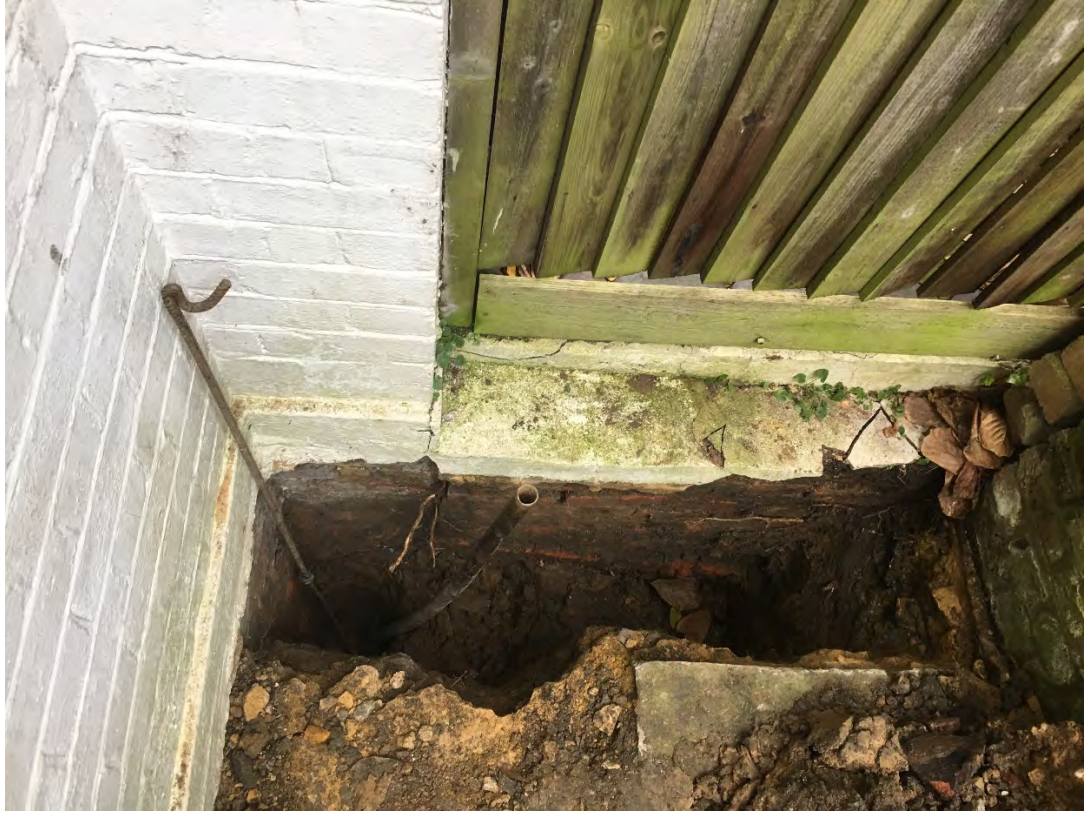
TRIAL PIT 4 PHOTOS

- 4.1.3 In BS5837, paragraph 4.6.2 states that RPA's should reflect the morphology and disposition of the roots; where pre-existing site conditions or other factors indicate that rooting has occurred asymmetrically, a polygon of equivalent area should be produced. Modifications to the shape of the RPA should reflect a soundly based arboricultural assessment of likely root distribution.
- 4.1.4 **No a priori modifications were made in the compilation of our report, However, subsequent trial pit investigations indicate no on-site rooting from T4 magnolia.** [Jomas Associates Ltd](#) appointed/sub-contracted [Oakland site investigation](#) to undertake the trial pits on 14/11/17 and bore holes on site and Nash Baker Architects witnessed them dig trial pit no. 4 manually with hand tools (App 4).
