BS5837 Arboricultural Impact Assessment

91 Regent's Park Road, London, NW1 8UT

Client: Alexander Martin Architects

Job Reference: 02960R

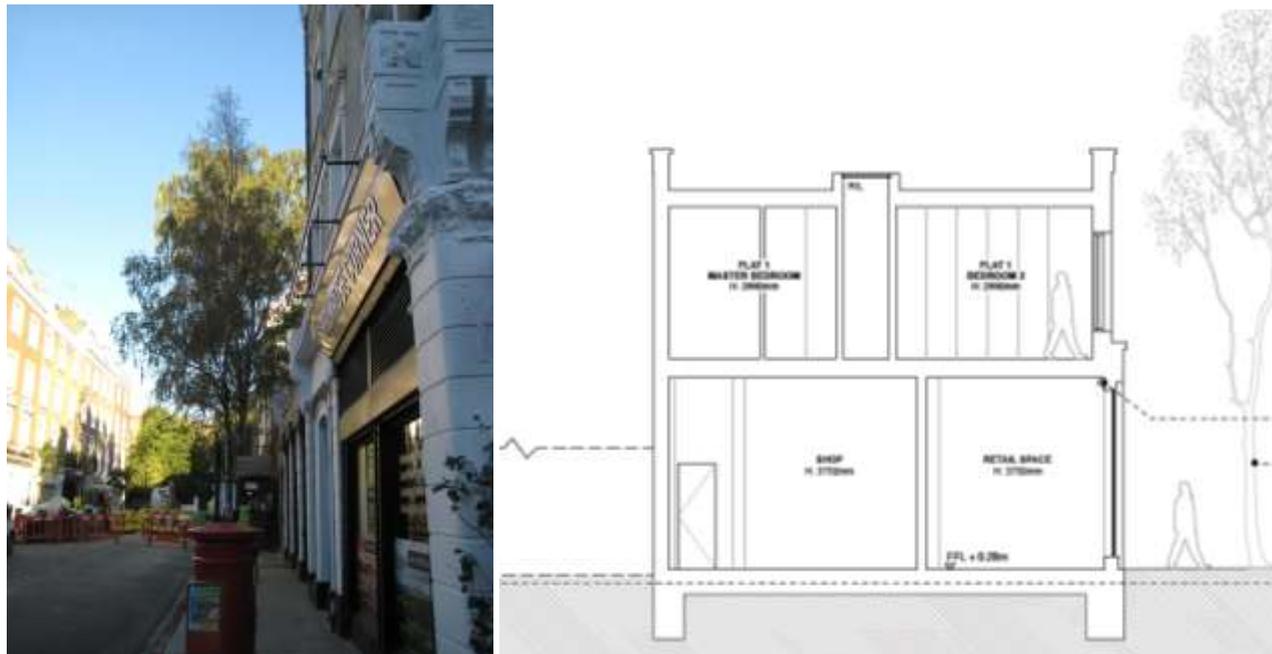
- 5.3.1 No trees will be removed to facilitate the proposal but minor tipping back of T1 may be required. The branch size affected will be minimal and such works would serve to establish points for future canopy reduction works. In addition the slight step back of the 1st floor addition likely reduces the need to do this work further. The tree is an early-mature example and will not be adversely affected by such works subject to them being carried out by a competent contractor and in accordance with BS5837 (Tree Works).

Fig 2 – T1 (left) looking down Erskine Road with section showing slight step back of 1st floor level. Any pruning will be limited to minor canopy branches.

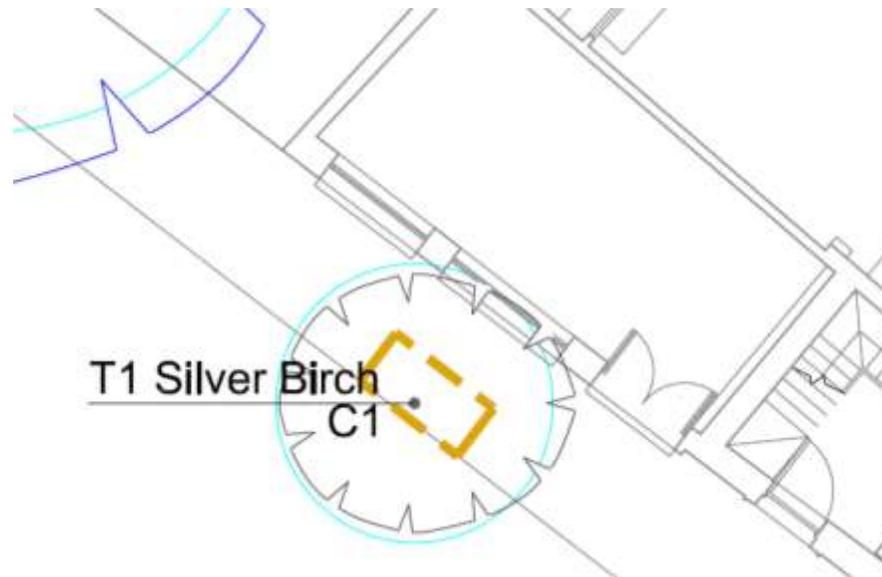
5.4.1 No demolition is proposed but we have been advised that there may be a requirement to strengthen existing foundations by way of localised (internal) underpinning works. Such works would be located outside the RPA of T1 and should therefore have no discernible impact on this tree.

- Building may require internal underpinning.
- All movements over existing hard surface.
- Basal shuttering for T1.
- Underpinning excavations outside RPA.

Fig 3 – T1 showing basal shuttering and RPA relative to existing building footprint.

5.4.2 As a precaution T1 will be basally shuttered to remove the risk of lower stem damage during site works:

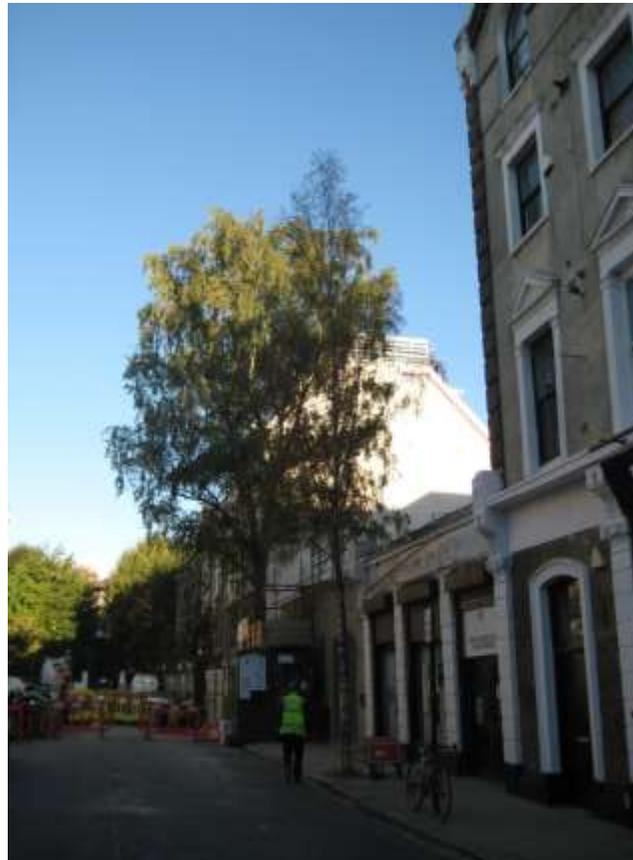
5.5.1 No new surfaces are proposed and the existing hard surface remains in place for the duration of the works removing the risk of ground compaction.

Fig 4 – T1 showing existing hard surface arrangement which remains unaffected by the works

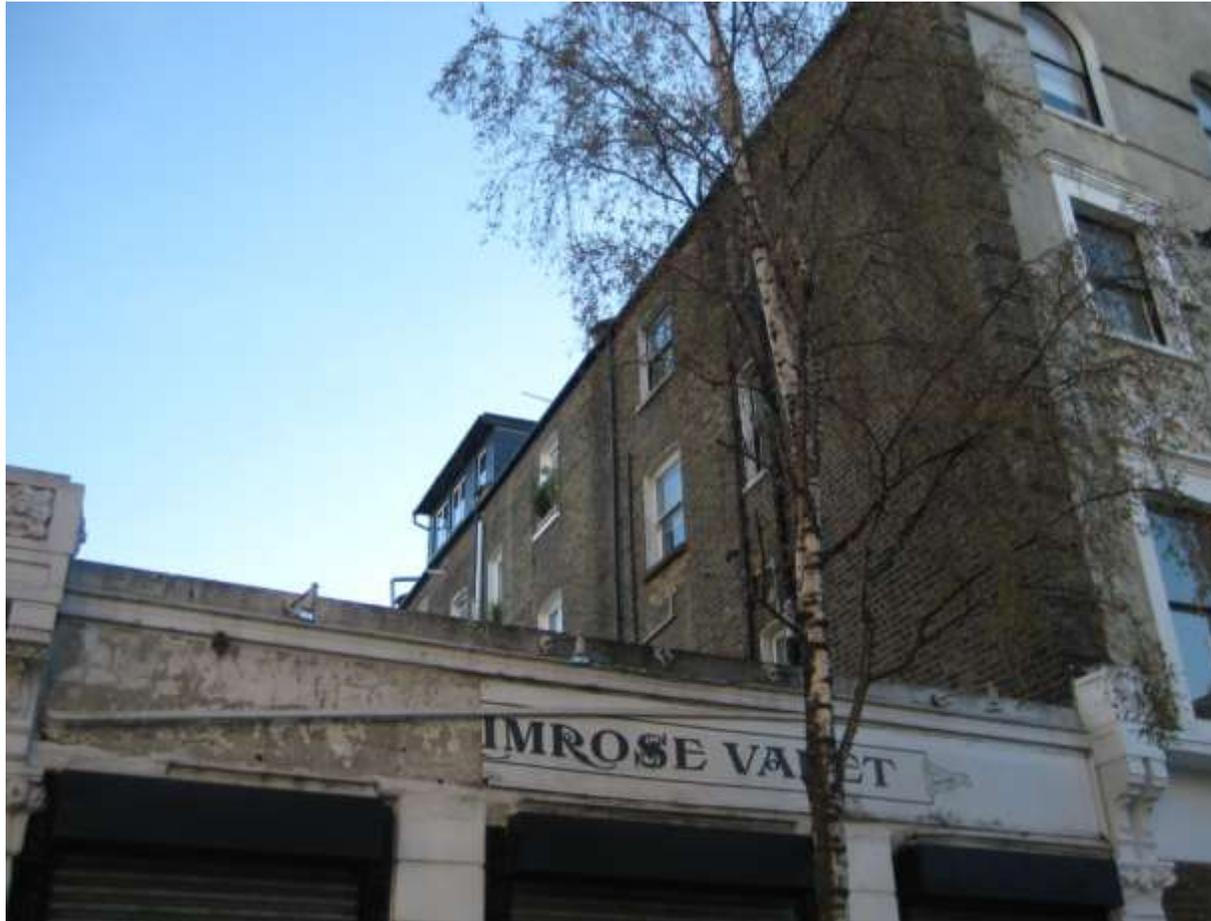
Image 1 – The proposal includes extending over the existing ground floor.

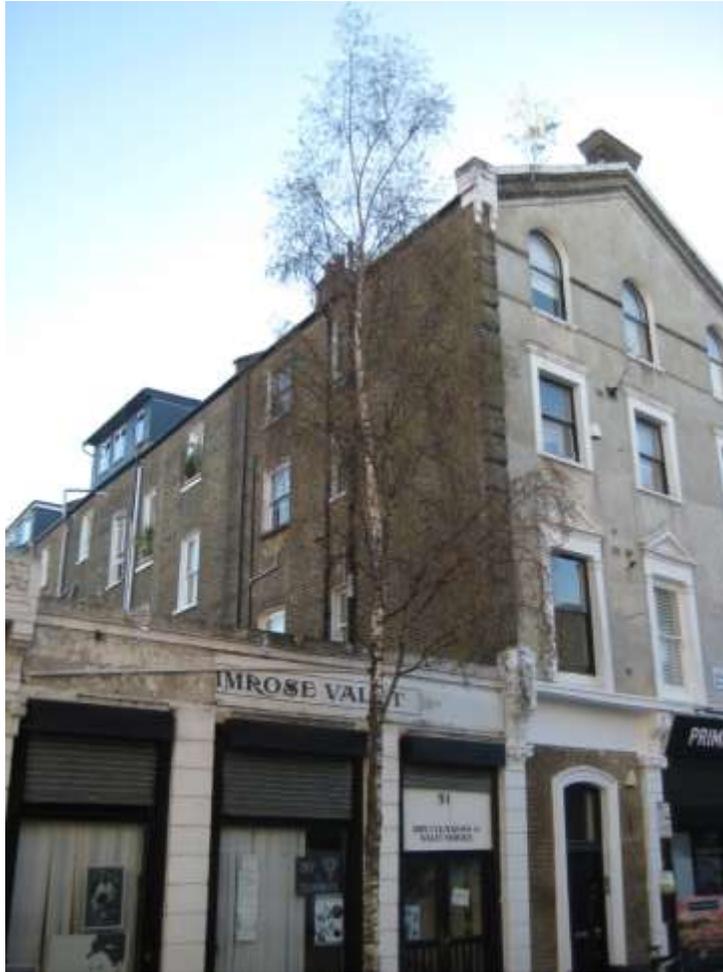
Tree No.	Species	DBH (m)	No of Stems	Ht (m)	Crown Spread				BS Cat	Age Class	Life Expect	Cr Ht (m)	Observation	Recommendations	RPR (m)
					N	E	S	W							
T1	Birch (Silver)	0.18	1	12.5	2	2.5	2	2.1	C1	Early-mature	20 to 40	3.2	Established tree with uniform shape. Evidence of drought stress.	Minor tipping back in accordance with BS3998 to provide 1.5m clearance from building as/ if required.	2.2
T2	Birch (Silver)	0.4	1	15	5	5.4	5.6	5.6	B2	Mature	10 to 20	2.6	Larger established tree already boxed in for development works. Limited access to inspect. V union at 4m.	No works	4.8

Image 2 – T1 Silver Birch

Tree No.	Species	Proposed Tree Works	BS Cat
T1	Birch (Silver)	Minor tipping back in accordance with BS3998 to provide 1.5m clearance from building as/ if required	C1

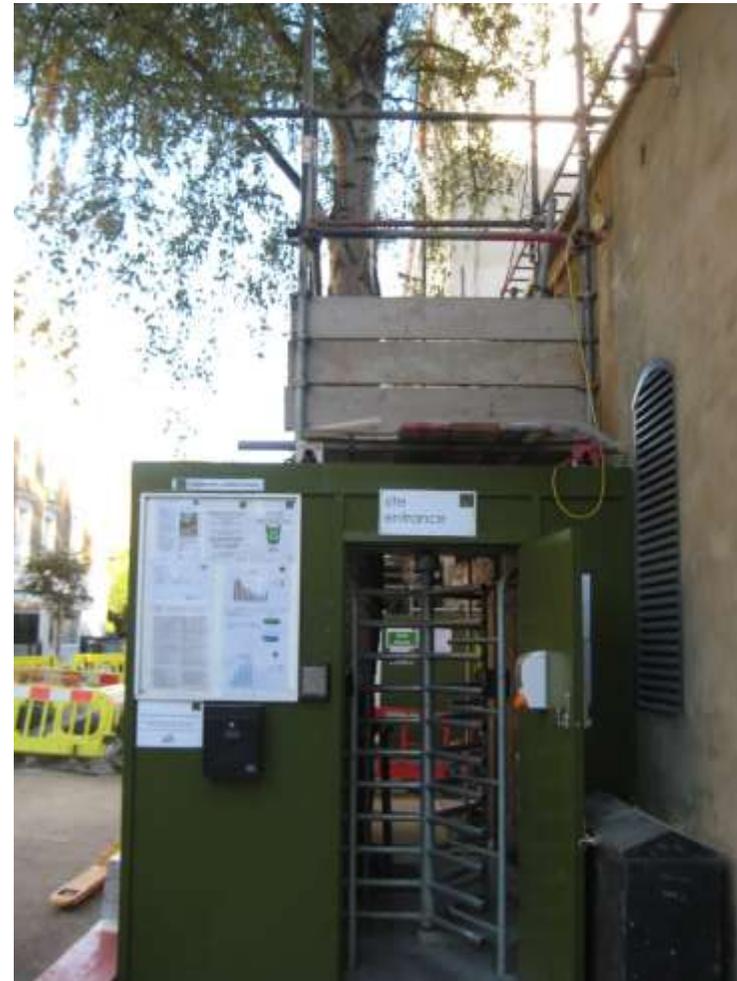
4.5 It is noted that development works are currently being undertaken close to T2. This tree is located away from the proposed works relevant to this report but it is included for completeness.

Image 3 – T2 is located away from the proposed works
