ARBORICULTURAL IMPACT ASSESSMENT

Mount Vernon, Frognal Rise,
NW3 6QR

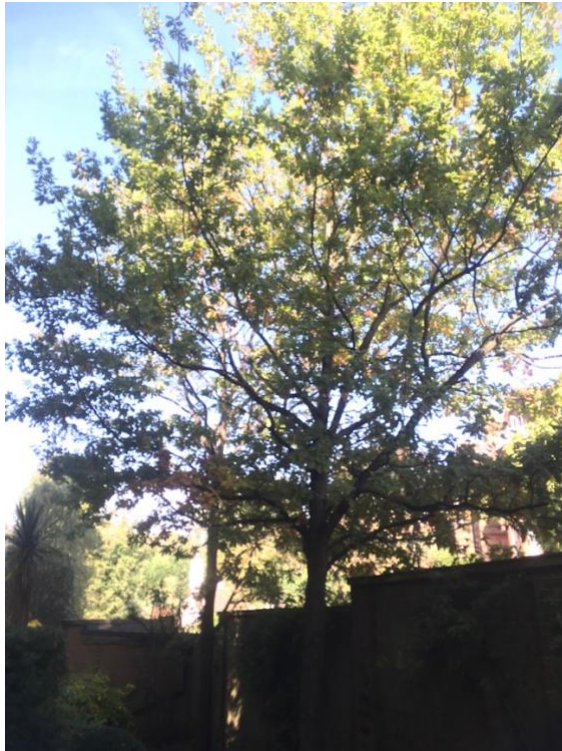
Figure 3 The tree T1

T1 and T2 distinct from the rest due to their vigour and landscape value and such were graded as 'A' category. Both trees crowns contain minor deadwood.

Trees T1 and T2 have a minor portion of the deadwood in crowns which is recommended to be removed due to the location of trees near the public pathway.

The tree T1 requires removal of lowest branches to avoid obstruction of the construction works and promote crown development above the proposed building.

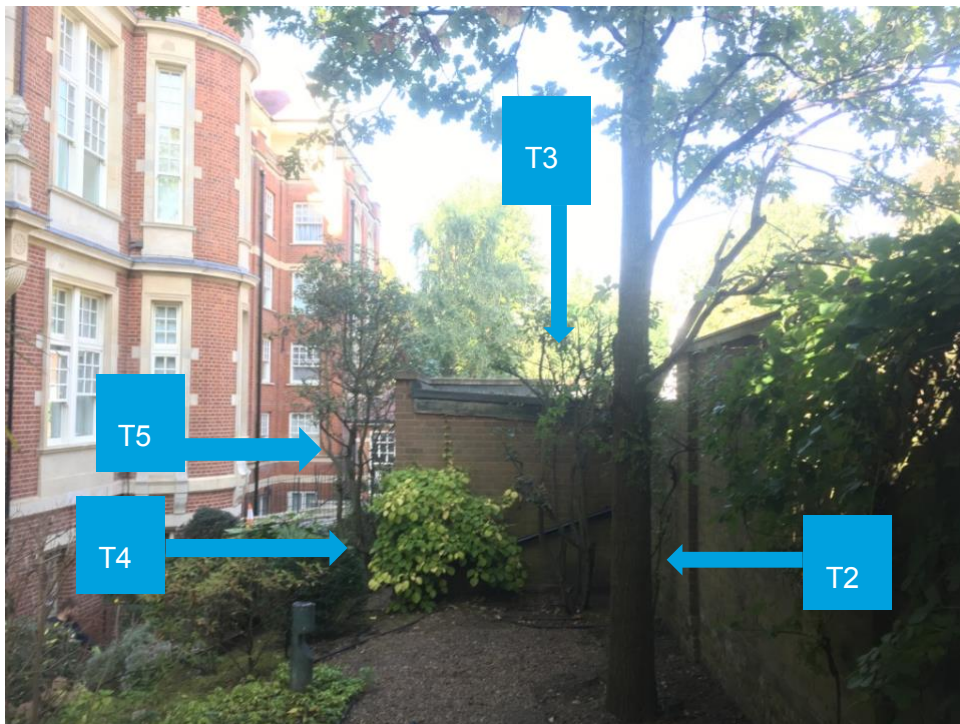
Figure 4 The picture shows trees T2, T3, T4 and T5

T3-T6 were identified as unremarkable trees due to their previous unsympathetic management, and the trees were graded as 'C' category.

According to the latest layout provided by the client, **none** of the trees RPA will be impacted by the proposed design. Development works will take place just outside RPA of the tree T2 (1.2m distance from the existing wall to the edge of the RPA of the tree T2).

The construction works will take place just outside the RPA of the tree T2 and care must be taken as there is 0.2 buffer zone between the proposed building wall and the edge of the Root protection zone. The underground root guard installation is recommended due to the relative proximity of the tree to the building.

The most recent layout supplied by the client indicates that the tree T3 needs to be removed in order to facilitate the development.

The tree T3 pose a constraint to the development and require removal.
