Project: 1604 - 11 Prince Albert Road – PL8 application

Design, Access & Heritage Statement - Works to Boundary Walls

11th October 2018

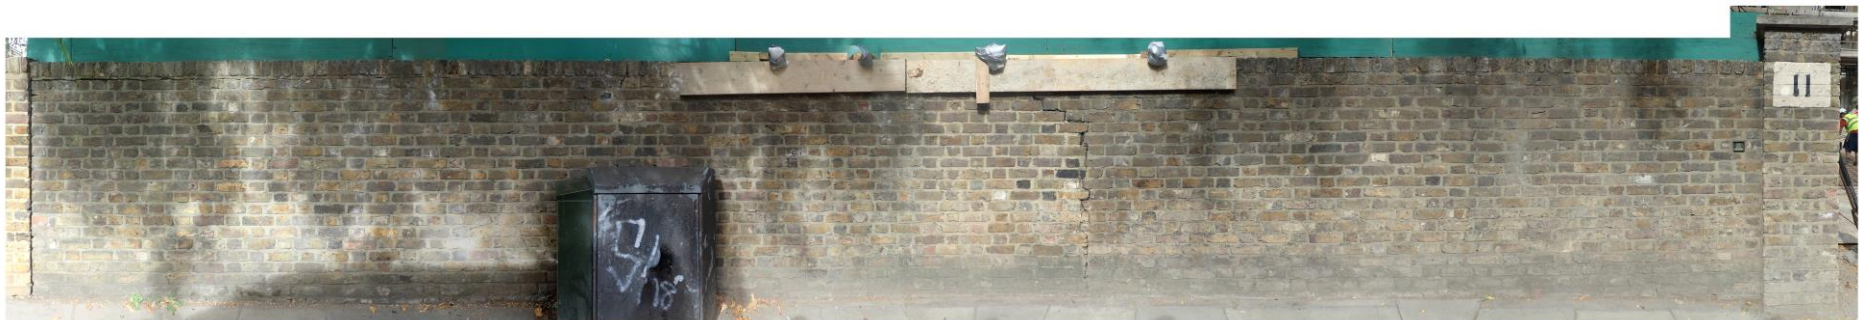
The front (south) boundary wall is out of plumb along the whole of its length, which has deflected in the middle and cracked in two places. A photographic survey of the wall has been undertaken and accompanies this application showing the extent of the problem. A trial pit identified the wall has negligible foundations, in addition to sitting next to two large trees.

It is proposed to carefully dismantle the Flemish bonded wall, salvaging as many of the buff bricks as possible. New footings will be created using small piles, following the method statement which has been developed with and endorsed by our Tree Specialist to ensure that no damage is caused to the nearby tree roots. The wall would then be rebuilt in lime mortar with the original bricks, plus any additional ones necessary chosen to match – either reclaimed from other sources or new handmade stock bricks.

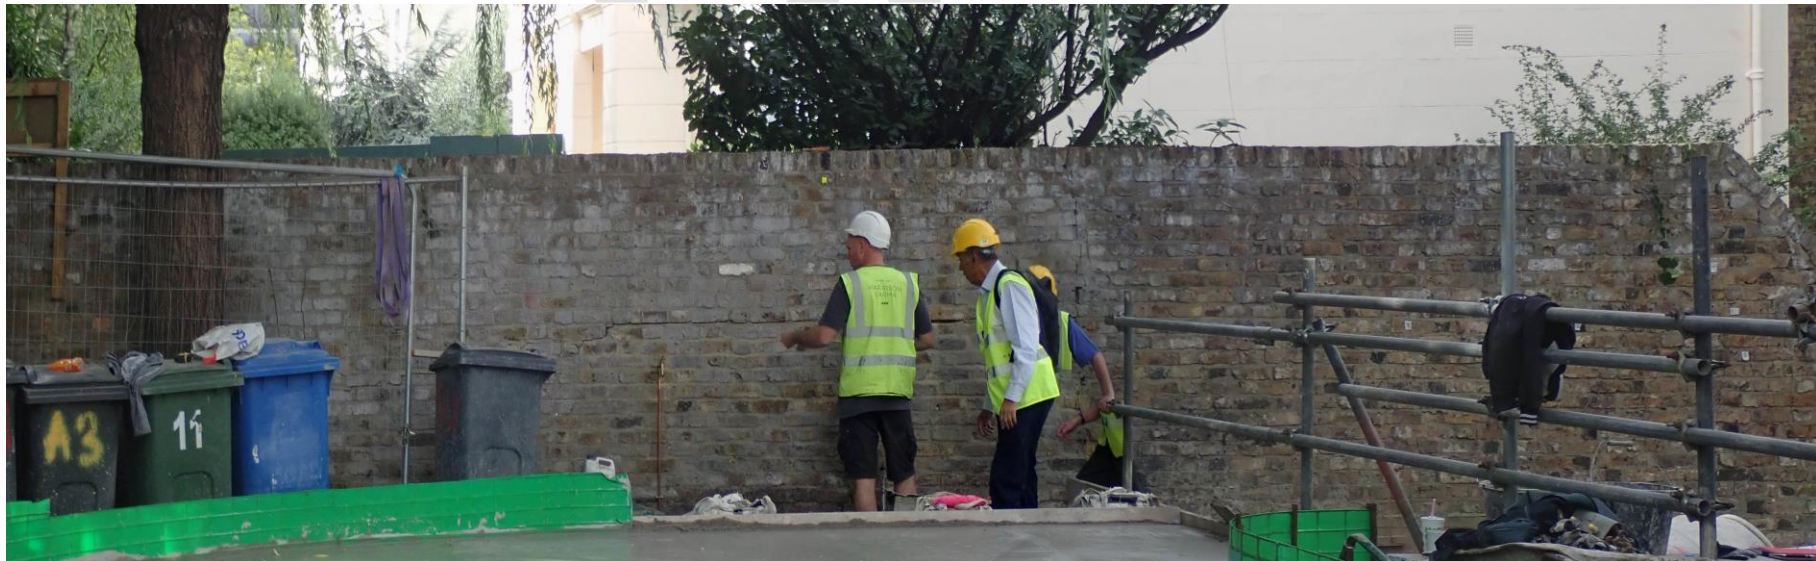
The west boundary wall between No 11 and No 12 Prince Albert Road is also affected by cracking. It has been identified that the 'front garden' section of this wall has little in the way of foundations, whereas moving back further into the site, the wall has deeper foundations due to an older wall below (believed to derive from when the ground in the wider area was 'made up' at the time the houses were built). This difference in foundations is expressed clearly in the cracks which have appeared – a vertical crack at the point where the foundations change, and a long horizontal crack across the front garden section of the wall. The wall has been pointed in cementitious mortar at some point in recent history.

It is proposed to carefully dismantle the existing front-most portion of the Flemish bonded wall, salvaging as many of the buff bricks as possible, and rebuild on new foundation, in the same manner as described above for the south wall. A movement joint would be created at the line of the existing

vertical crack, where the foundation changes, to allow for future differential movement in this location. To the retained portion of wall, it is proposed to remove the cement pointing wherever found and repoint the wall, including the minor cracks, in a lime mortar.

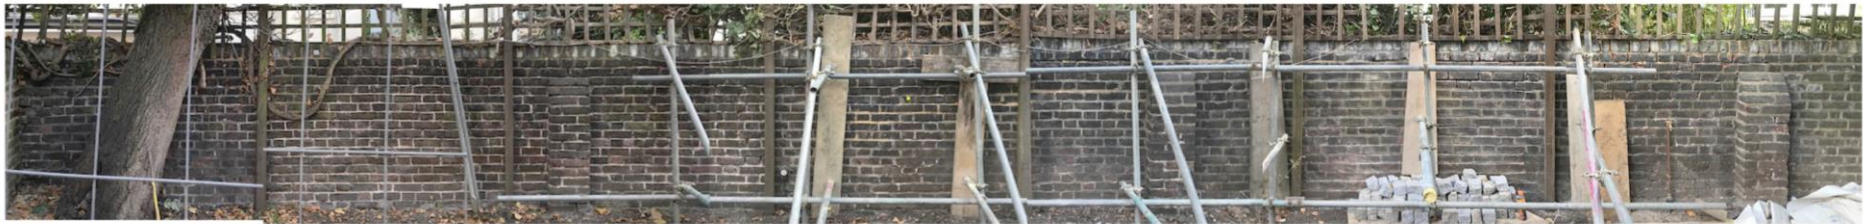
The red brick north boundary wall sits between No 11 Prince Albert Road and the properties along Regents Park Road at the rear of the site. Land registry records confirm this wall is owned by and the responsibility of the owner of No 11. The wall has 3 slender piers on the south side and disconnected perpendicular walls to the north dividing the neighbouring gardens. A recent survey has confirmed the north boundary wall has developed a pronounced lean along its length, into the site. A trial pit has confirmed that this wall has only a tiny stepped foundation.

It is proposed to carefully dismantle the Flemish bonded wall, salvaging as many of the red bricks as possible. New footings will be created using small piles, again following the method statement to ensure that no damage is caused to the nearby tree roots. The wall would then be rebuilt in lime mortar with the original bricks, plus any additional ones necessary chosen to match – either reclaimed from other sources or new handmade stock bricks. The brick piers would be replicated in the same position.

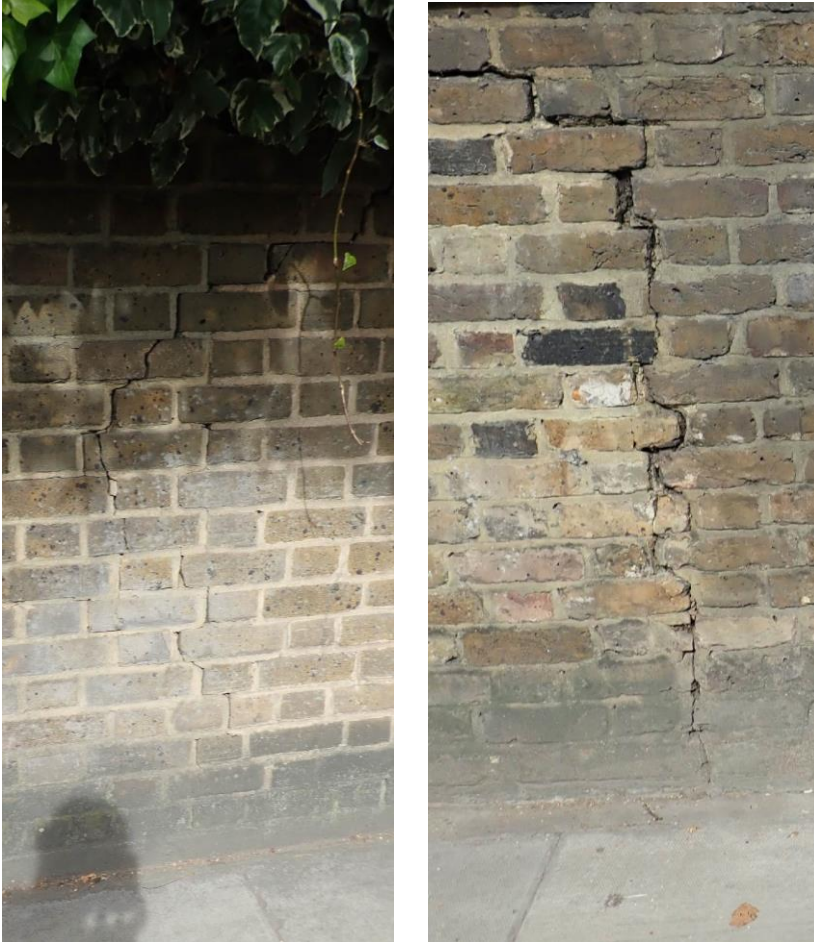
Left: and Centre: cracks in street-side south boundary wall.

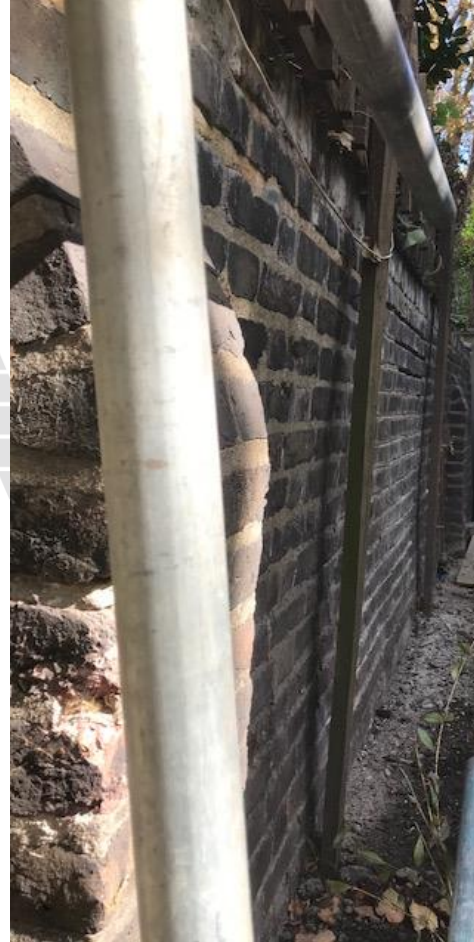
Right: Deflection to north (rear) boundary wall.

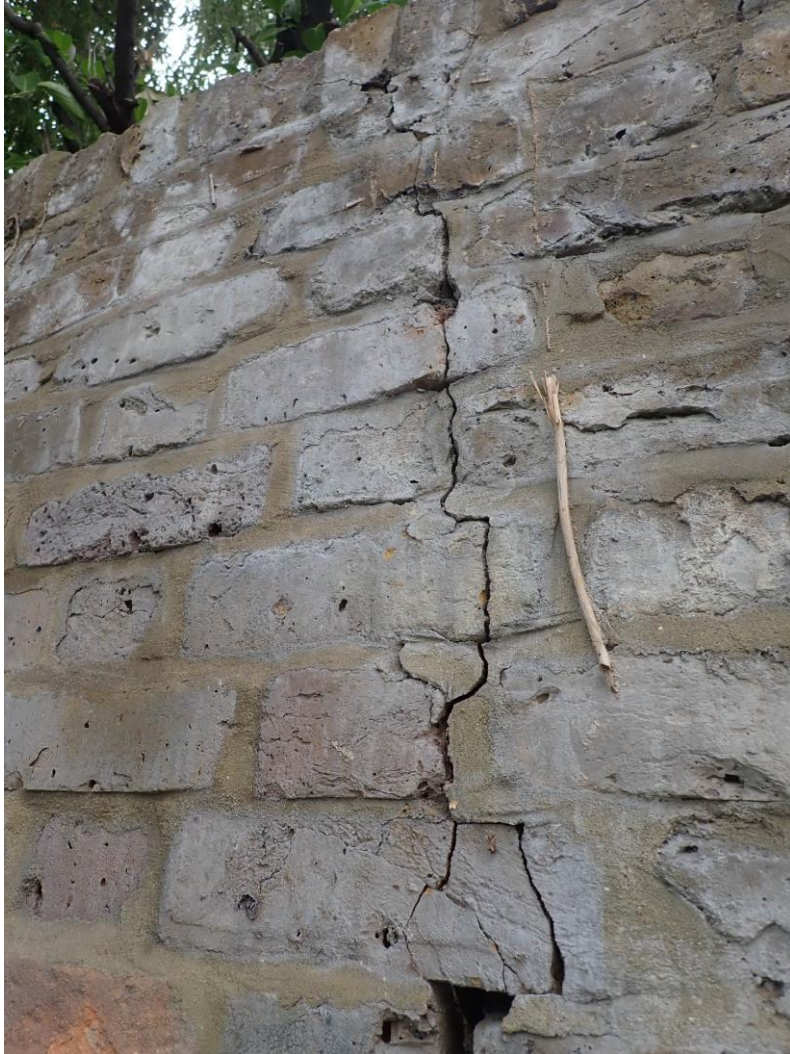
Left: vertical crack in west boundary wall at point where foundations change -position of future movement joint (left of this line proposed for careful deconstruction and rebuilding)

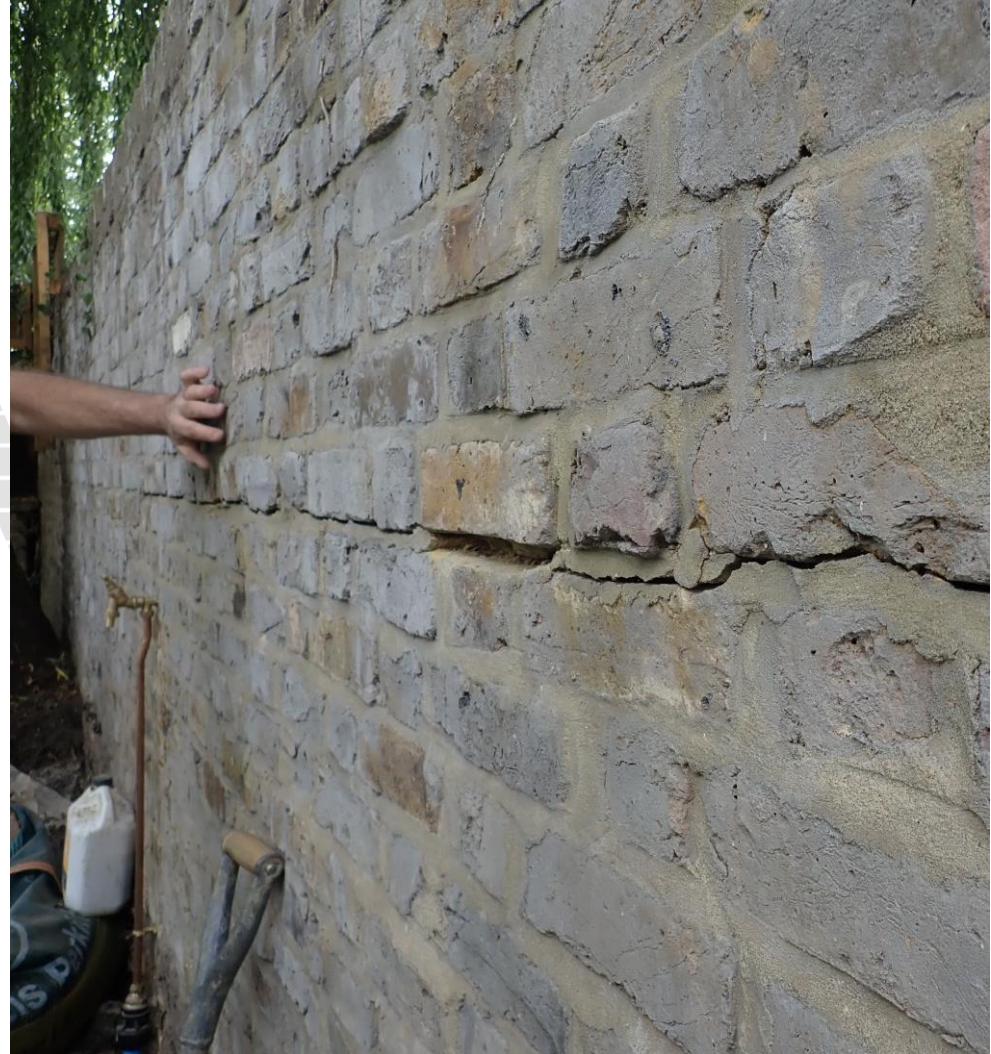
Right: Longitudinal crack in west boundary wall adjacent to front garden. Crack runs right through wall – upper portion is detached.
