ARBORICULTURAL IMPACT ASSESSMENT REPORT:

11 Prince Albert Road

Ref: HVL/11PAR/AIA/04

Date: 5th October 2016

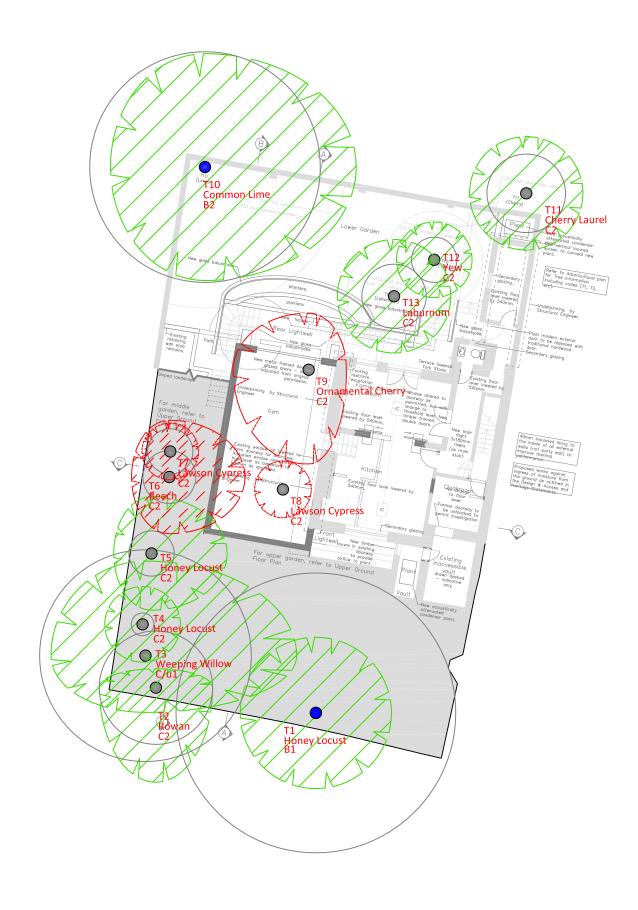
Proposed Lower Ground Floor Plan

- 1.3 The principal primary impact in the current proposal remains the proposed basement excavation within the theoretical RPA of category B tree T10, although the degree of encroachment has been considerably reduced and is considered sustainable at under 5% of the RPA. The excavation would require the use of mini-rigs, as the current ground clearance is 6m.

- 1.5 The latest revisions introduced stepped planters in the rear garden, the base of which has a very minor impact on T13 of approximately 0.2m². Such an impact will be of negligible consequence to the tree provided any excavation within the RPA is carried out by hand with pre-emptive root pruning.

- 6.3.2 The line of the foundations within the RPA of T2 should be manually excavated with preemptive root pruning to 750mm under arboricultural supervision; any roots encountered within the trenches / pits will be cleanly pruned back to an appropriate junction with a sharp pruning saw or secateurs back to a junction. Roots larger than 25mm diameter may only be cut in consultation with an arboriculturalist.

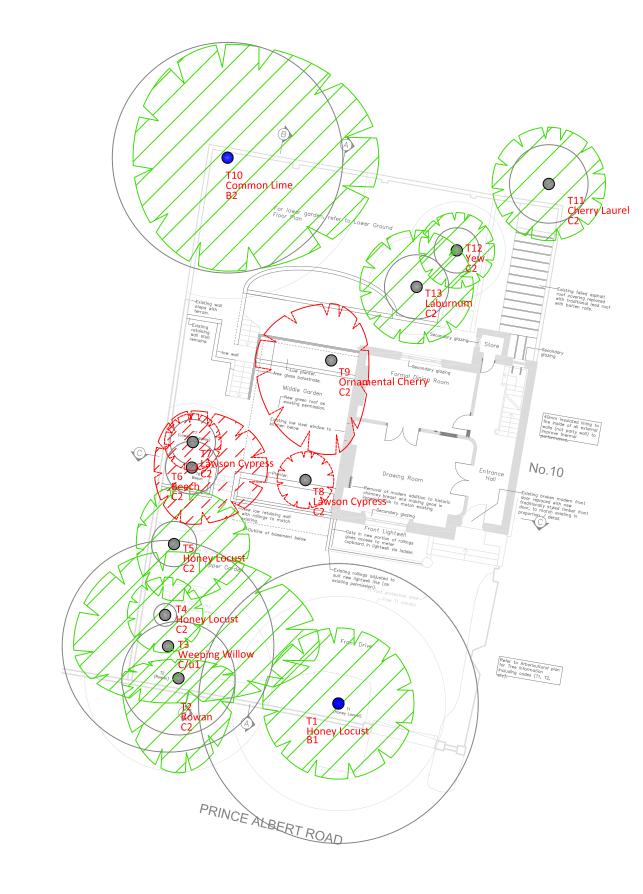
Proposed Ground Floor Plan

- 1.4 Other primary impacts comprise the felling of mainly young category C trees T6, T7, T8 and T9. The loss of these trees is rated as a low impact, with no significant effect on the visual character of the local conservation area. The replanting scheme will offer considerable enhancement and replaces the three young/one semi-mature trees with species specifically selected for the proposed site, healthy and fit-for-purpose. There will also be some very minor canopy encroachment during construction only to T5 (3m ground clearance). It is recommended that the canopy is either tied back or minor pruning works used to facilitate the construction of the LFG/GF extensions beneath the canopy.
