Addendum to: Tree Report & Arboricultural Impact Assessment. (Previous report ref: SB/JS/450 date February 2016).

Land at 6 Templewood Avenue, London NW3.

Date: October 2018.

Reference: SB/JS/616.

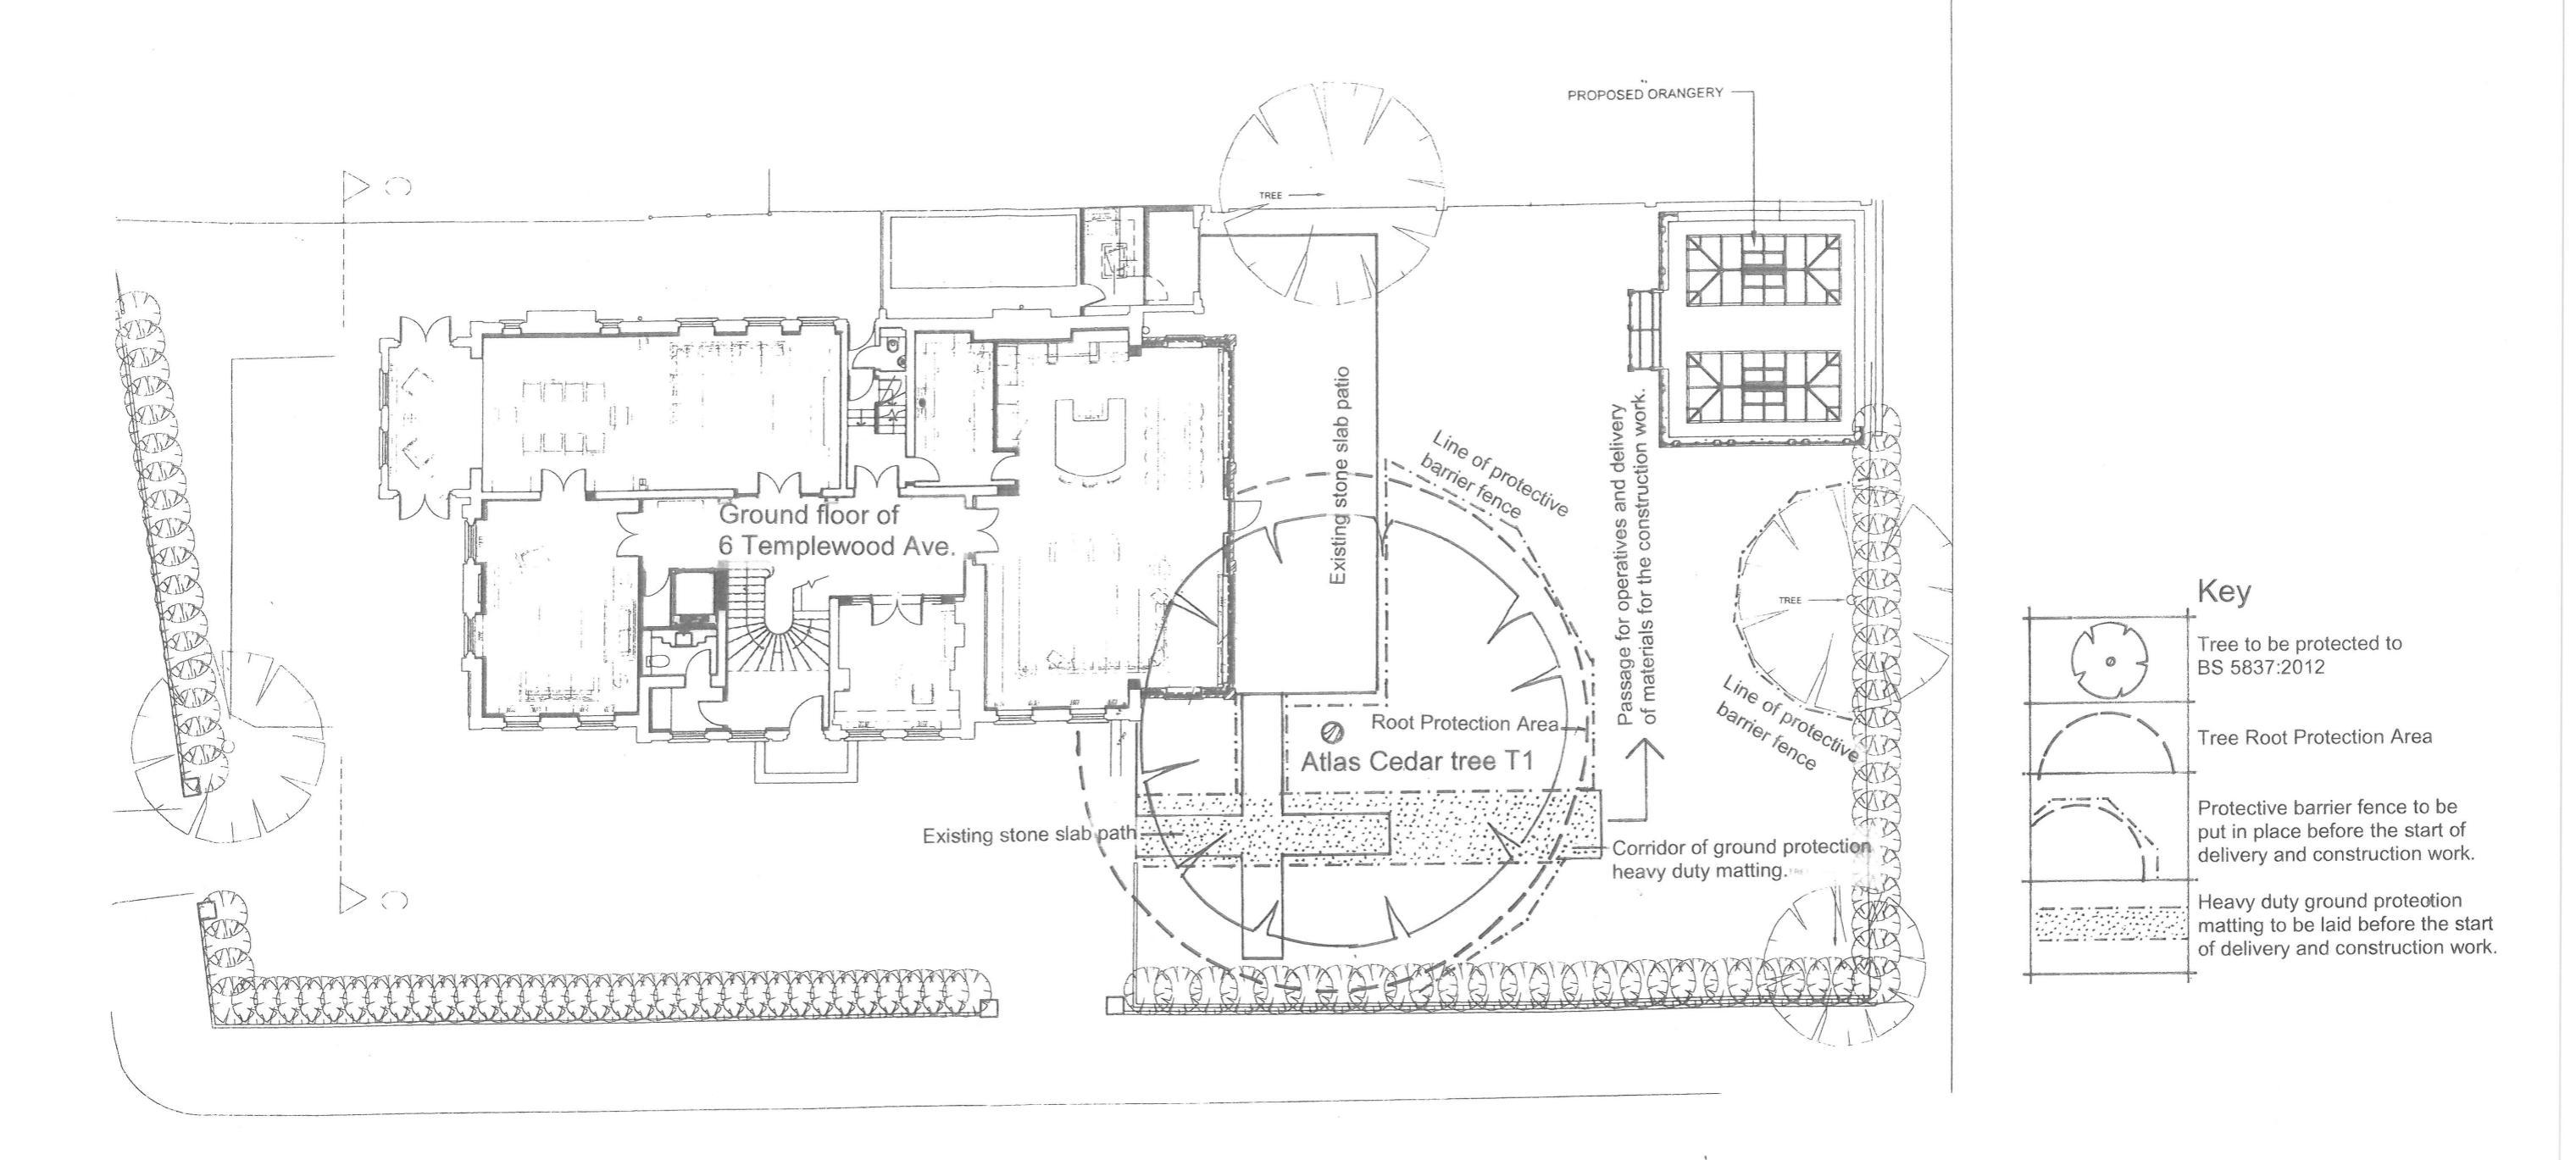
- 5.1 The measured tree canopy and Root Protection Area for Cedar tree T1 is shown on the Tree Survey and Protection Plan. RPA's should be regarded as Construction Exclusion Zones unless development has been permitted within this area and special measures of mitigation are taken. Based upon the recommendations of BS 5837:2012, the Root Protection Area (RPA) is calculated at a certain radius from the base of the tree. This is the minimum area in m² that should be left undisturbed (without special measures of mitigation). The RPA is calculated as an area equivalent to a circle with a radius 12 times the stem diameter for single stem trees when measured at 1.5 metres above ground level. The crown spread should not be used as a guide to the possible extent of major roots.

6.1 The Root Protection Area for the retained tree has been plotted on the Tree Survey and Protection Plan. This is based upon the tree stem diameter and measured as a radius from the centre of the tree.

Tree Number	RPA Radius (m)	
T1	7.8m

- 5.2 Unless special measures of surface protection are used or existing hard surfaces are retained, the whole of the RPA shall normally be fenced and protected from any disturbance and excavation during the construction period. In this situation the proposed construction will take place well outside the RPA but pedestrian and possibly light vehicular access will have to be taken across the RPA. A passage will need to be provided across the lawn so that operatives can carry the pre-constructed units over to the erection site in the northeast corner of the garden. Special ground protection will be provided to avoid soil compaction and to protect the root zone of the tree. See Method Statements below.

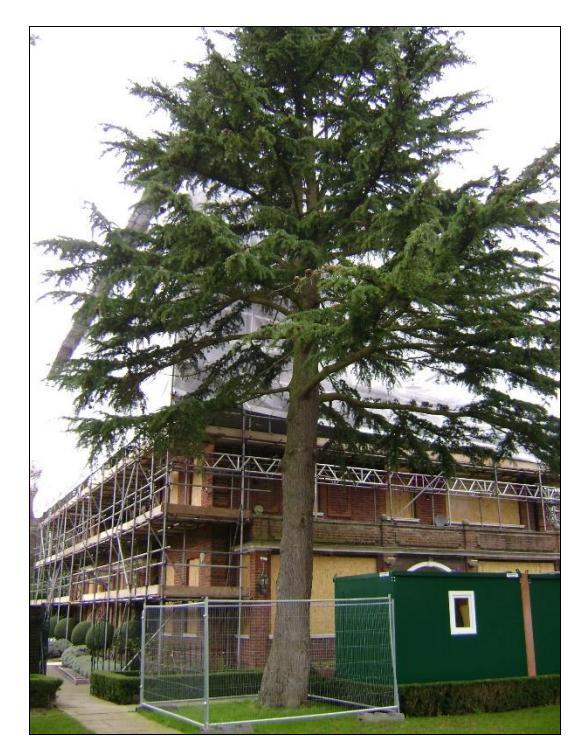
Photograph 1 – Cedar tree T1. The site cabins have been placed on the stone patio surface for the duration of the construction work. The protective fencing is a temporary measure and will be moved out to protect all the soft ground within the Root Protection Area.

There is still a small amount of dead wood in the crown of Cedar tree T1. The recommendation in the tree schedule is for the dead wood throughout the crown to be removed. The tree work shall be carried out in accordance with BS3998: 2010

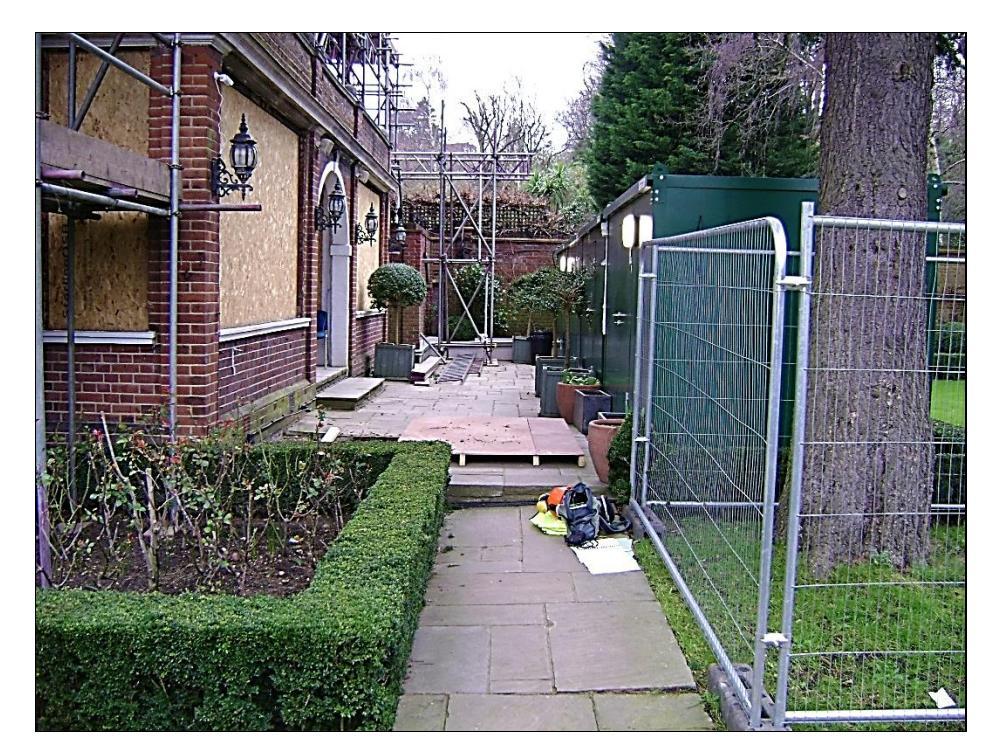
Photograph 2 – Looking down the side of the building and the existing stone slab path and patio. The stem of the Cedar tree to the right of photograph.
