Details Pursuant to British Standard 5837:2012,  
Trees in relation to design, demolition & construction  
Land @ 95 Canfield Gardens, London NW6 3DY

## **BS5837:2012 Survey and Report**

November 2018

**DKS/664**

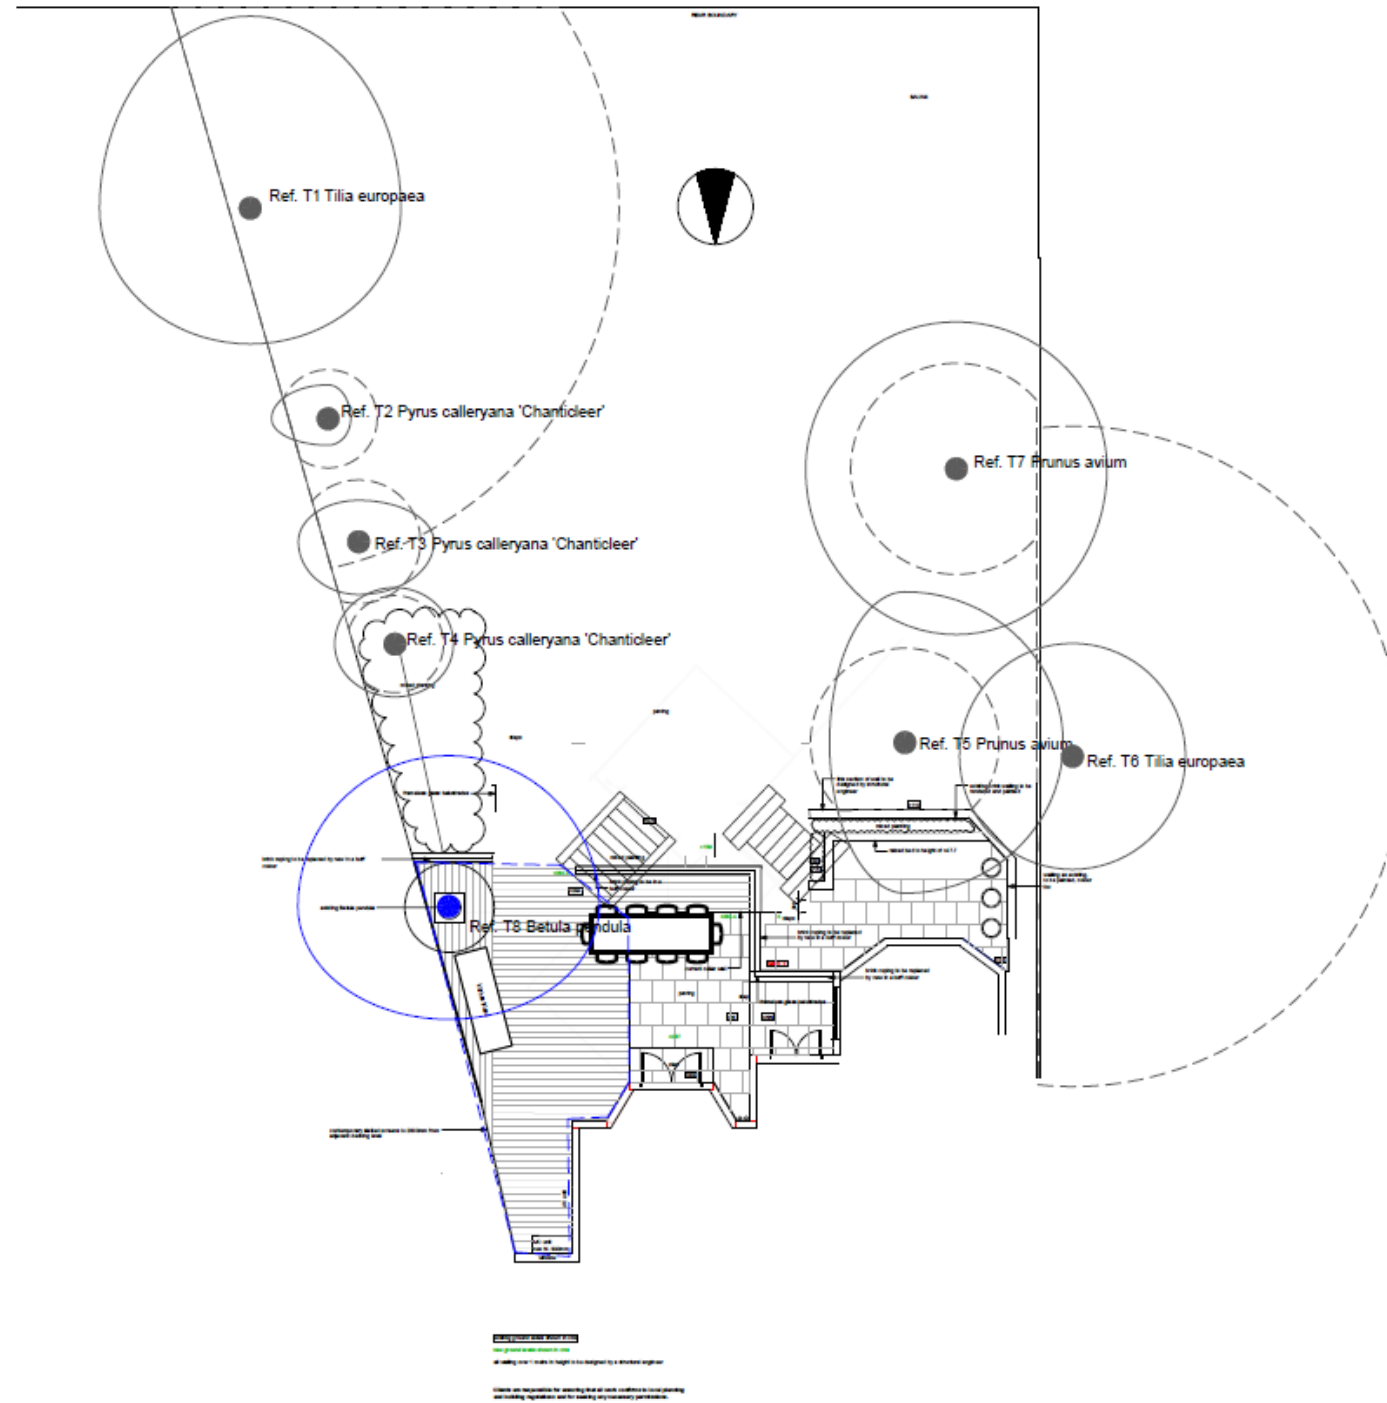
**Appendix 2: Tree Plan Existing**

Tree no.	Life stage	Sc	Pc	Eml	BS5837 Category	Comments
T6	Semi - mature	Good	Good	10+	C1	Relatively small off-site, neighbouring property tree with amenity ltd to private rear amenity areas. Root morphology was assessed as asymmetric (Appendix 2 plan, shows root morphology) due to relatively deep boundary garden wall foundation (probed to >500mm depth), located adjacent & to the tree's E: Damage to the wall was evident from structural root pressure potentially providing a minute & significantly ltd area for root ingress into the site. Wall repair sensitive to the tree's roots would be prudent. Tree's close proximity to dwellings should inform tree management to retain at current size, through continued pollarding. Where the tree is not regularly pollarded it should be the subject of triennial monitoring. <b>Effective protection can be provided with sustainable tree retention.</b>
T7	Semi - mature	Average	Average	10+	C1	Small tree of ltd garden amenity. Where the tree is not regularly managed at/near current size; quinquennial monitoring is recommended. <b>Effective protection can be provided with sustainable tree retention.</b>

RPAs shown are reflective of assessed actual root morphology. Plan PDF @ accurate scale size provided separate from this report. DWG available upon request.

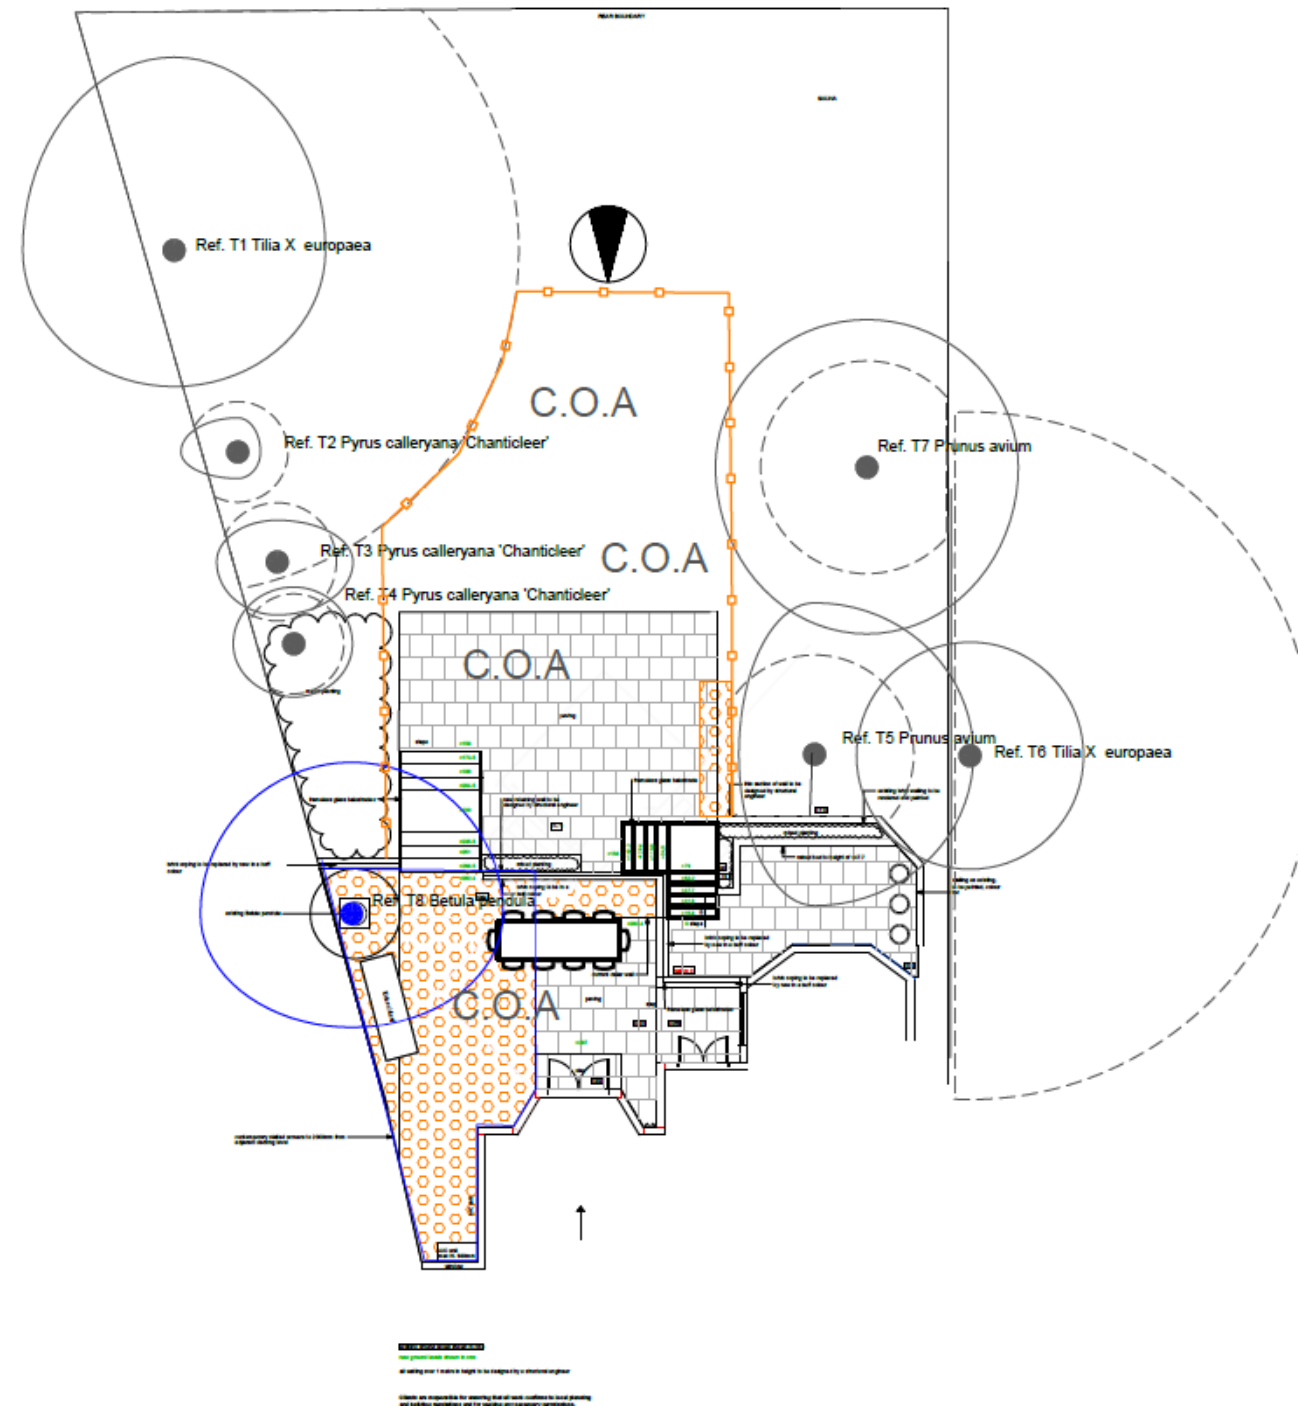
### Appendix 3: Tree Protection

The proposed development including decking and the western edge of the stone patio would be located within the BS5837 theoretical optimal radial root protection zone (TORPZ) for trees' T5 and T8. However, the impingement upon T5 would be <5% of its TORPZ, perfectly tolerable for a young tree particularly, with SPM (S.7.1.) implemented. With regard to T8, both the current decking would be removed and the new decking constructed by hand. With the new decking floating on a framework attached to carefully located vertical struts. Decking removal and construction shall also be the subject of SPM (S.7.1.). The new decking will also require a small garden wall to be removed increasing the potential rhizosphere into an existing soil bedding area for T8. A small amount of construction facilitation pruning may be required to T5 on its eastern side but limited to branches of <50mm diameter and only to a maximum height of 2.5m above ground level. Facilitation pruning where required shall be conducted in accordance with the British Standard for Tree Works (B3998, 2010). With protection measures in place the impact upon the trees would be de minimus and with a long-term rhizosphere benefit for T8. No trees are required to be removed to facilitate development.

In order to ensure the tree roots of T8 are not damaged, implementation of the current decking demolition and new decking construction must be phased first. Therefore, as development commences the new decking area will in-part provide ground protection for T8's roots. With regard to T5 and the new stone patio, measures need to be implemented in relation to the slight impingement into the tree's TORPZ to prevent potential far reaching root damage.

The construction operations area consists of the hatched area for special protection measures and the area contained within the barrier fencing and south of the existing building

All construction operations must take place entirely within this area to protect the root zones of existing trees on site.
