PBA Consulting

Tree Survey to BS5837:2012

Flat 1, 3 Carlingford Road, London NW3 1RY

PBA Ref: Q10017

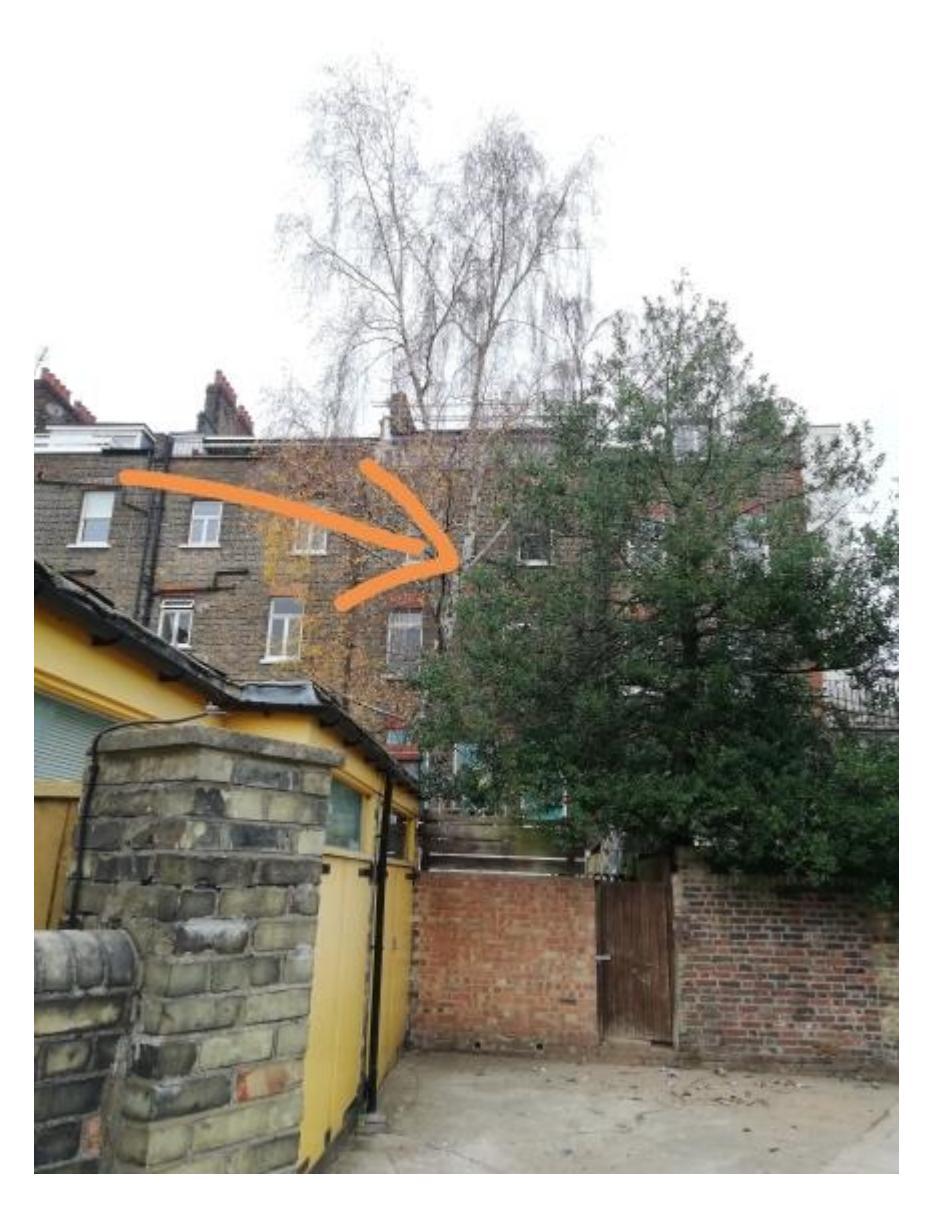
- 2.2 The Silver Birch tree referred herein as T1 is approximately 5.6m from the rear of the property, 5.5m from the eastern boundary and 4.9m from the rear boundary. The tree is situated adjacent to the western boundary. There is a low (three brick course) retaining wall around the area within which the tree grows. The level of thelower ground floor flat patio area is lower than the garden and there is a retaining wall. It is unknown if and when any alteration in ground levels have been altered since the tree has existed. The tree leans east towards the rear garden.

T1 in relation to rear aspect

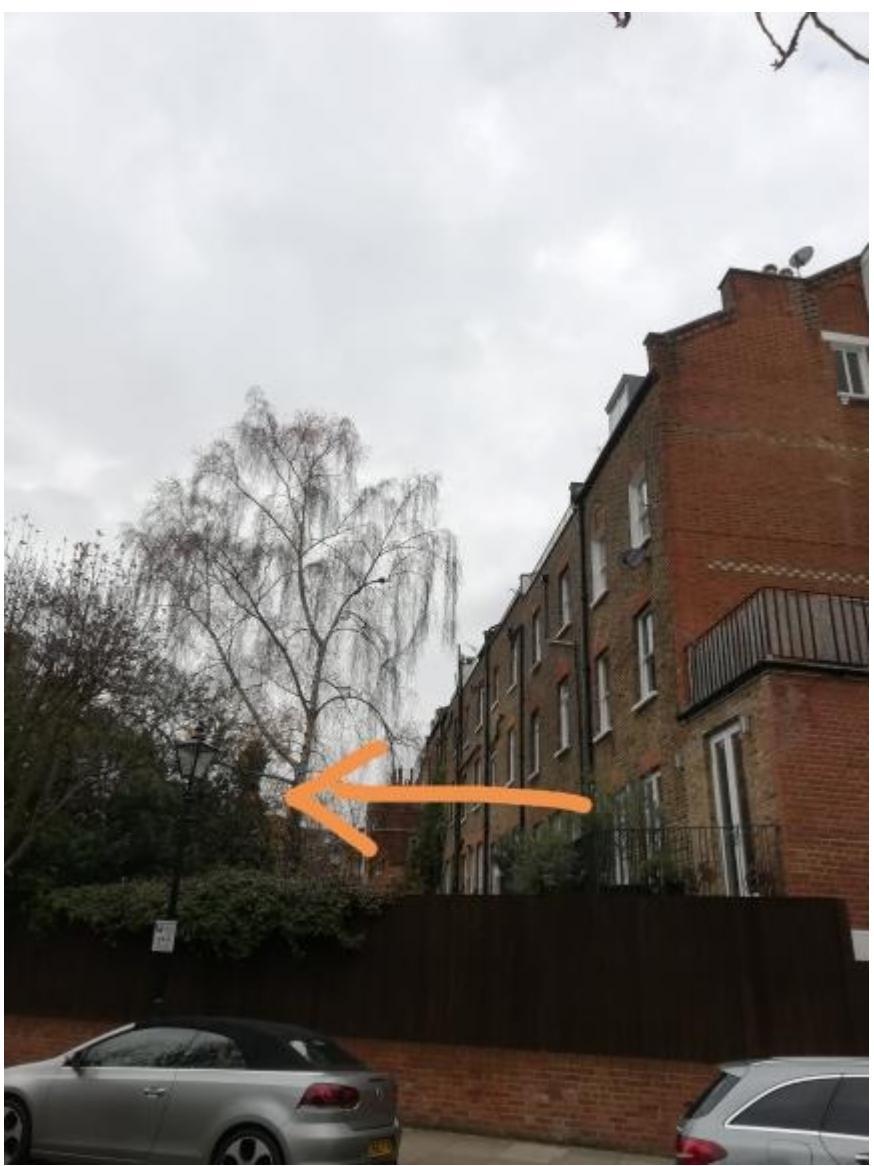
T1 in relation to rear aspect
