20 Theobald's Road, London, WC1X 8PF

APPENDIX 6: Heritage Impact Schedule

APPENDIX 8: Opening-Up and Investigative Works

All photographs of the site were taken between September and October 2018. The photographs of each room are given a reference on the associated floor plans.

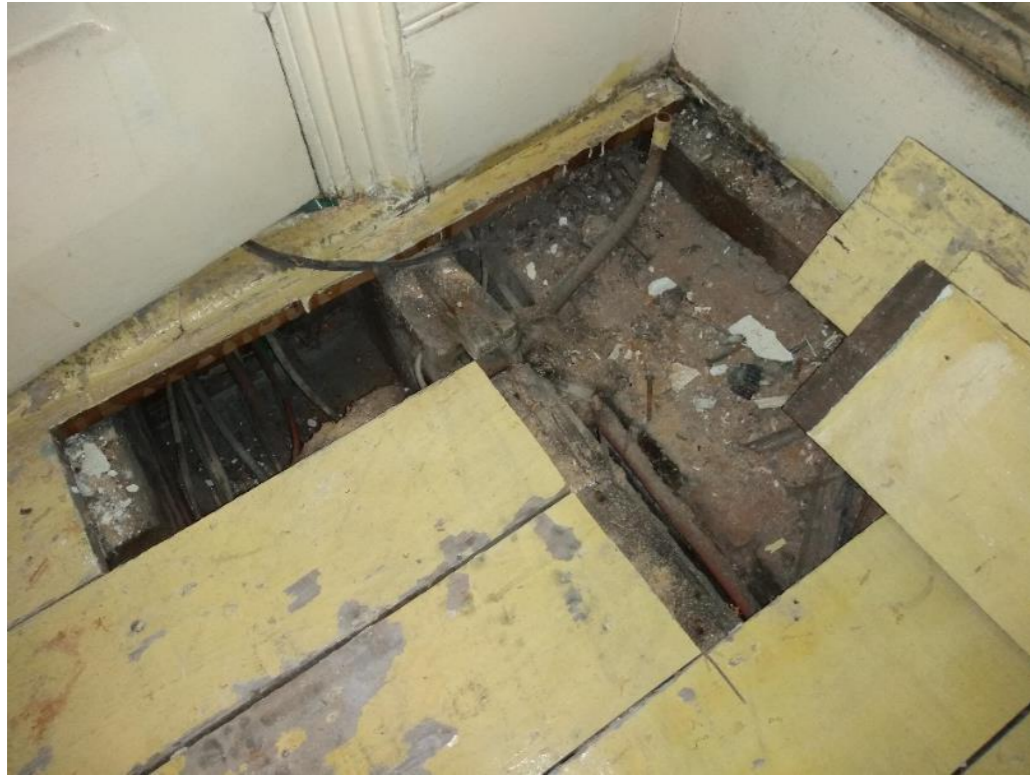
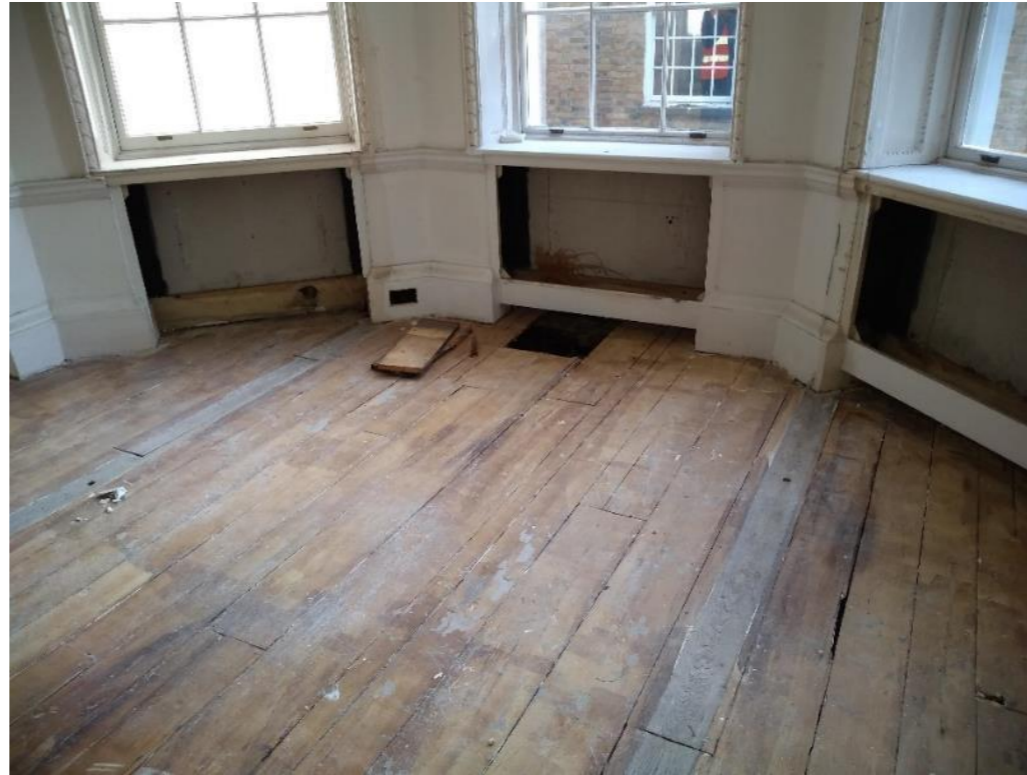
GF - 2-00-01

The opening-up works have revealed, and confirmed our expectation, that the remaining historic fabric in No 20 has been altered in the past. The floorboards appear to either be modern, or a patchy combination of modern and historic floorboards. Similarly, most ceilings appear to be modern plasterboards and brickwork throughout has been covered with a thick hard layer of what appears to be a cementitious plaster. It has also revealed some potential structural issues with the historic load bearing timber beams and joists – this is explained in detail within the structural engineer’s report – and addressing the appropriate way to preserve and protect the historic fabric as much as possible.
