## ARBORICULTURAL IMPACT ASSESSMENT REPORT:

36 Redington Road  
London  
NW3 7RT

**Ref:** ARC/36RDR/AIA/02

**Date:** 27<sup>th</sup> May 2015

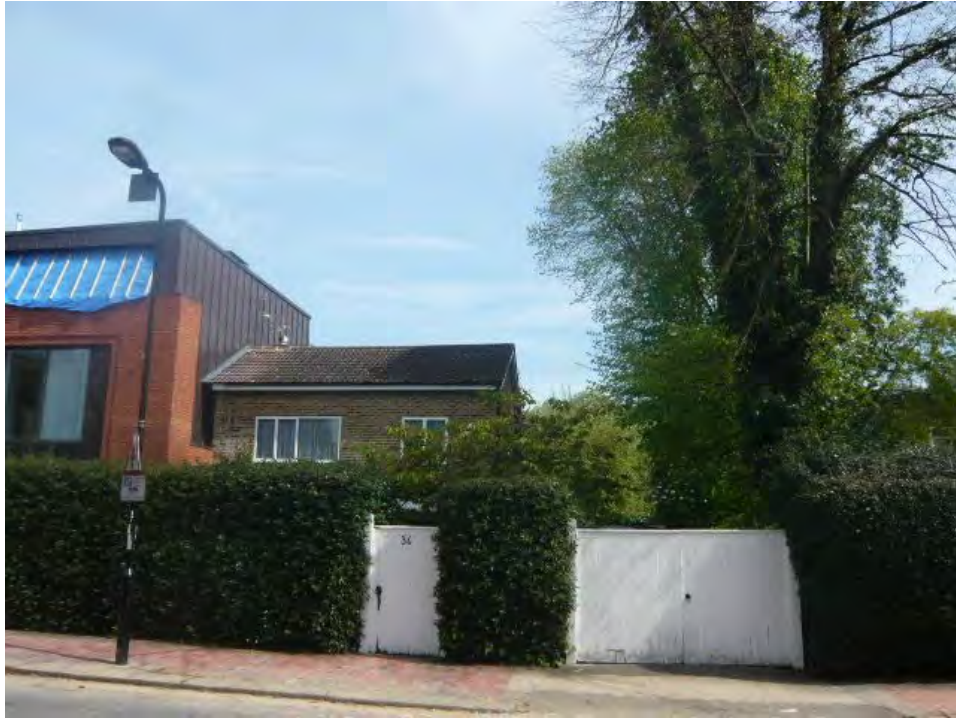
Photograph 1: View of the Site from Redington Road

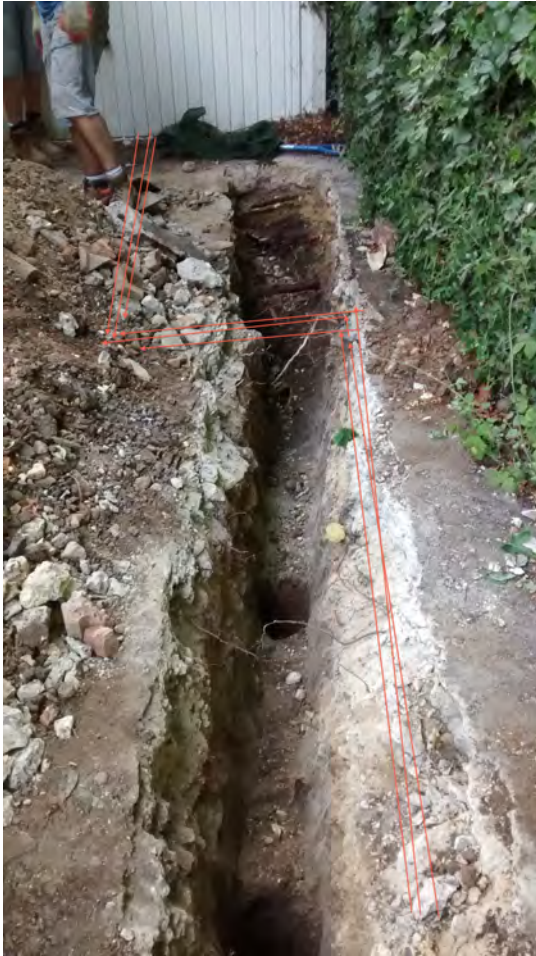
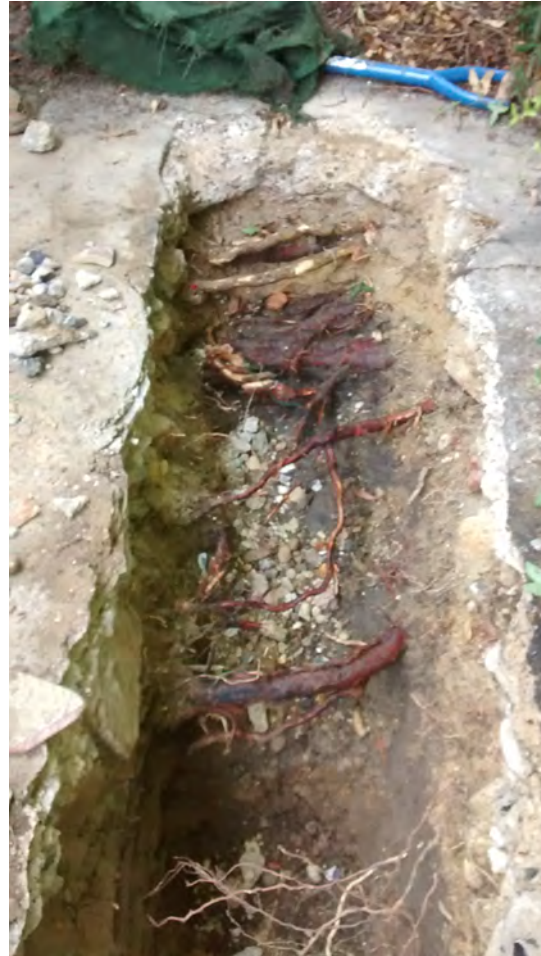
Trial Pit	Results
TP1	Roots over 50mm encountered towards the north-eastern end of the trial pit. Basement outline amended accordingly.
TP2	Two remaining significant roots encountered; both below 50mm.

Photographs A5.1 and A5.2 illustrating results of Trial Pit 1 and amendment to basement line in red

A5.2.1 The trial pit results are shown in table A5.2 below and illustrated in the photographs. Where significant roots were found, the basement outline has been amended.

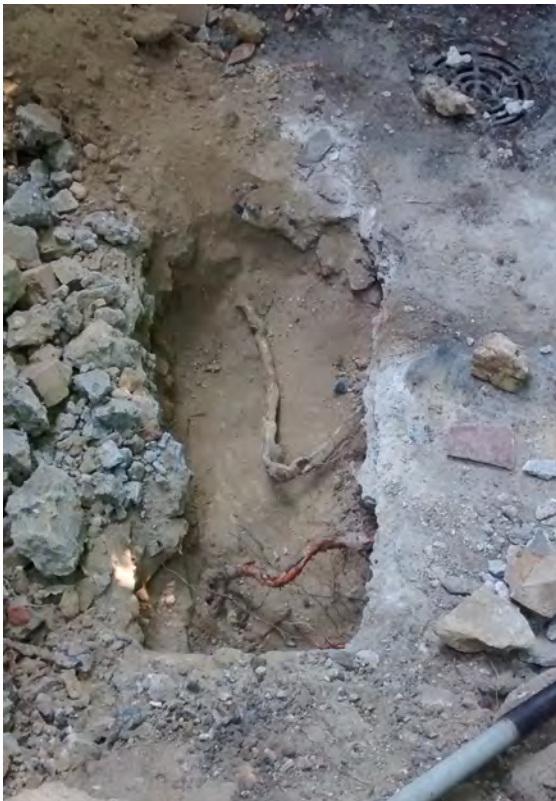
Photograph A5.3: Results from Trial Pit 2
